MHB Badger Breaker® rubblizing continuously reinforced concrete pavement (CRCP) on I-70, Clark County, IL during 2003. 37 lane miles of rubblization and HMA overlay.

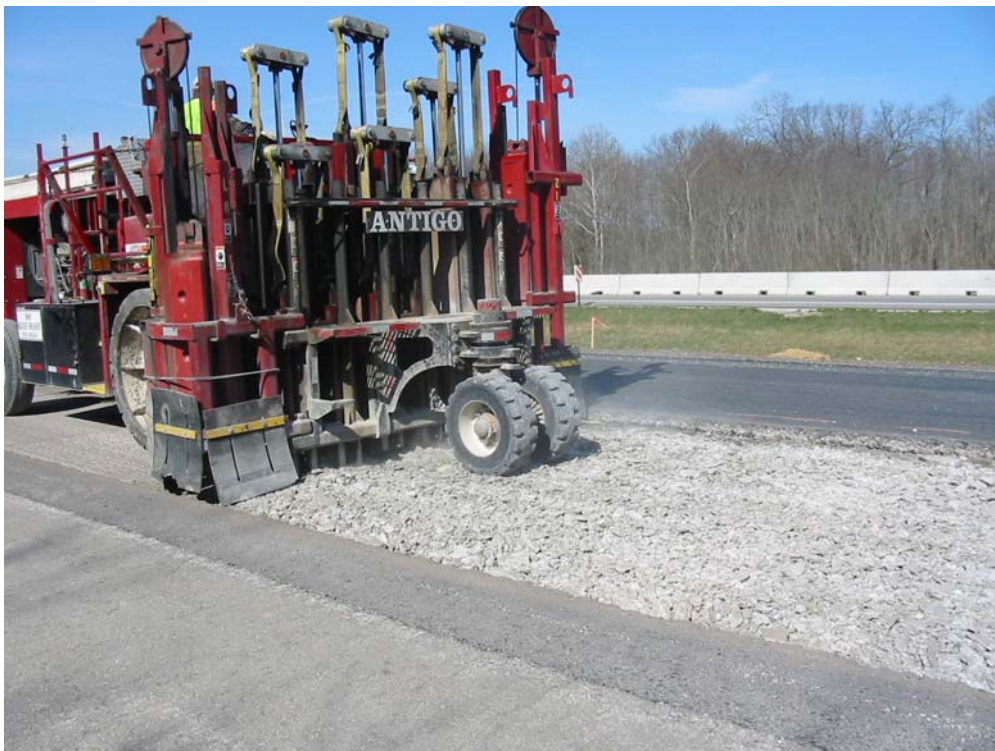
1 lane of existing HMA overlay removed and underlying CRCP rubblized.

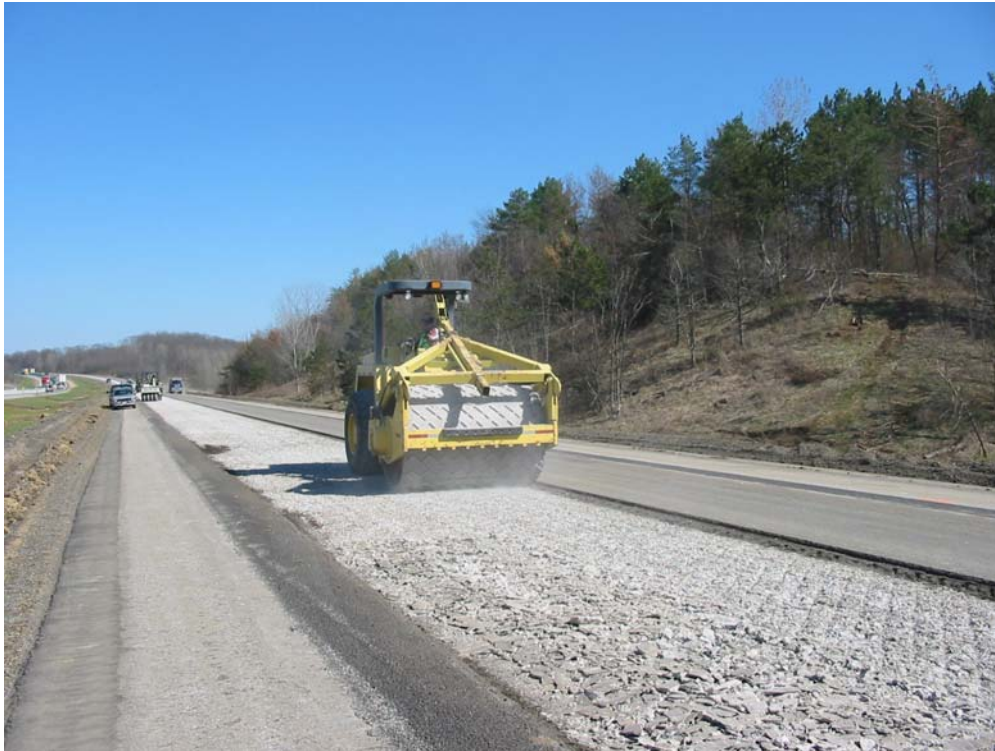
First compaction/seating pass with grid roller.

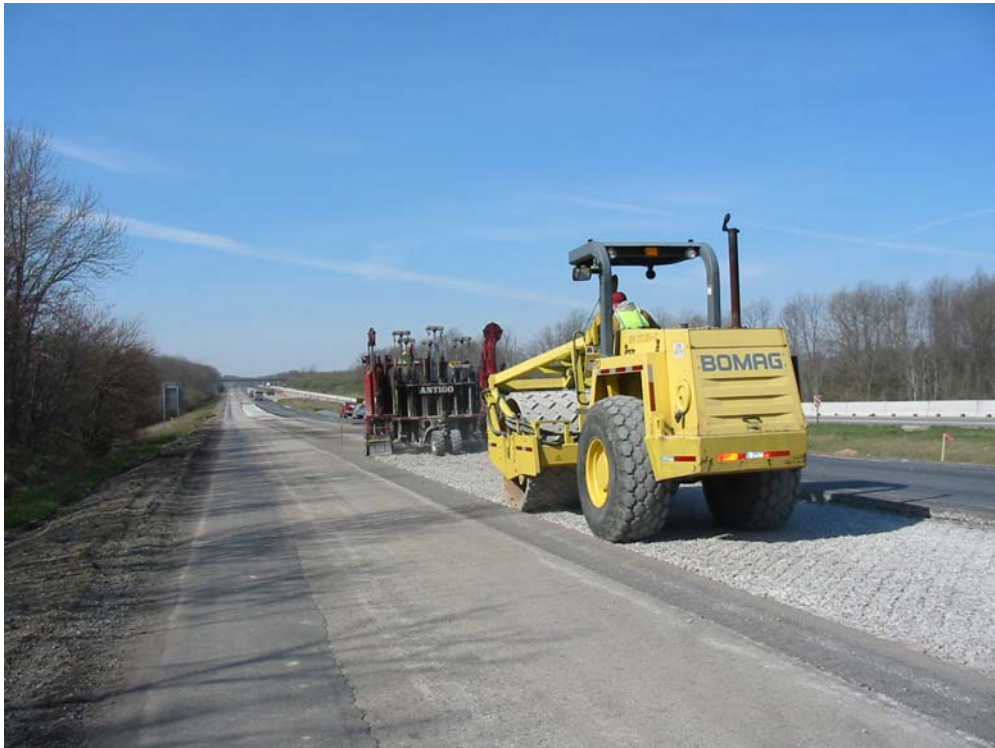
2nd compaction/seating pass with grid roller.

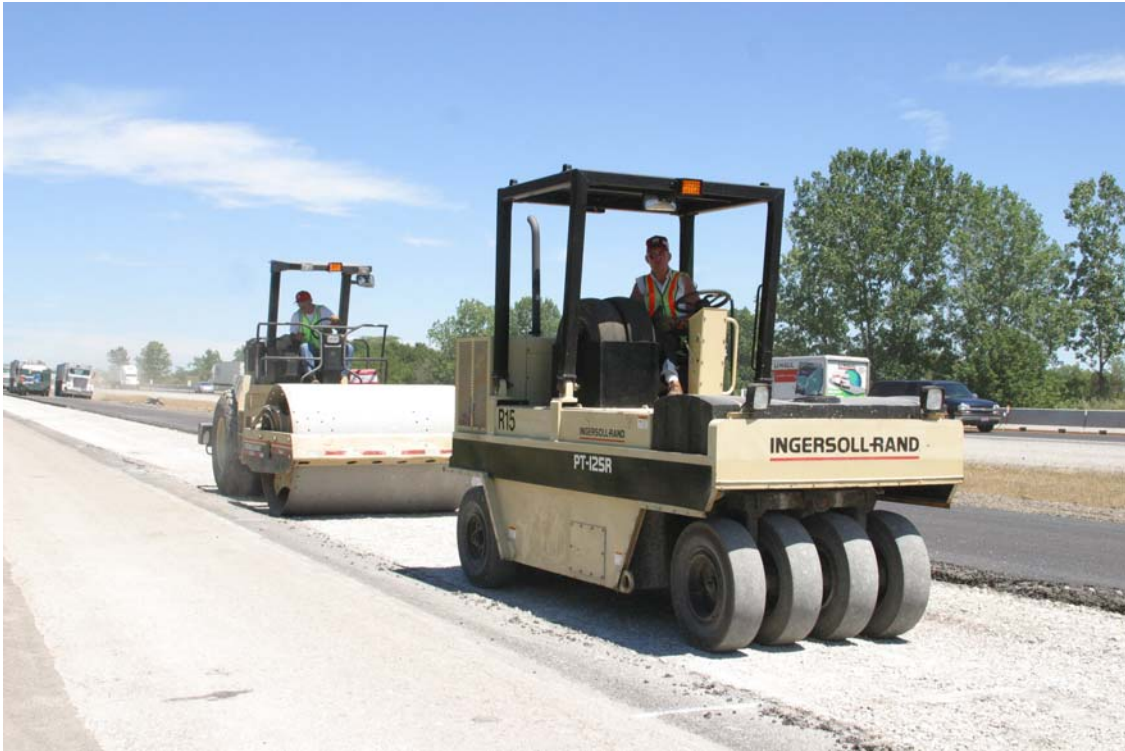
2 passes with PTR and 2 passes with vibratory smooth drum.

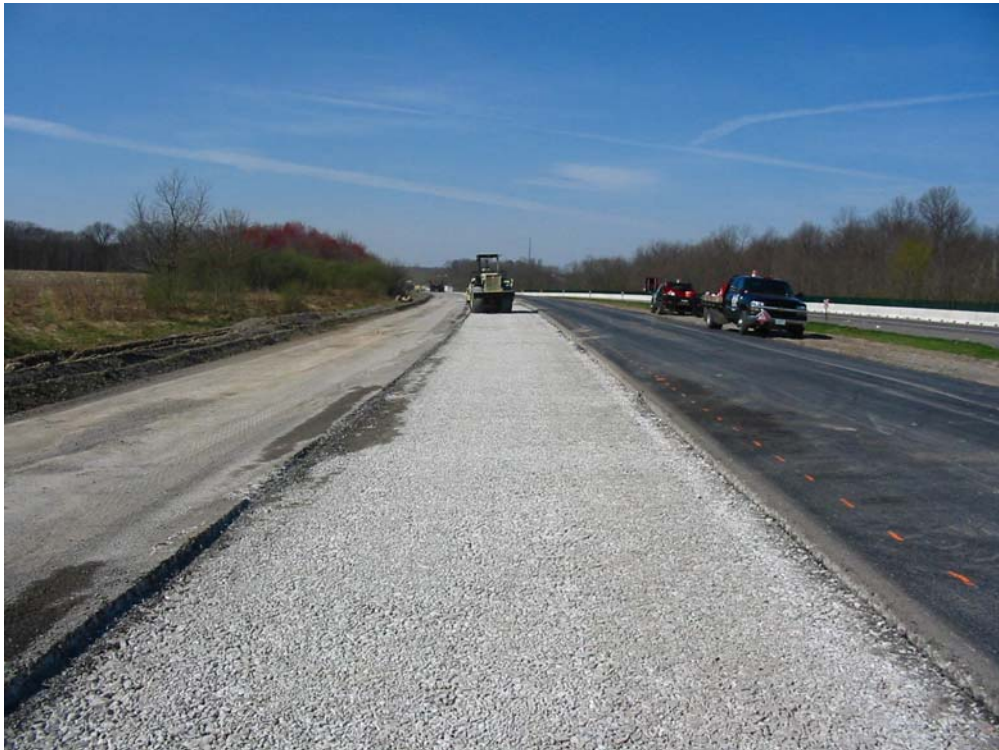
Final surface after compaction/seating - ready to overlay with HMA.

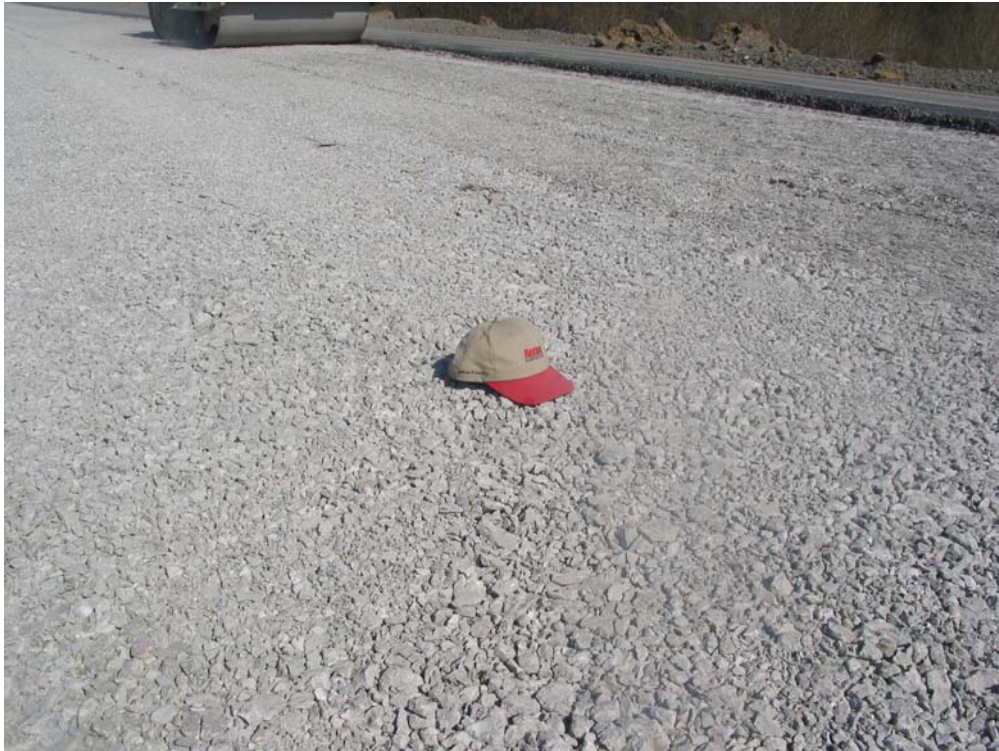
Typical final surface after compaction/seating.

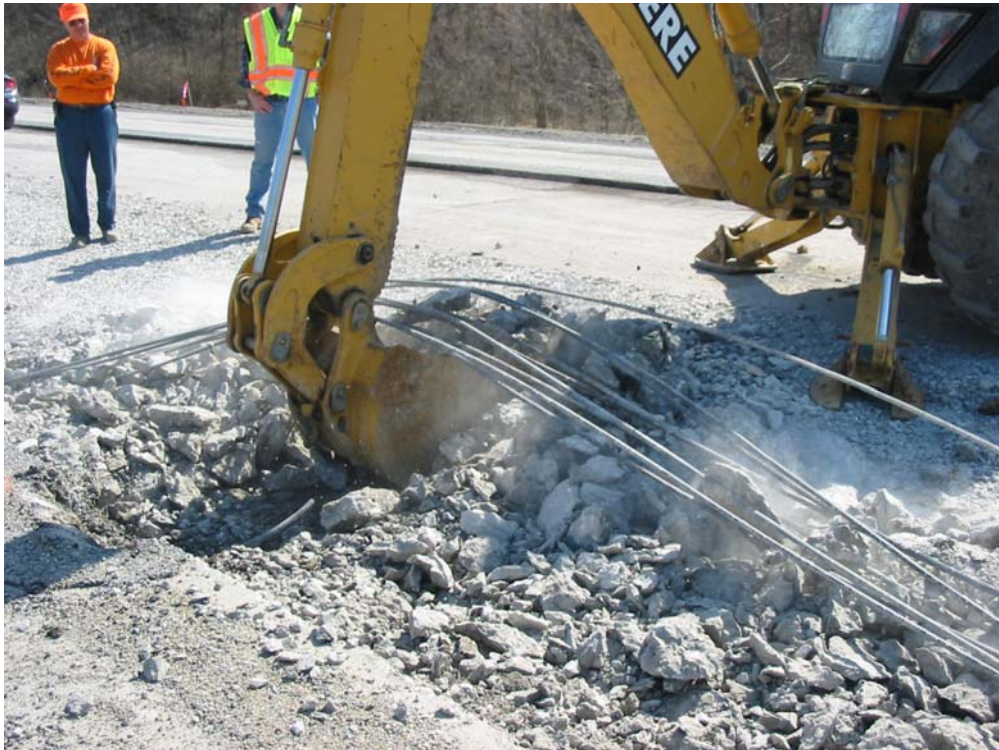
Digging test hole in rubblized CRCP.

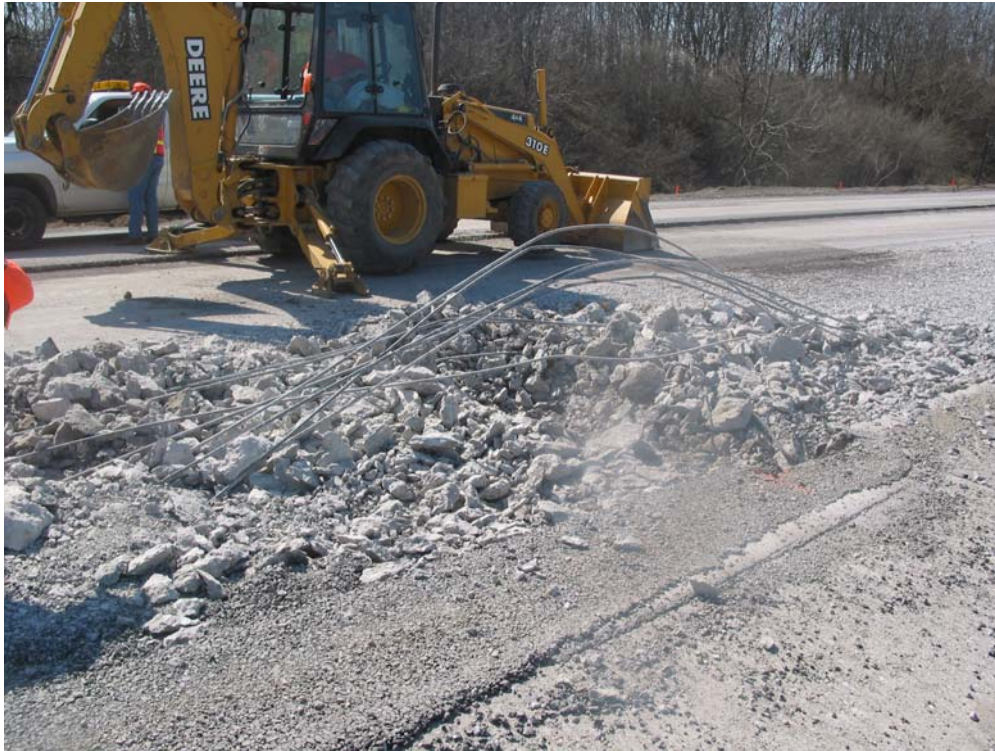
Completed test hole.

Note debonded rebar and particle sizes - results will vary somewhat depending on subgrade/base support.

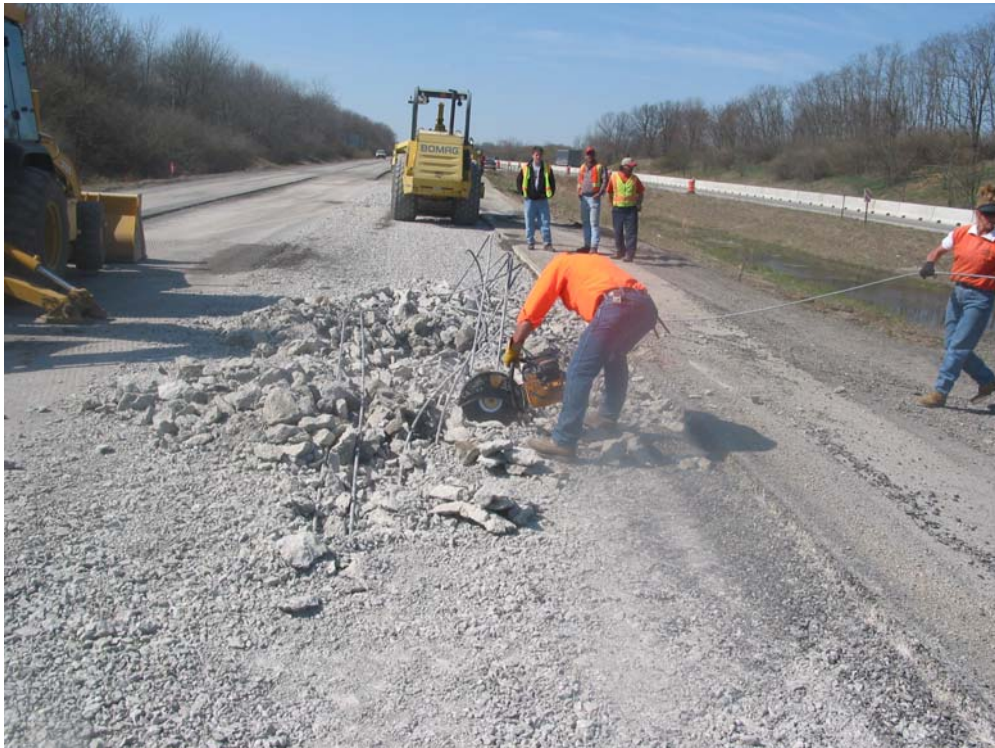
Cutting rebar from test hole to dispose of off site.

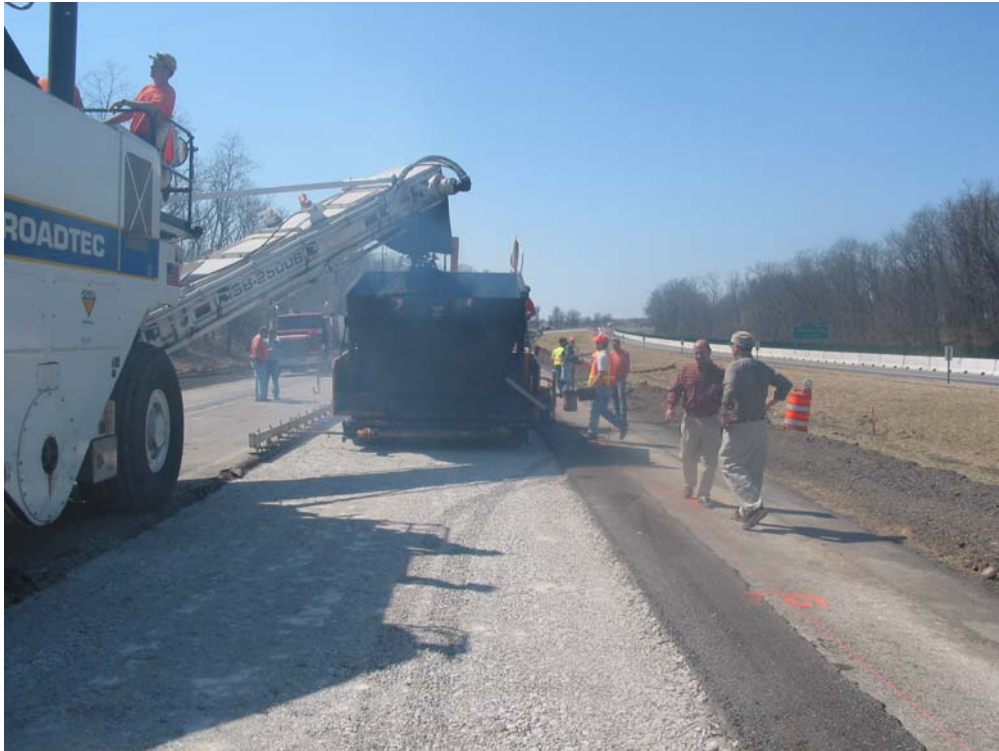
Paving first lift of HMA utilizing an MTD.

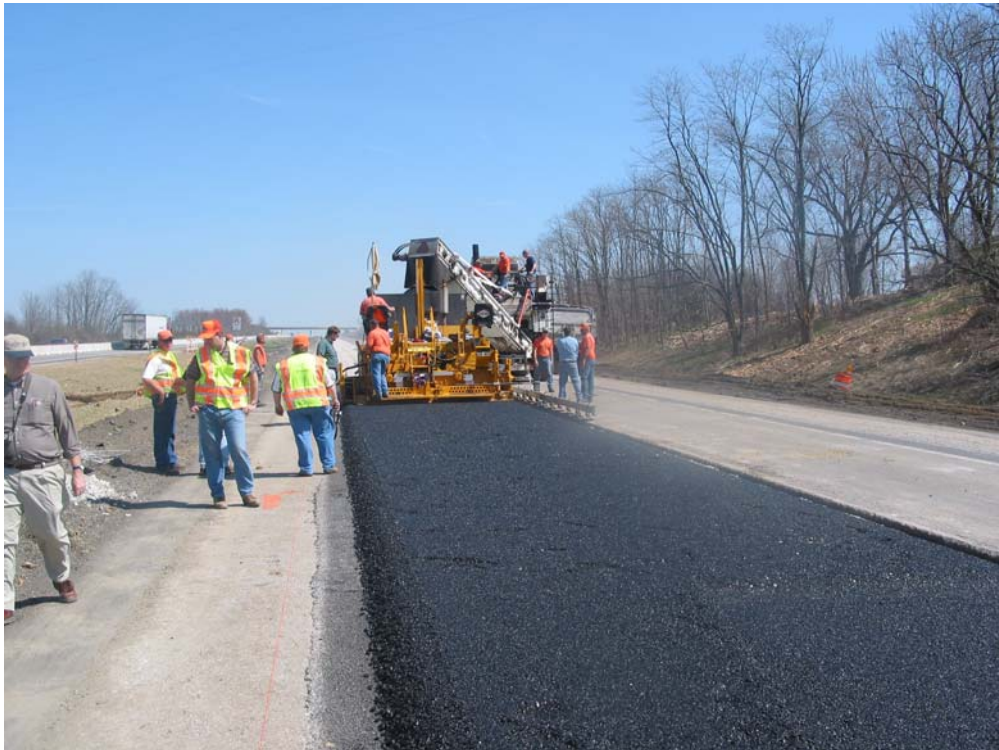
Paving first lift of HMA.
