# From Rubble to

***The arrival of a lone KC-135 at Grand Forks AFB, N.D. on Oct. 30, 2005 marked the unofficial opening of Air Mobility Command's newest state-of-the-art runway and the end of a long summer of construction at the base.***

# Runway

# The Rubblization Procedure

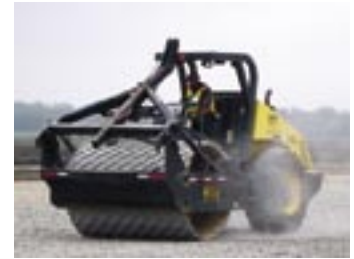
*Left: The guillotine breaker cracked the pavement into 12"-15" pieces. Center: The multiple-hammer breaker—with up to 16 separate, 1,000-1,500 lb. breaking hammers—broke the chunks from the guillotine breaker into 6" pieces. Right: The Z-Grid roller seated the rubblized concrete and vibrated the pieces into a stable base. (photos courtesy Applied Research Associates)*

The specifications called for rubblization using both resonant and gravity breakers. The project was started using a resonant breaker to send very fast shock waves into the concrete, literally vibrating it apart. The method worked, but was too slow, and the machine was plagued by breakdowns, so only a small percentage of the pavement was broken in this way. The remainder of the surface was done using a common guillotine breaker to crack the pavement into 12"–15" pieces and then a multiple-hammer breaker—with up to 16 separate, 1,000 to 1,500-pound breaking hammers—broke the top half of the concrete slabs into 6" pieces. These machines were followed

by special rollers with "Z-grid" drums to seat the concrete pieces and vibrate them into a very stable permeable base. Because the new runway is paved atop the existing pavement, its elevation is 1.8' higher than its predecessor.

Two types of breakers are used for rubblization: resonant and gravity. Resonant breakers use vibrating hammers to send high-frequency, low-amplitude shock waves into the concrete layer while maintaining the base integrity of the pavement. Gravity breakers work in pairs. The first, a guillotine breaker,

employs a wide drop-hammer to make the initial fracture. Then a multi-head breaker—with up to 16 individual drop-hammers weighing 1,000–1,500 pounds—breaks up the fractured slab into smaller particles. After the breakers comes a vibratory drum roller that seats the fractured concrete and breaks up larger particles on the surface.

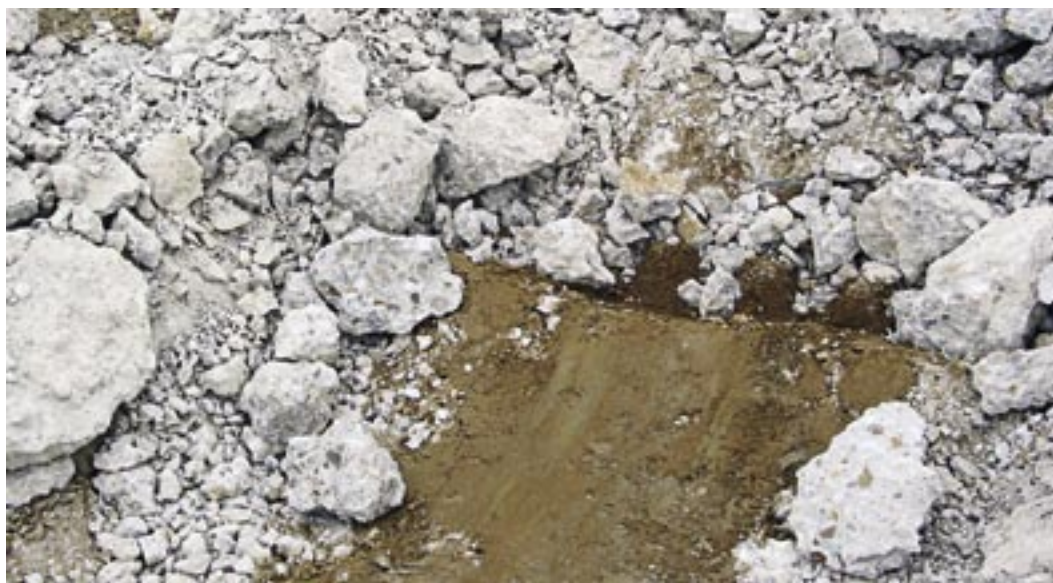
*Intermediate results of rubblizing at Selfridge ANGB, Mich. (U.S. Air Force photo)*

Rubblization fractures the existing slab and breaks it into particles ranging from sand-sized to 3" at the surface and from 12"–15" at the bottom of the rubblized layer. The end result is a material comparable to a high-quality aggregate base course. There is no need to align joints when the new concrete overlay is applied. The rubblized layer also eliminates thermal expansion/contraction, thus helping to prevent reflective cracking in the concrete overlay.
