New Runway Ready for Take-Off

Rebuilding a critical runway at Fairchild Air Force Base required attention to every last detail—from the concrete to the construction technique to the calendar.

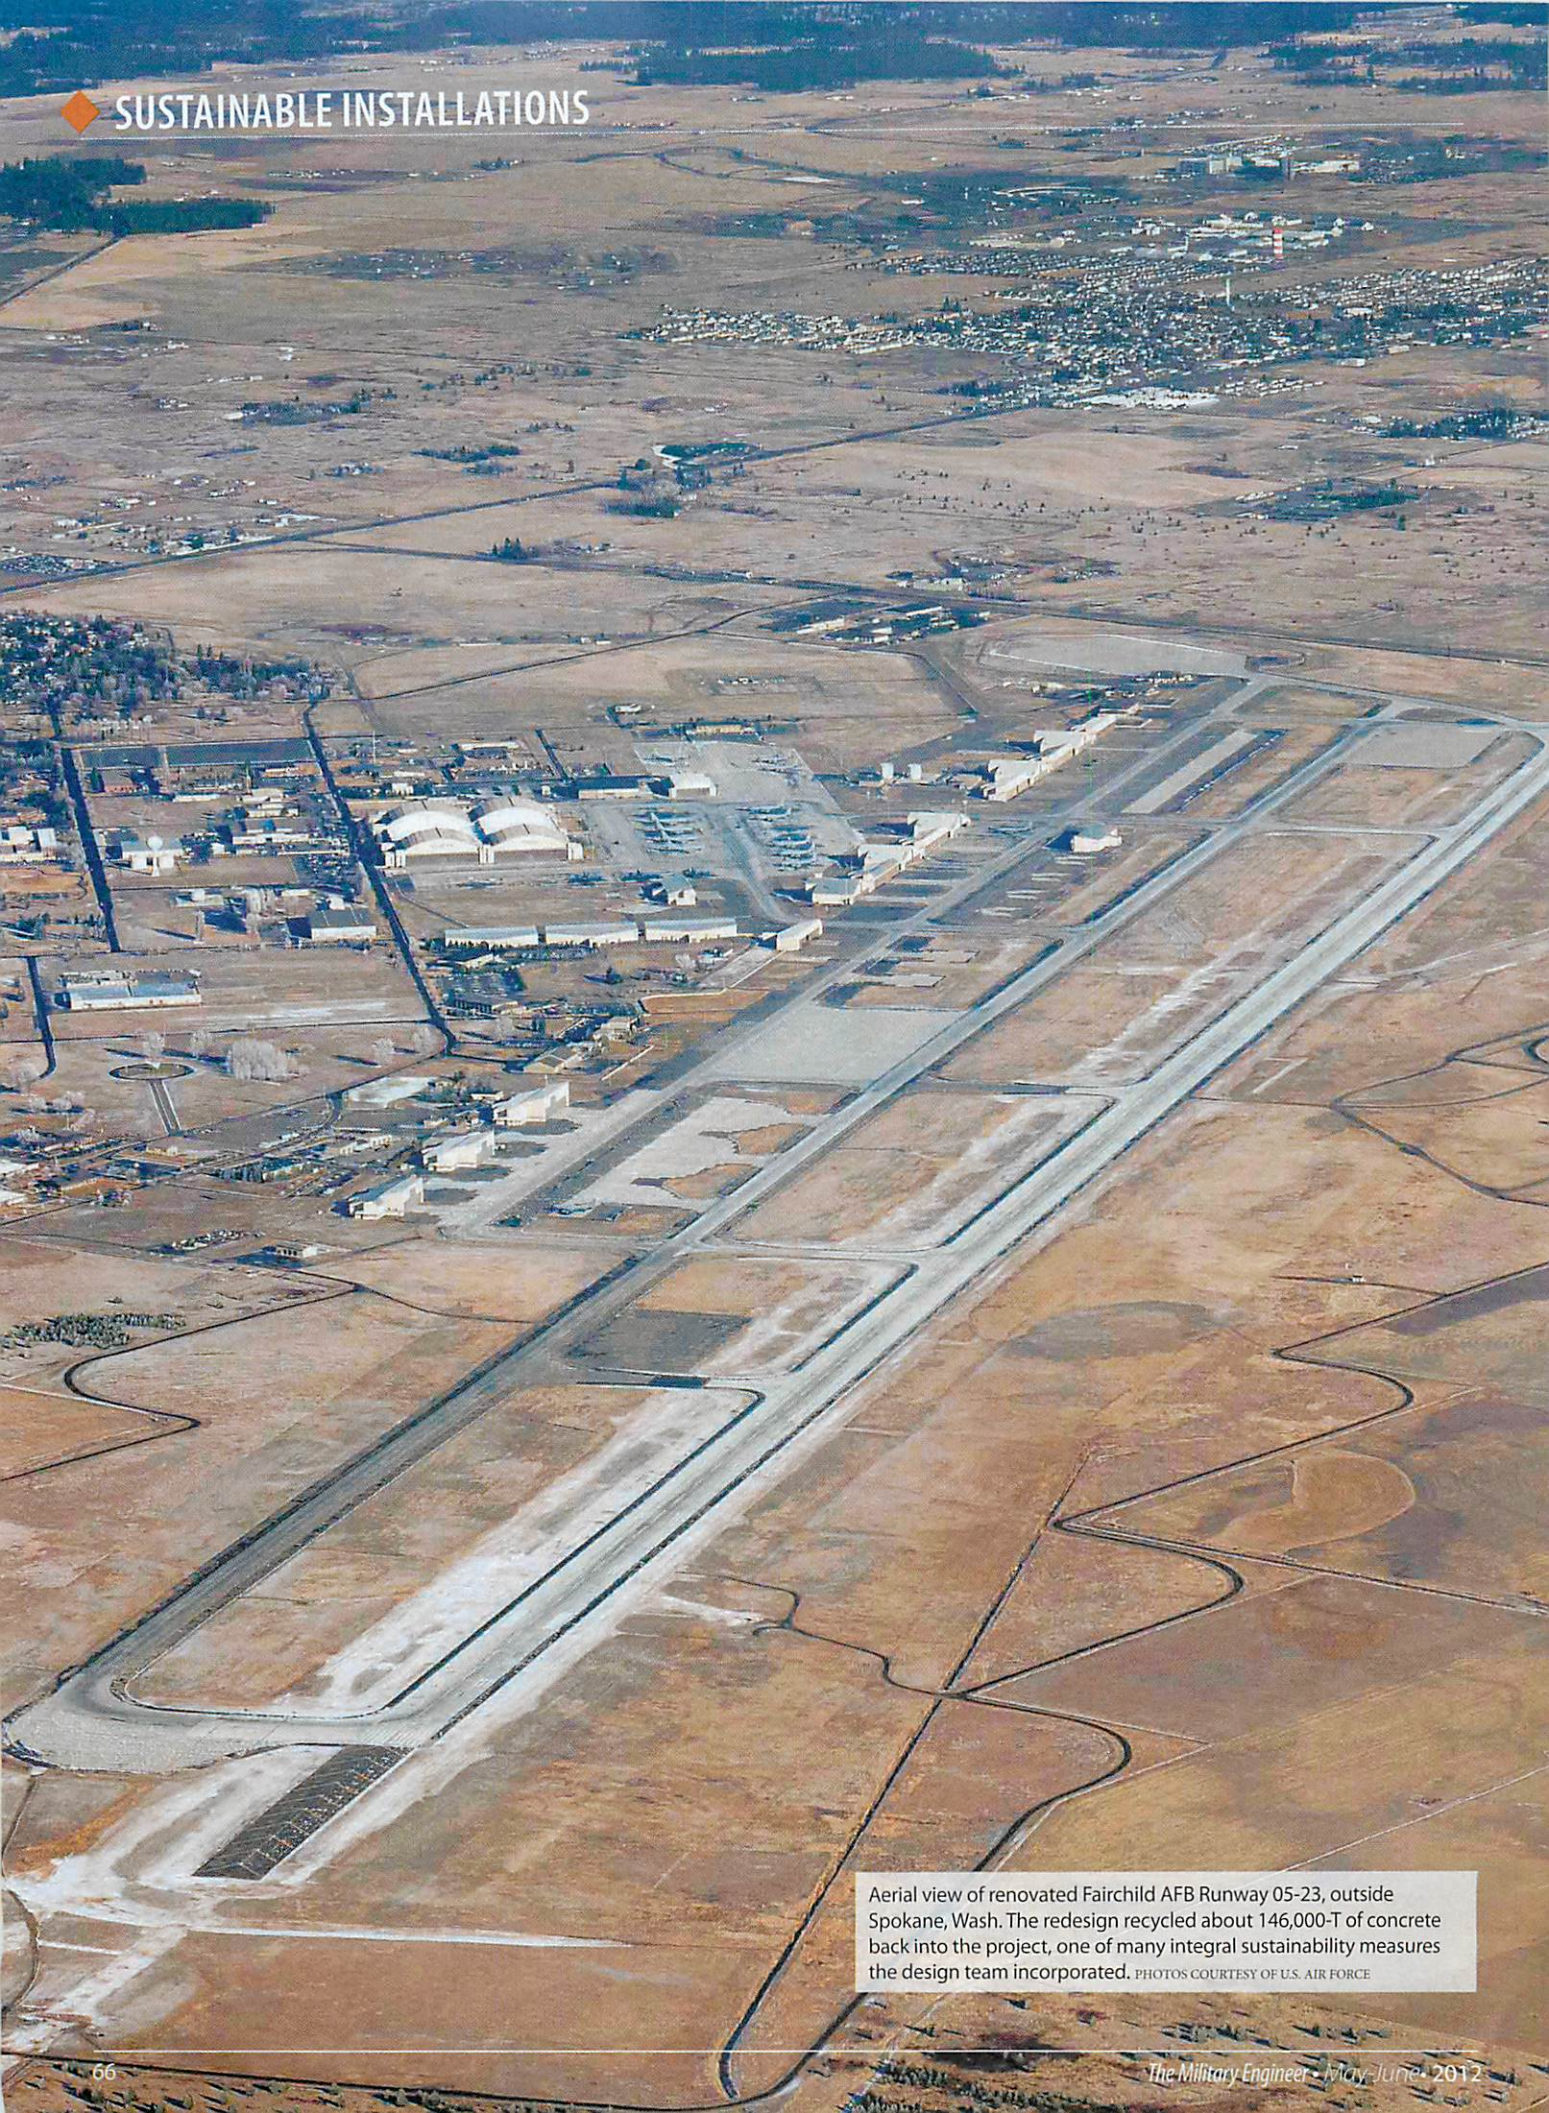
Aerial view of renovated Fairchild AFB Runway 05-23, outside Spokane, Wash. The redesign recycled about 146,000-T of concrete back into the project, one of many integral sustainability measures the design team incorporated. PHOTOS COURTESY OF U.S. AIR FORCE

By the time all the work had been completed, some 146,000-T of concrete had been recycled back in and used as aggregate base material. This accounted for roughly 60 percent of the total amount of concrete removed from the project. In addition to the recycled concrete, the aggregate base material placed under the runway also consisted of approximately 4,400-T of recycled asphalt millings. Additionally, another 87,000-T of concrete and 63,000-T of asphalt millings was salvaged to a local construction company for use on other projects. Everything on site that could be used was; extraneous materials were recycled and the project did not endure any of the delays that are common on runway renovations in other parts of the country.
