INTERNATIONAL INC.

Concrete Pavement Rehabilitation

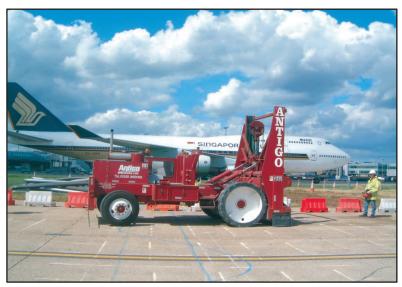
Typical airport cracking operation using an 8600 Badger Breaker®

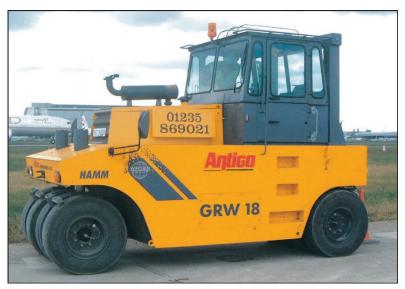
Typical pneumatic rubber tyre roller utilized for the seating operation [min weight 20 tons]

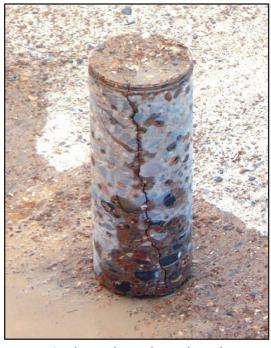
Fine vertical crack, induced with a single strike of the 8600 guillotine blade

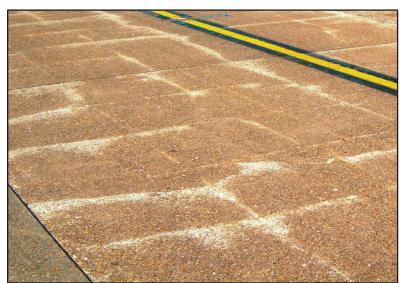
Typical grid cracking pattern

The grid can be varied to control the amount of structural strength retained in the cracked pavement in order to meet the design requirements.

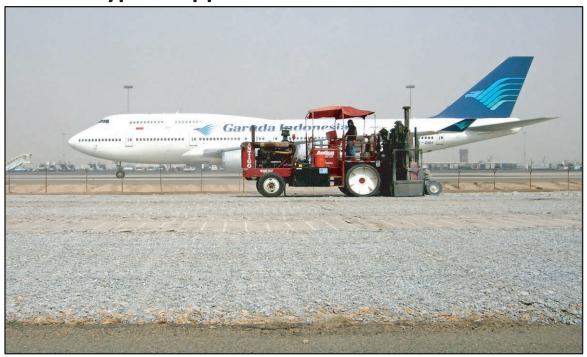
MHB Badger Breaker® rubblizing an airport runway

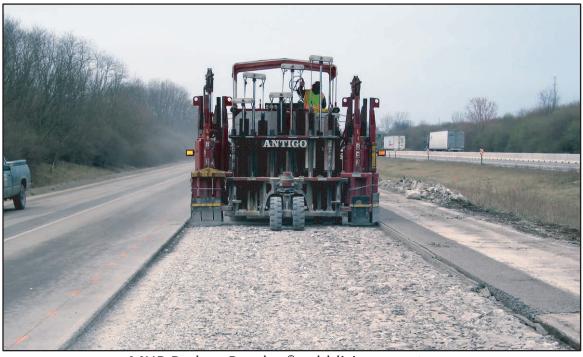
MHB Badger Breaker® rubblizing a motorway

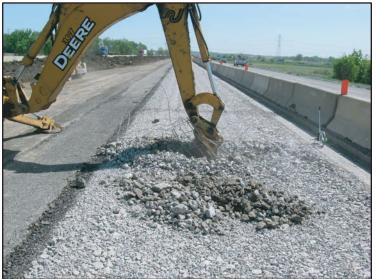
Jointed reinforced concrete pavement

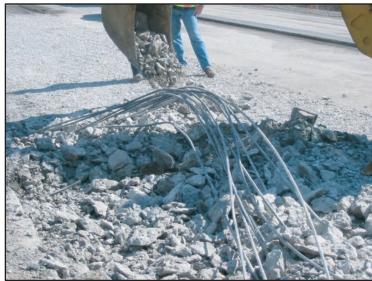
Continuously reinforced concrete pavement

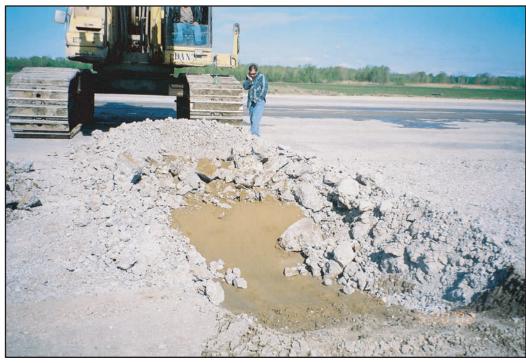
Non-reinforced concrete pavement, 21-inch (530mm) thick airport runway

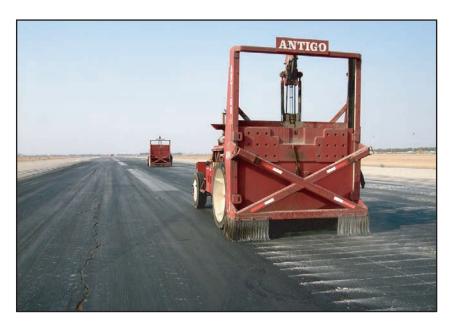
Phase 1

Pre-breaking using an 8600 Badger Breaker® (may be required depending on thickness and strength of existing concrete and base layers)

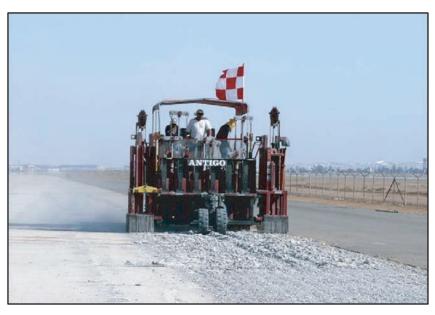
Phase 2Rubblization using a MHB
Badger Breaker®

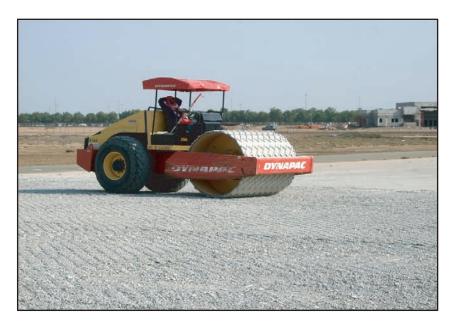
Phase 3

Grid Roller produces uniform surface particles and begins seating the rubblized layer
