# Construction Digest

■ **Special Report**  
**Making inroads  
in asphalt paving  
technology**

# Crack and seating done without removing asphalt surface on runway rehab project.

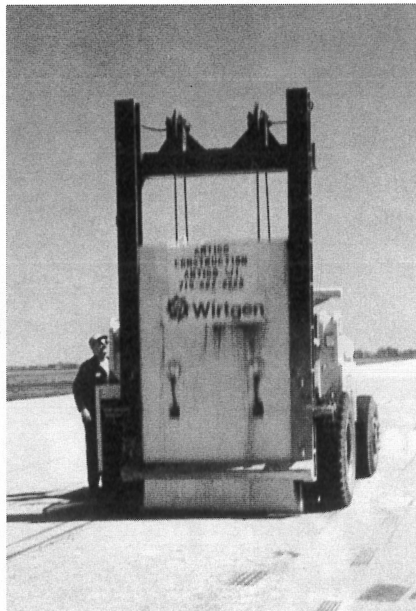
PCC pavement underlying asphalt surface was cracked with a Wirtgen CB700 6-ton guillotine.

A 75 by 240 foot (6 lanes by 16 slabs) portion of Runway 5-23 was used as the test strip to gauge the effectiveness of the contractor's crack and seat operations. Cracking was performed with a Wirtgen 6-ton guillotine, operating at varying drop heights, offsets and forward travel speed. Various combinations of 35-ton pneumatic and 10-ton vibratory rolling were evaluated for seating.

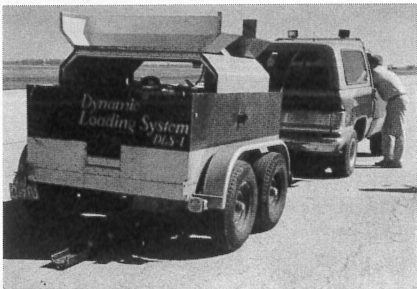
Nondestructive testing equipment being operated by Roy D. McQueen & Associates crew.

The NDT program was undertaken by Roy D. McQueen & Associates, Ltd., using a heavy mass Dynamic Loading System. This machine is designed to generate a dynamic load on a pavement surface and measure the resultant vertical response of the pavement system, including subgrade, base courses, and surface layers.
