Cracking & Seating of Existing Jointed Non-Reinforced Concrete Pavements – Airfield Pavements in the United Kingdom

Antigo Construction Family of Companies

Concept

To minimize the extent and severity of reflective cracking in asphalt overlays of existing concrete pavements

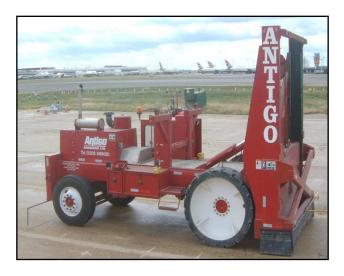
Equipment used for Cracking & Seating

8600 Badger Breaker® (guillotine-style breaker)

20-ton Pneumatic-Tired Roller (PTR)

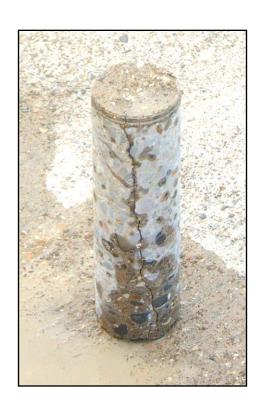
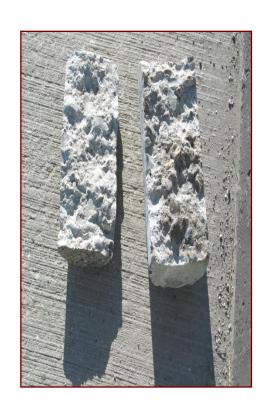
Typical Induced Crack

- Core taken from a 450mm thick pavement
- Broken core showing the good aggregate interlock
- Crack should be vertical throughout the depth of the core

Cores showing any deviation from the normal tight, vertical crack may require a reassessment trial to establish any variations in the existing pavement (e.g. thickness or strength) which may require the resetting of the concrete breaker's drop height
