**RUBBLIZATION OF EXISTING AIRFILED PAVEMENTS AT  
KING ABDULAZIZ INTERNATIONAL AIRPORT, JEDDAH  
SAUDI ARABIA**

**2014 FAA WORLDWIDE AIRPORT TECHNOLOGY  
TRANSFER CONFERENCE**

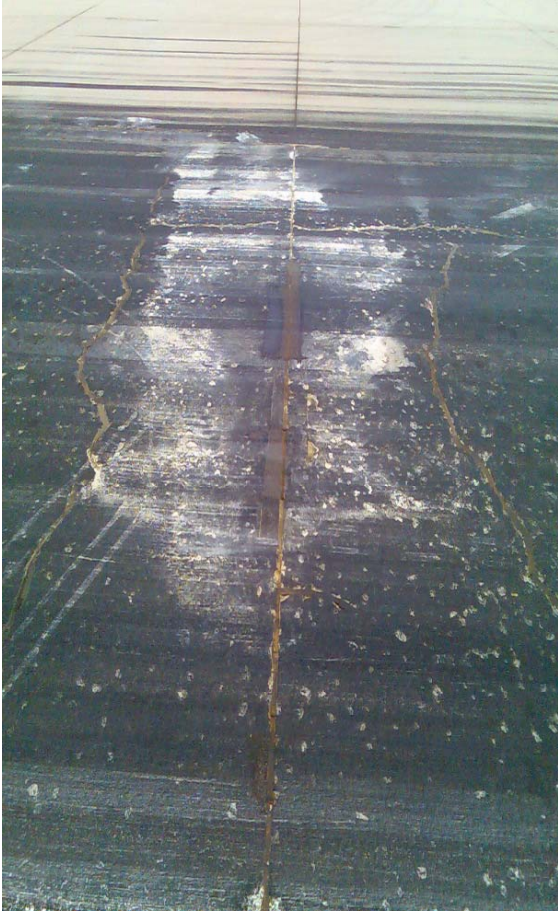
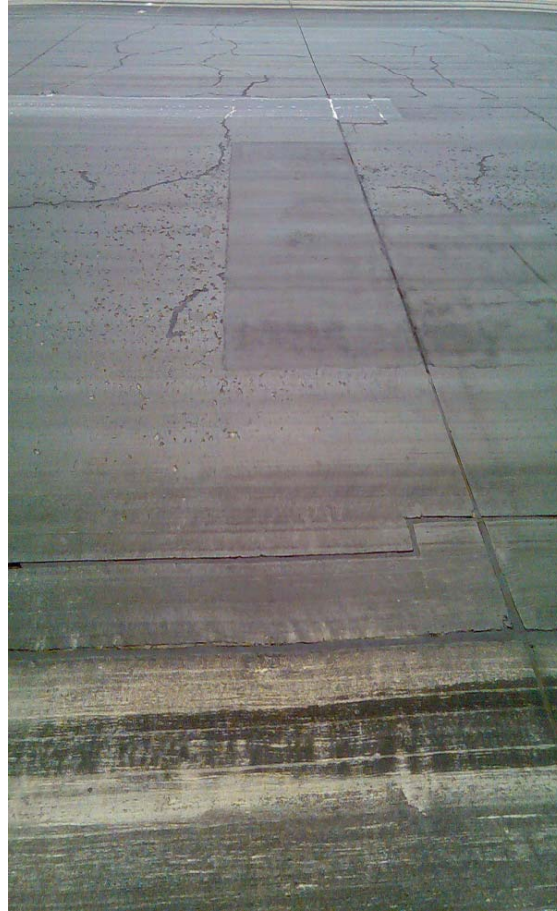
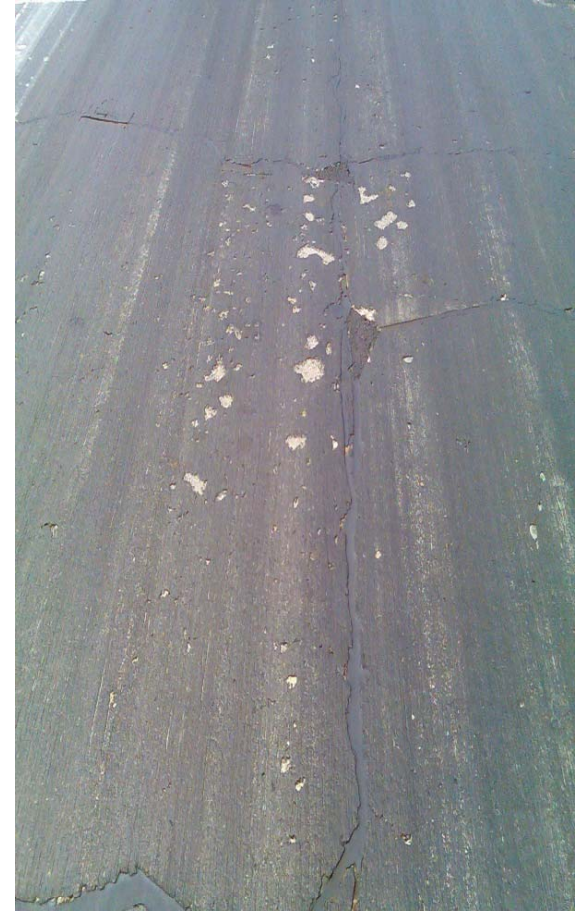
# Typical Distresses

## *Low to High Severity Scaling*

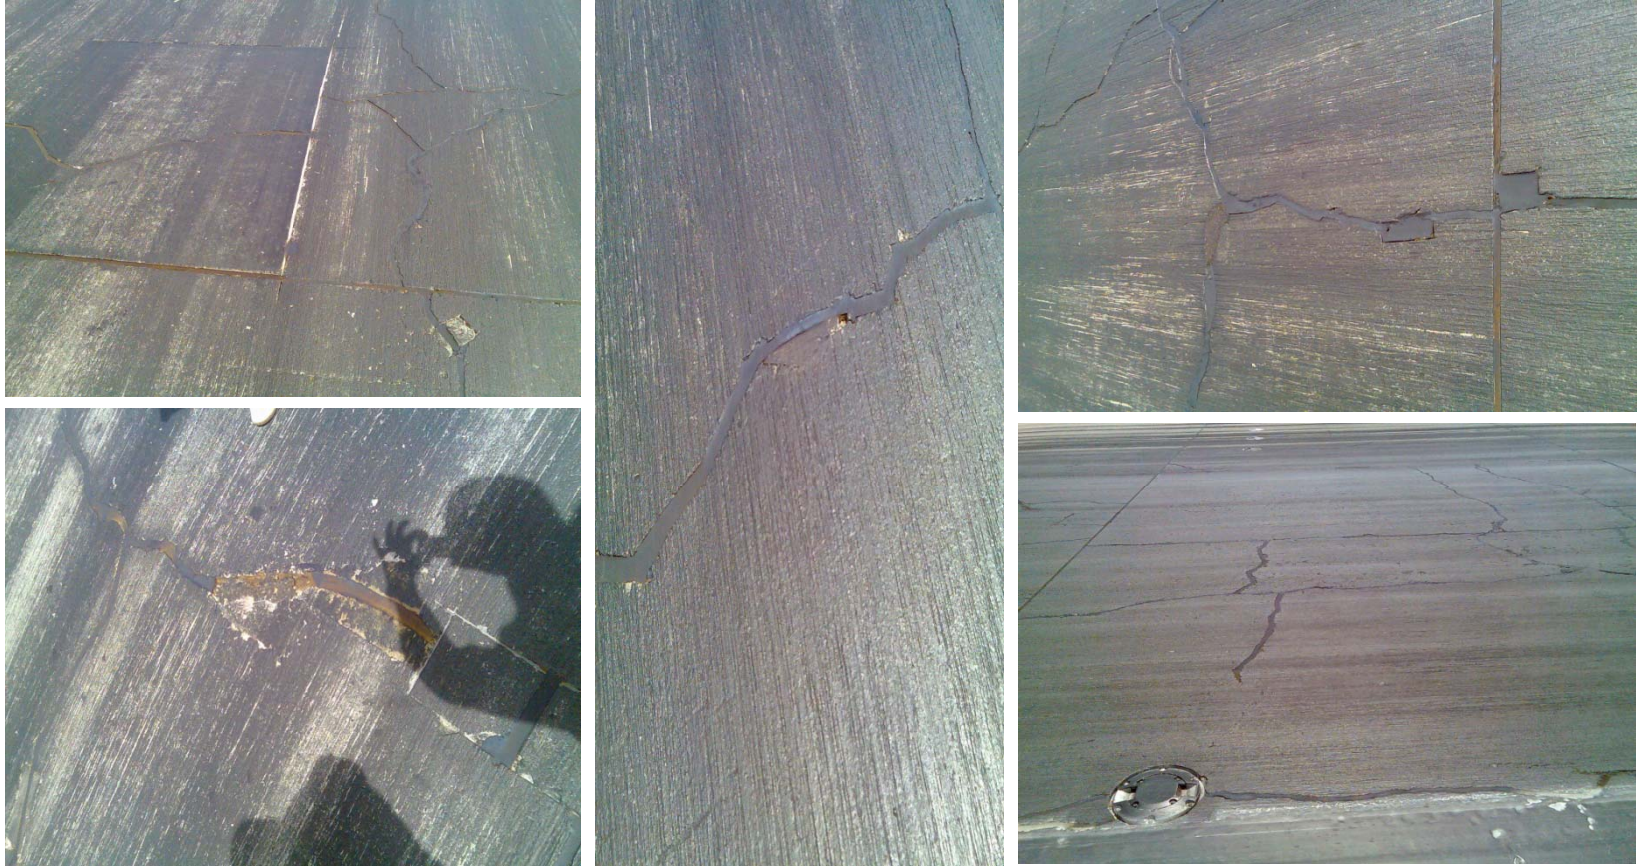
# Typical Distresses

## *Low to High Severity Corner Break & Linear Cracking*

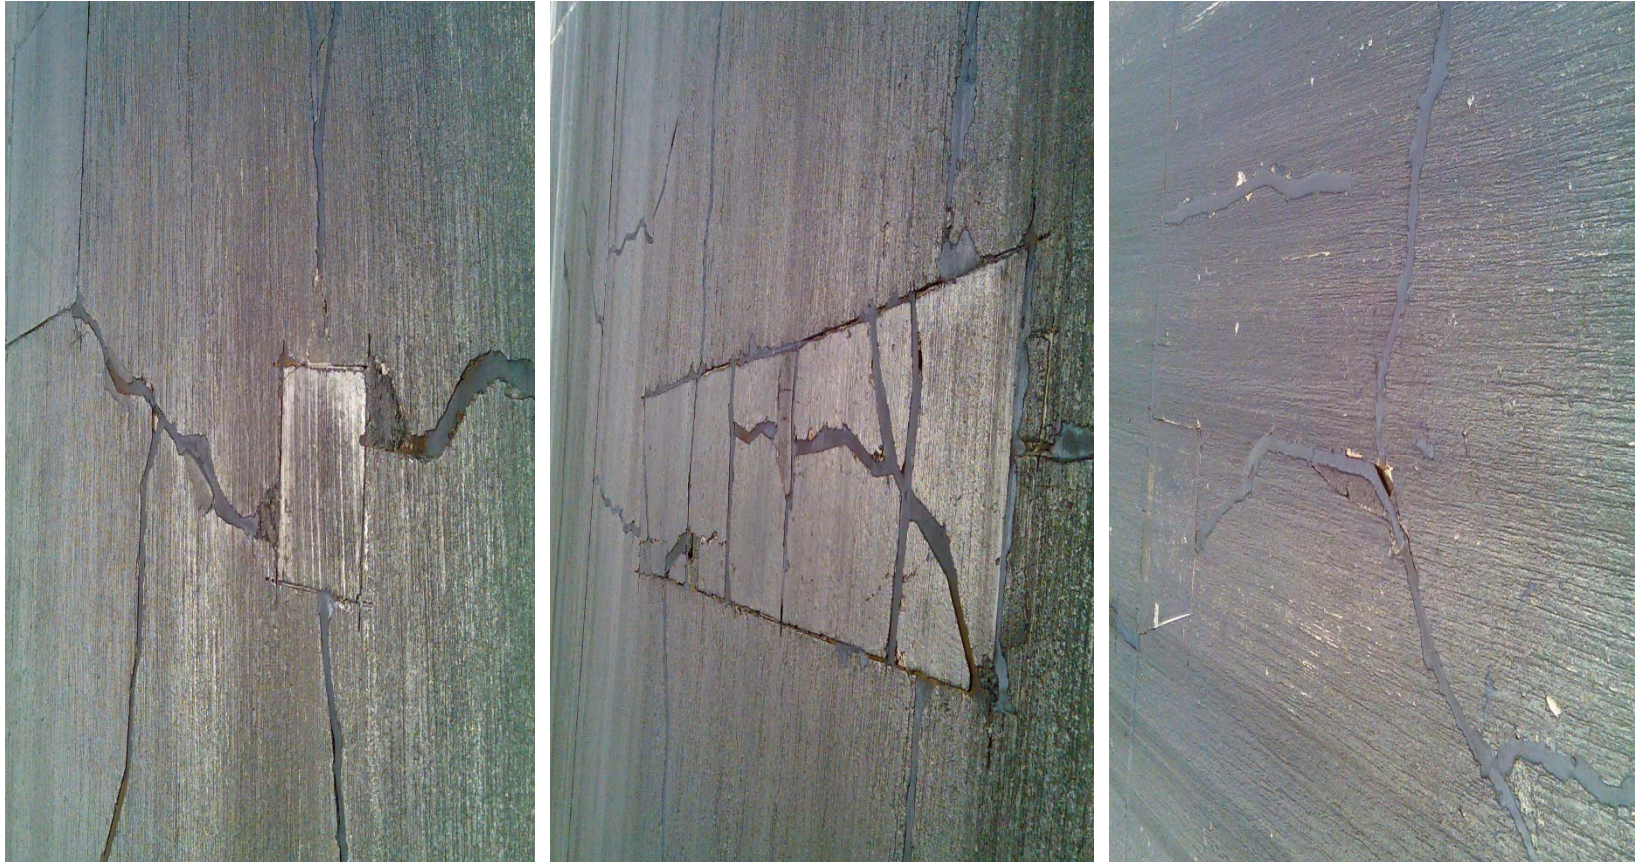
# Typical Distresses

## *Low to High Severity Shattered Slab & Patching*

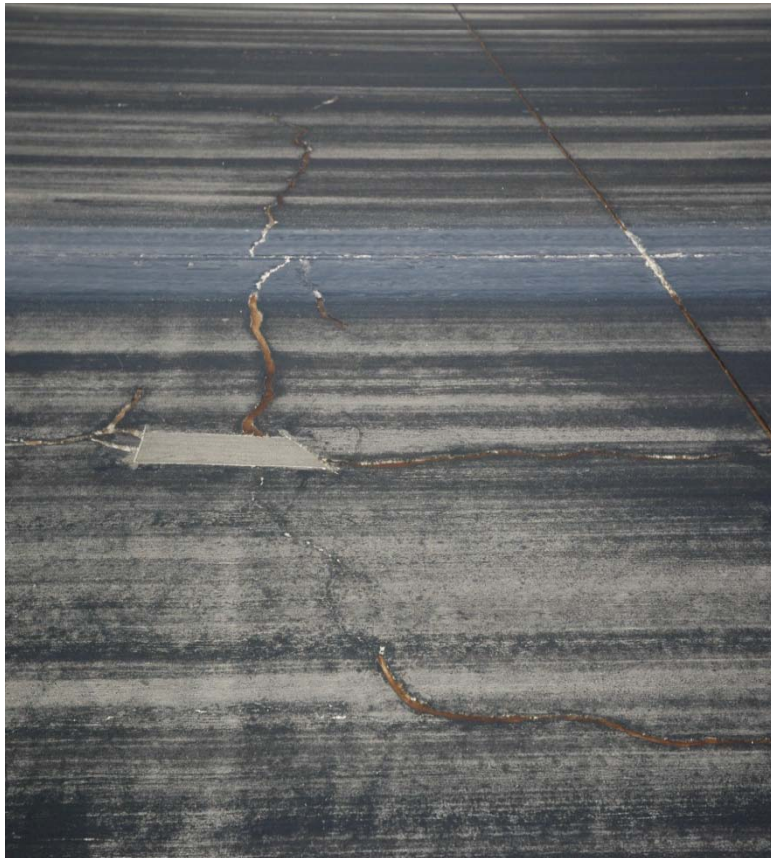
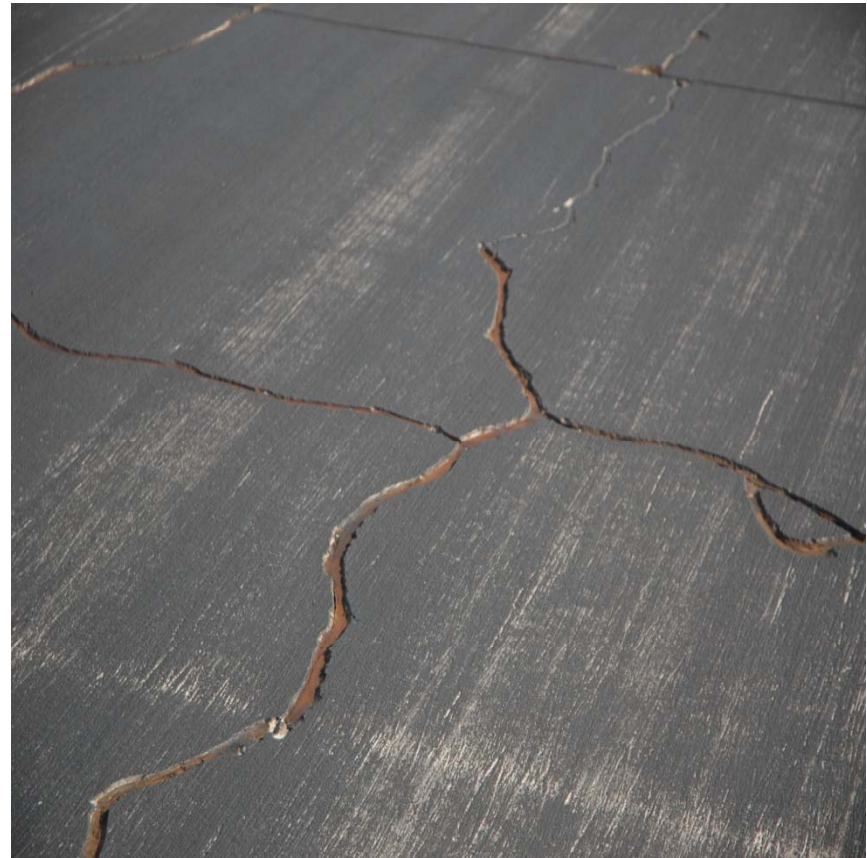
# Typical Distresses

## *Low to High Severity Shattered Slab & Patching*

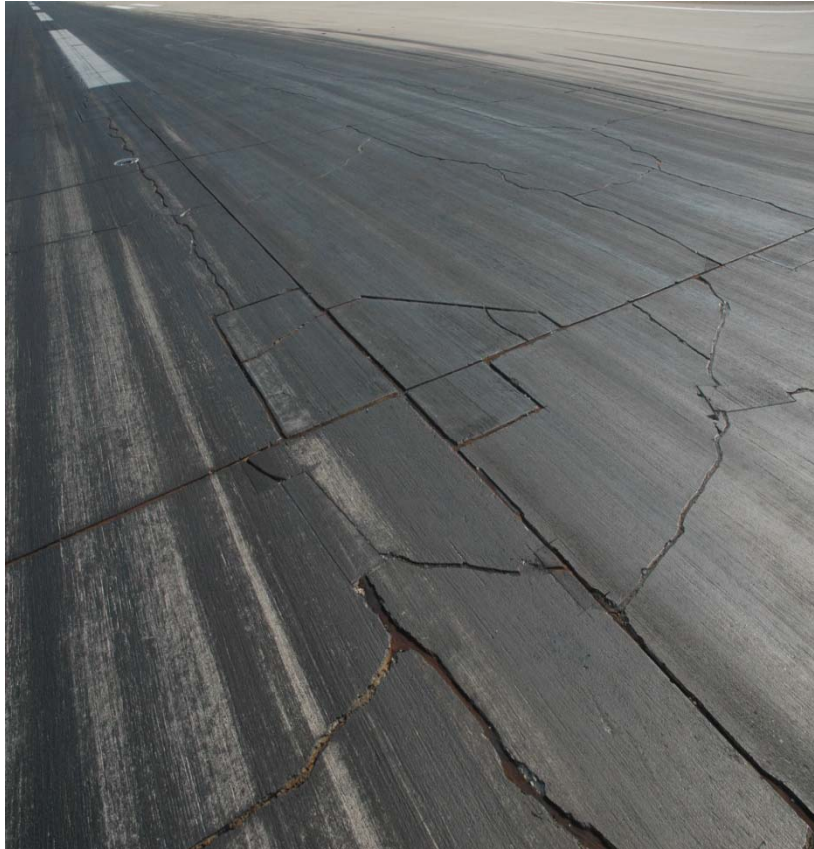
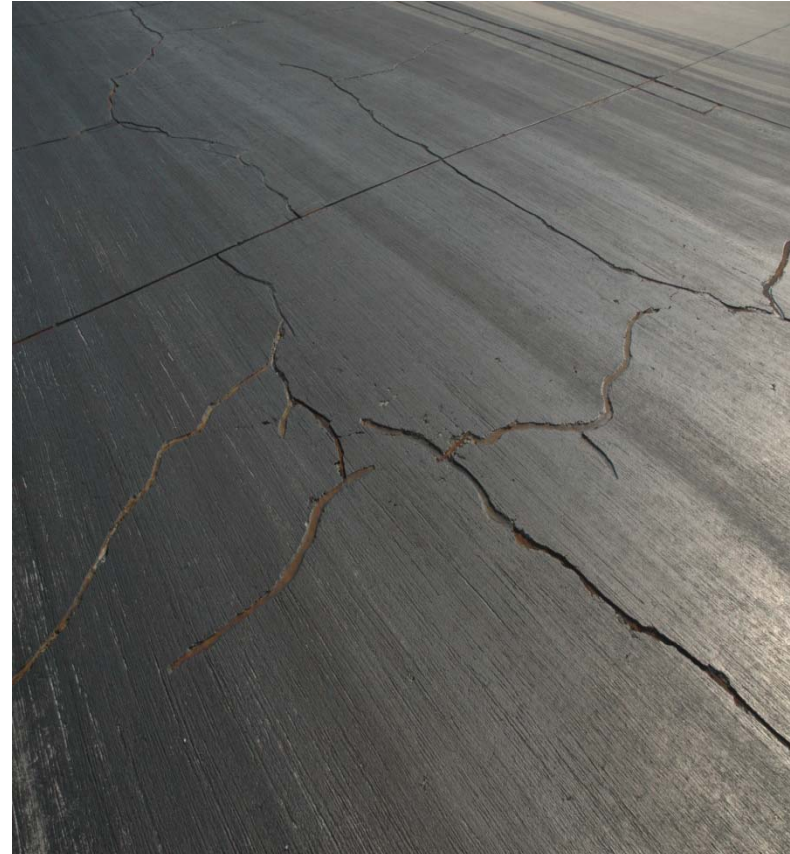
# Typical Distresses

## *Low to High Severity Shattered Slab & Corner Break*

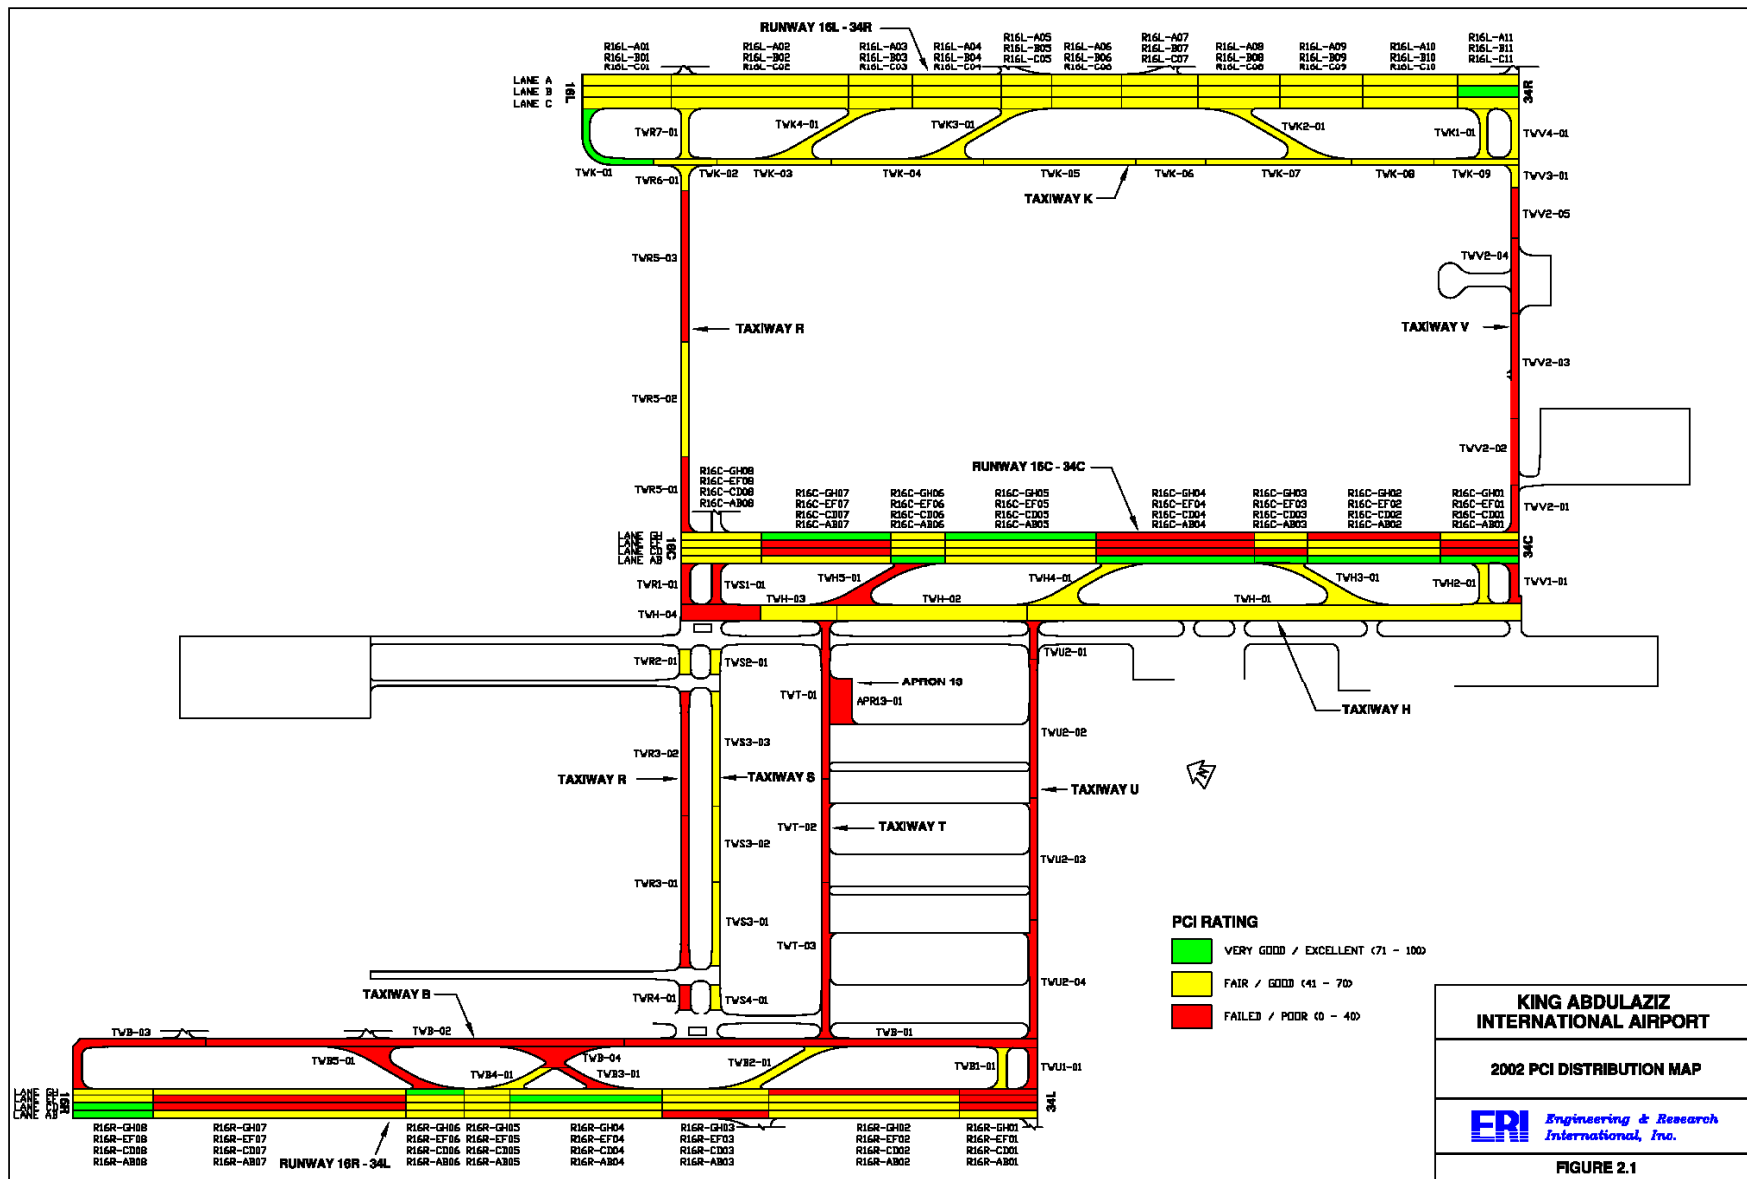
# ACTUAL PCI 2002

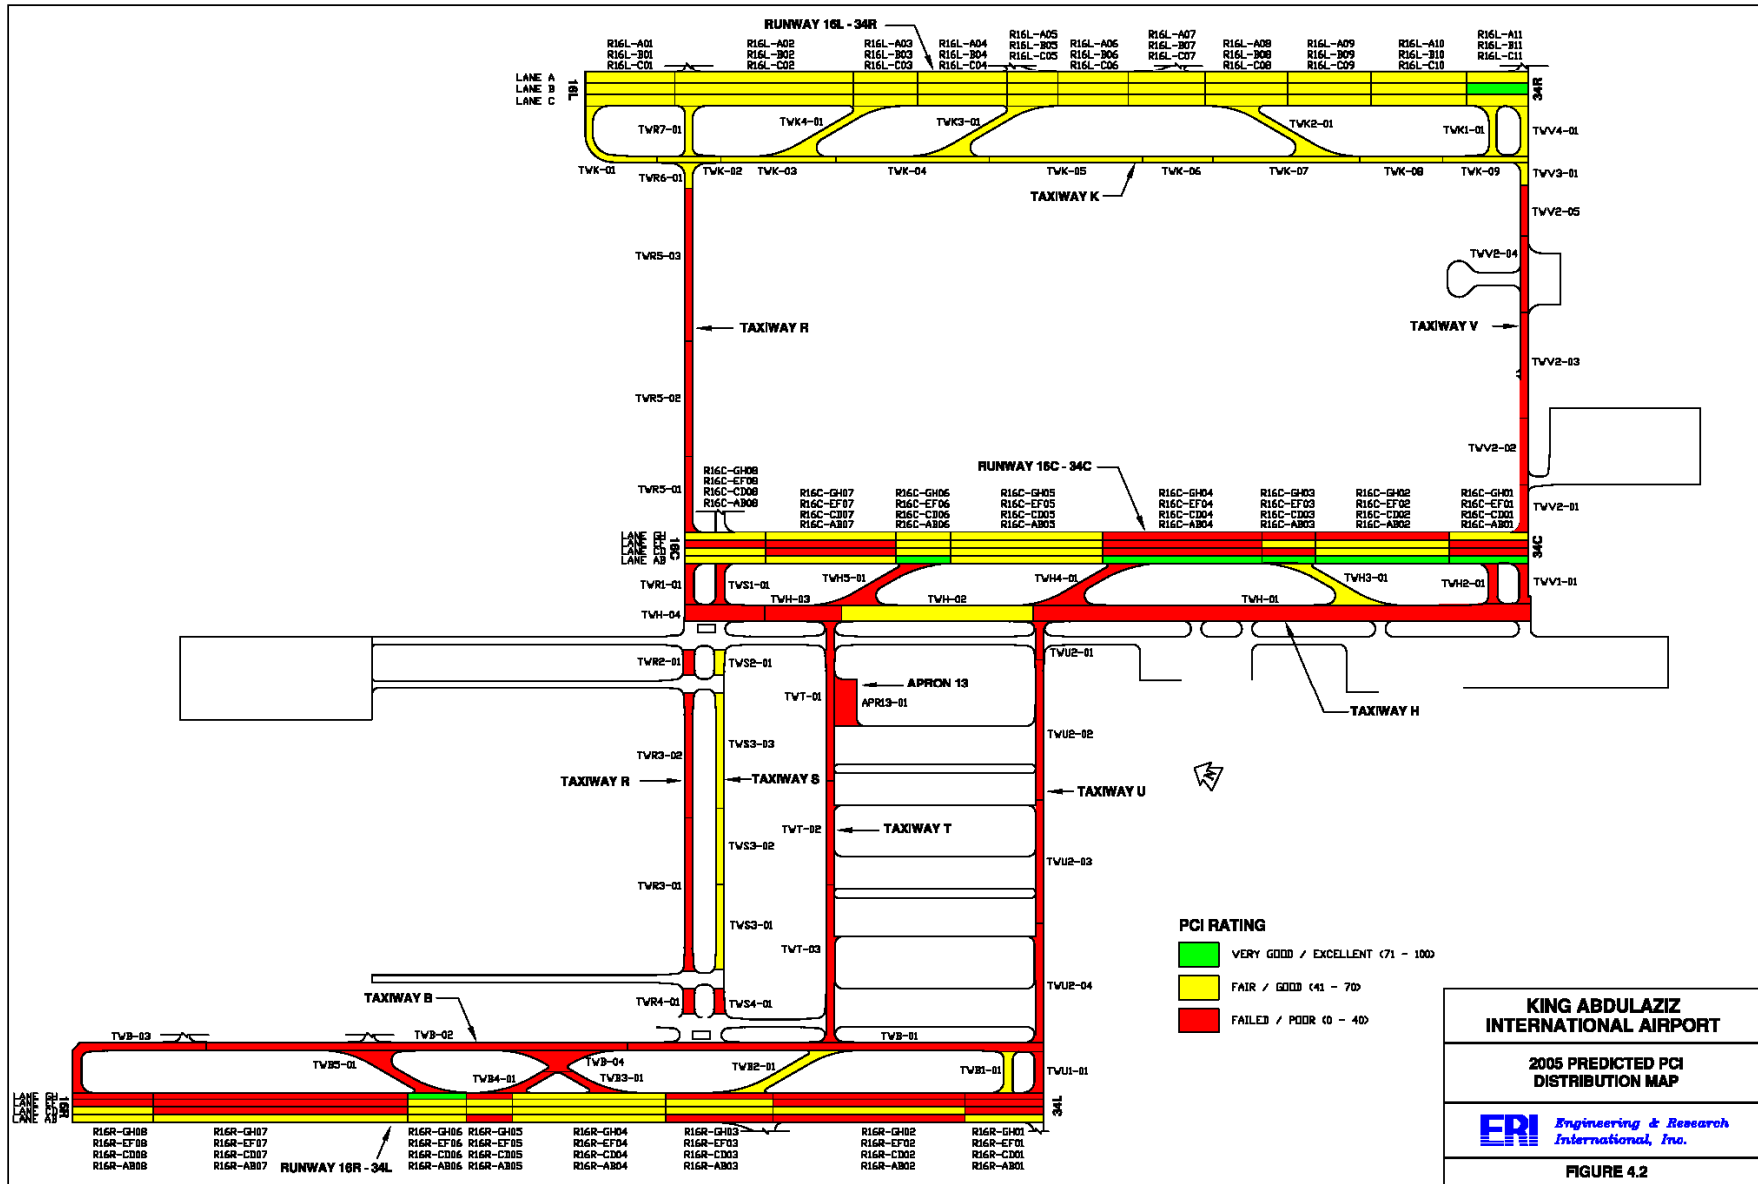
# Predicted PCI 2005

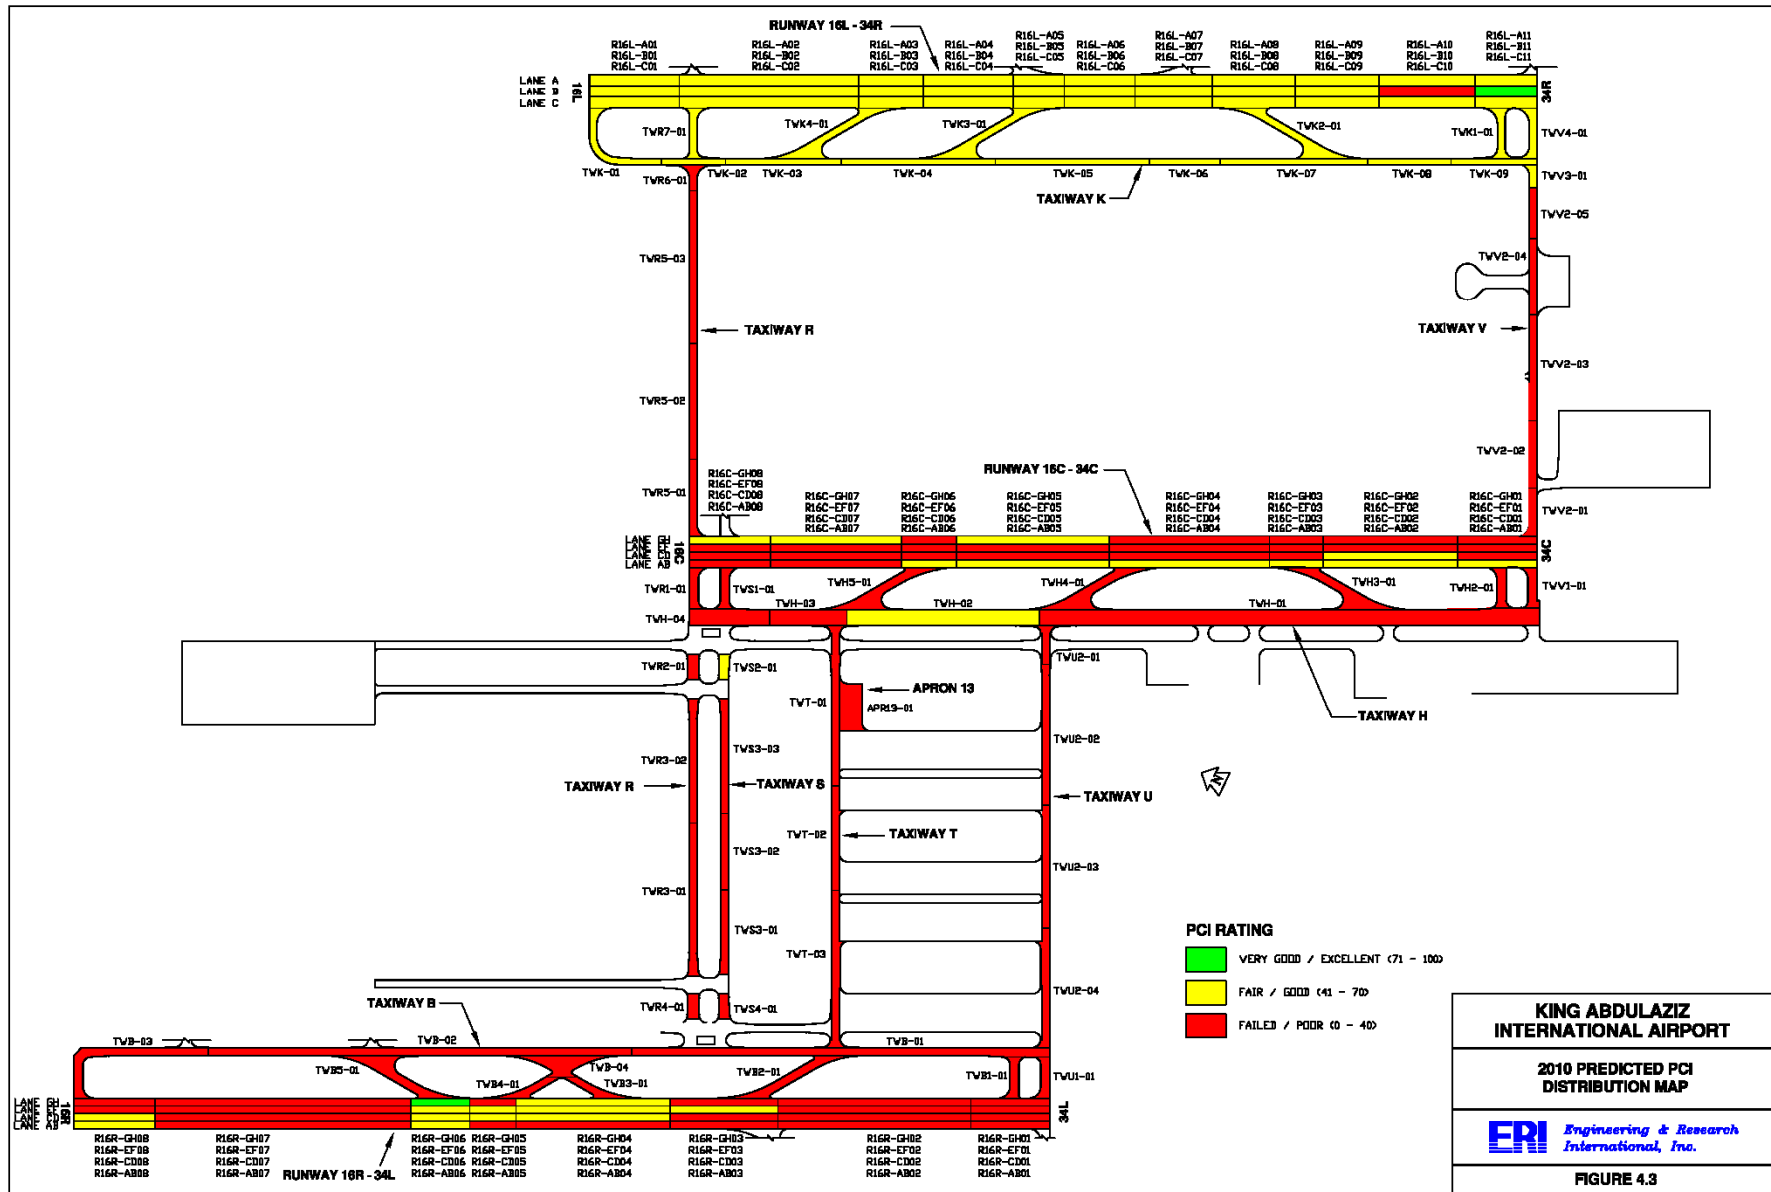
# Predicted PCI 2010

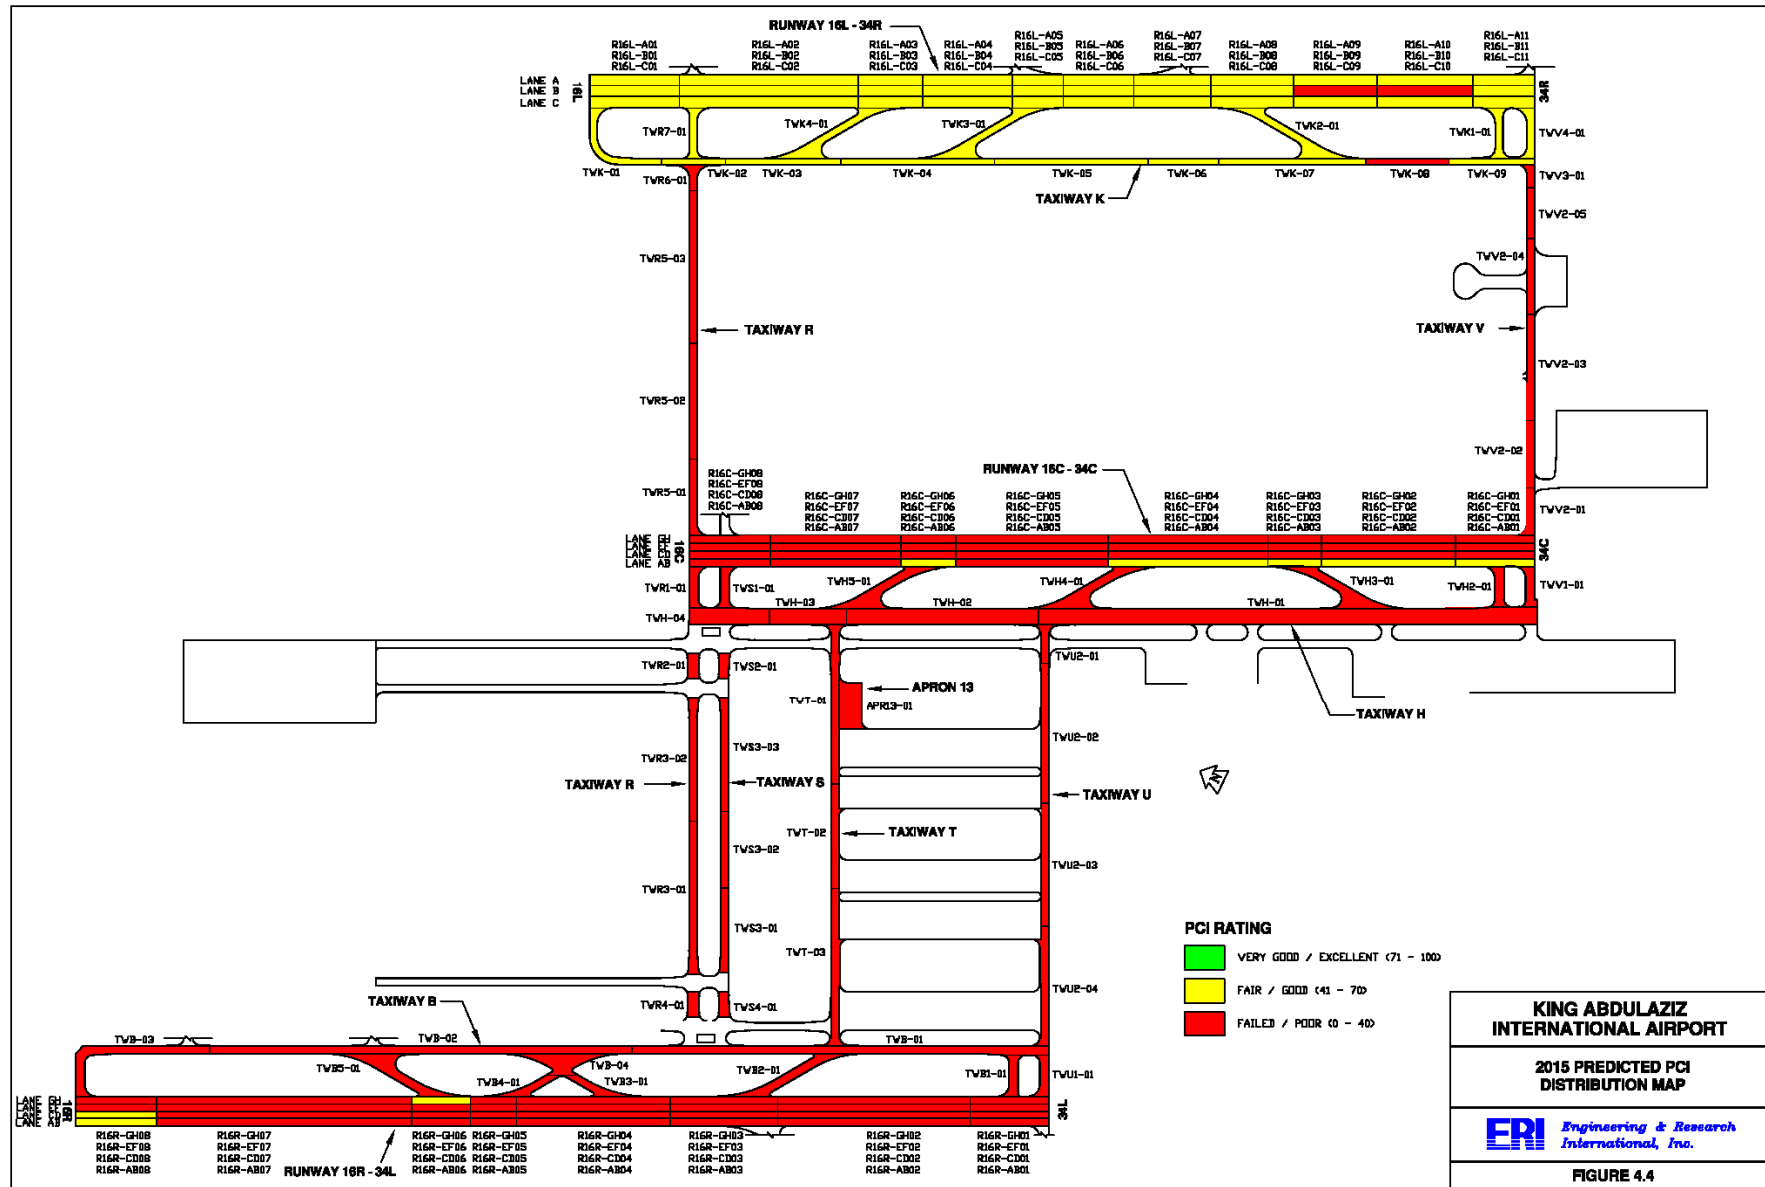
# Predicted PCI 2015

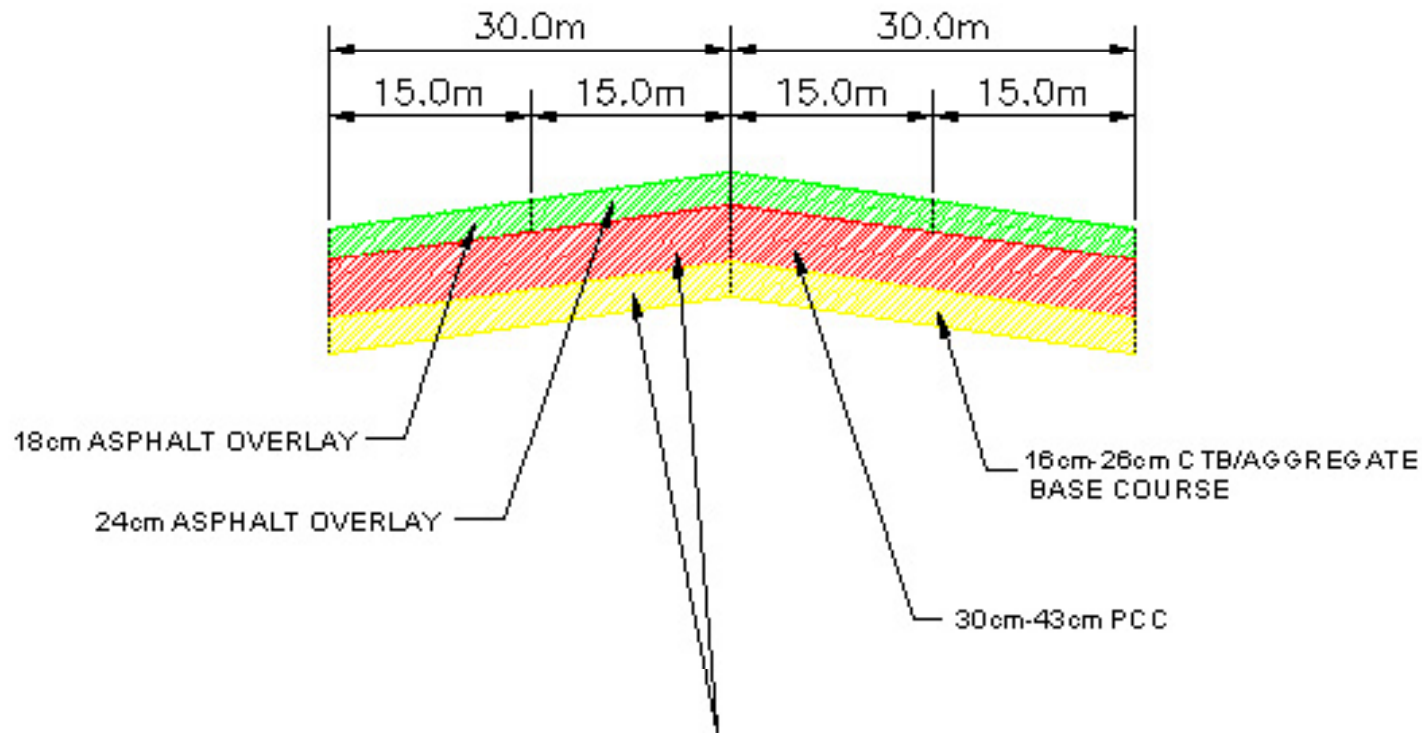
# Asphalt Overlay with Rubblization

RUBBLIZE ENTIRE 60m WIDTH (PCC & CTB)  
THEN ASPHALT CONCRETE OVERLAY

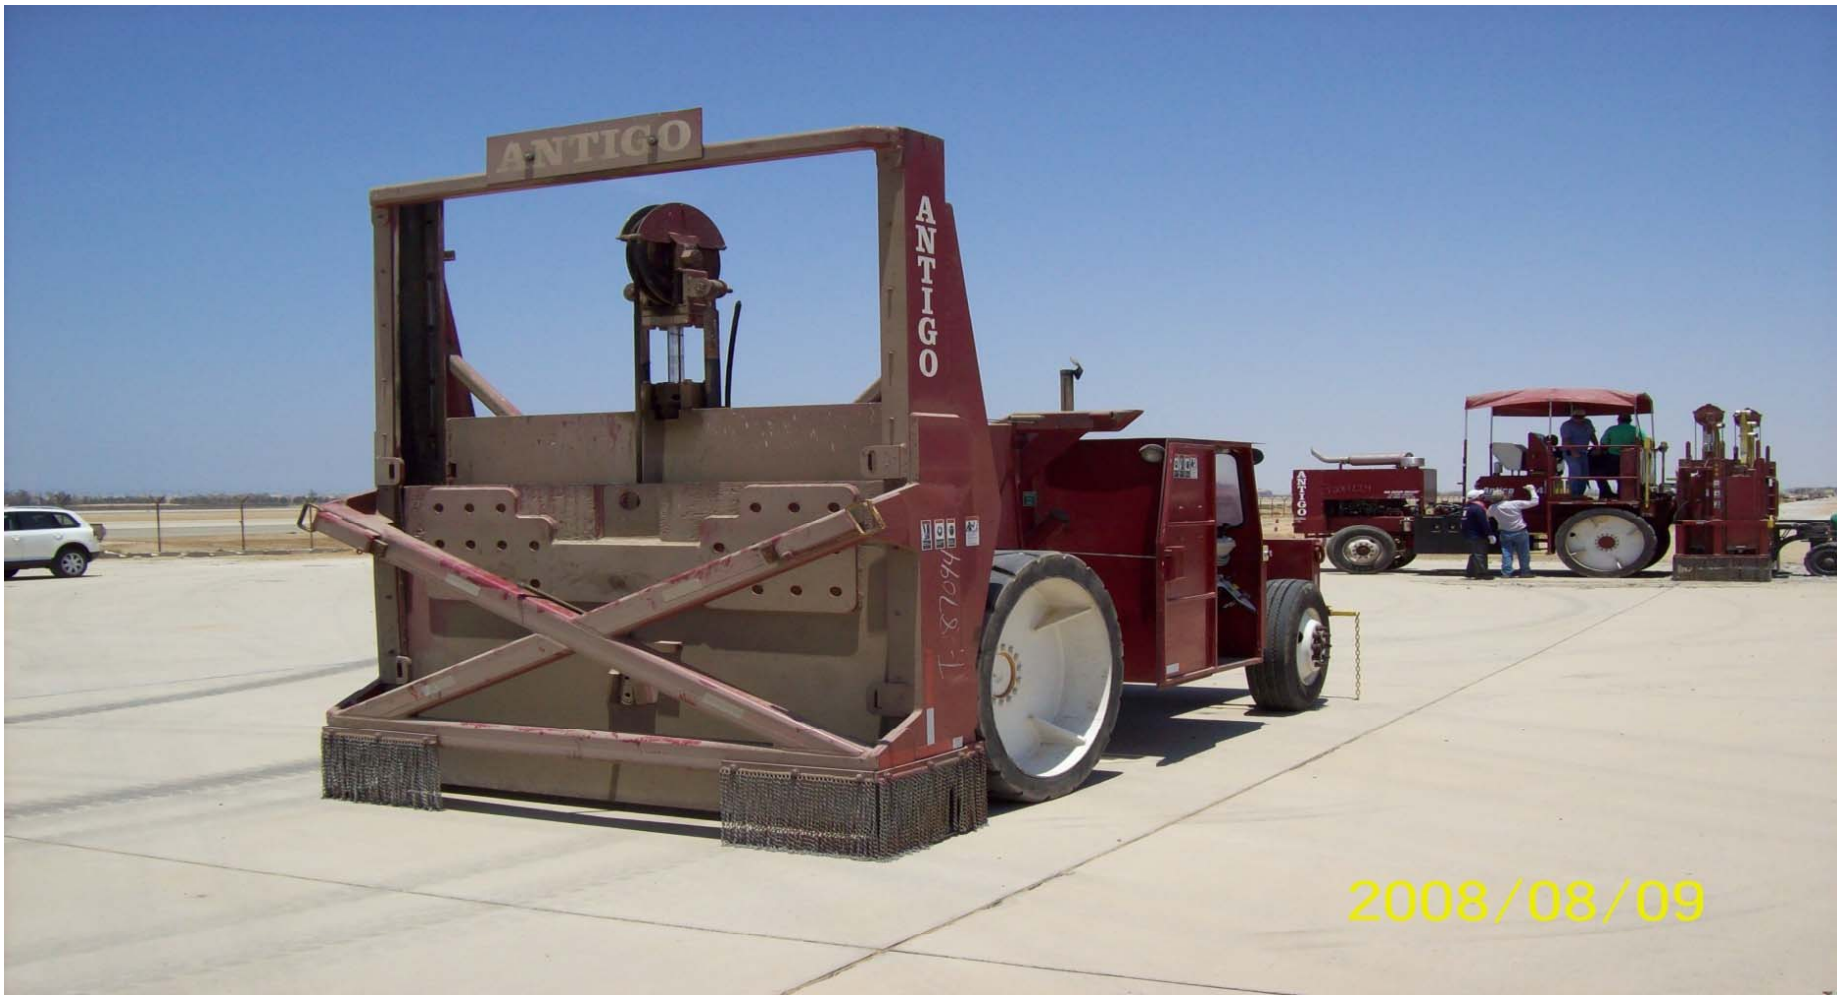
The Guillotine Breaker weighing 5,440 kg (12,000 lb) with 2.4 m (8 ft) wide drop hammer was used to make the initial fracturing of the concrete layer.

# 8600 BADGER GUILLOTINE BREAKER

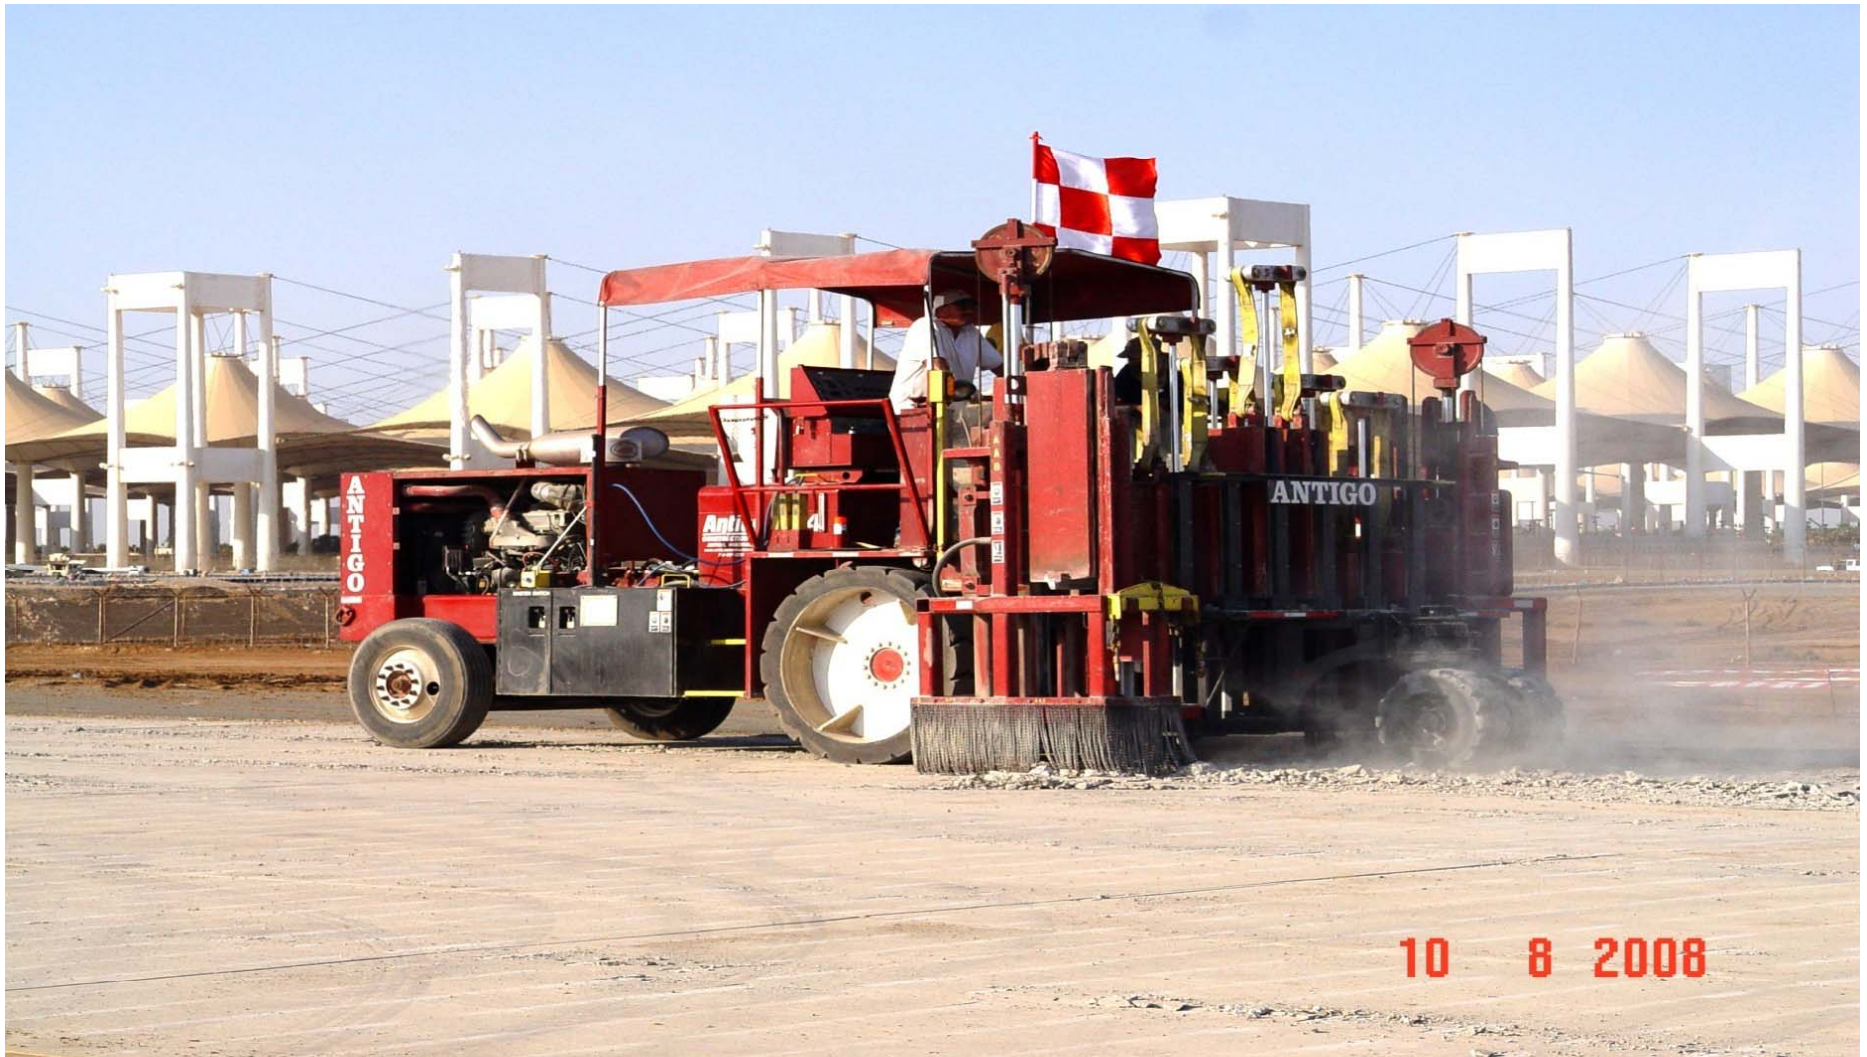
After the Guillotine type breaker fractured the concrete the Multi-Head breaker was used to rubblize the concrete layer. The Multi-Head breaker was 4 m (13 ft) wide and had sixteen 450 kg (1,000 lb) individual drop hammers. Each hammer can be dropped individually from up to 1.5 m (5 ft) height.

# MHB Badger Breaker 16-hammer

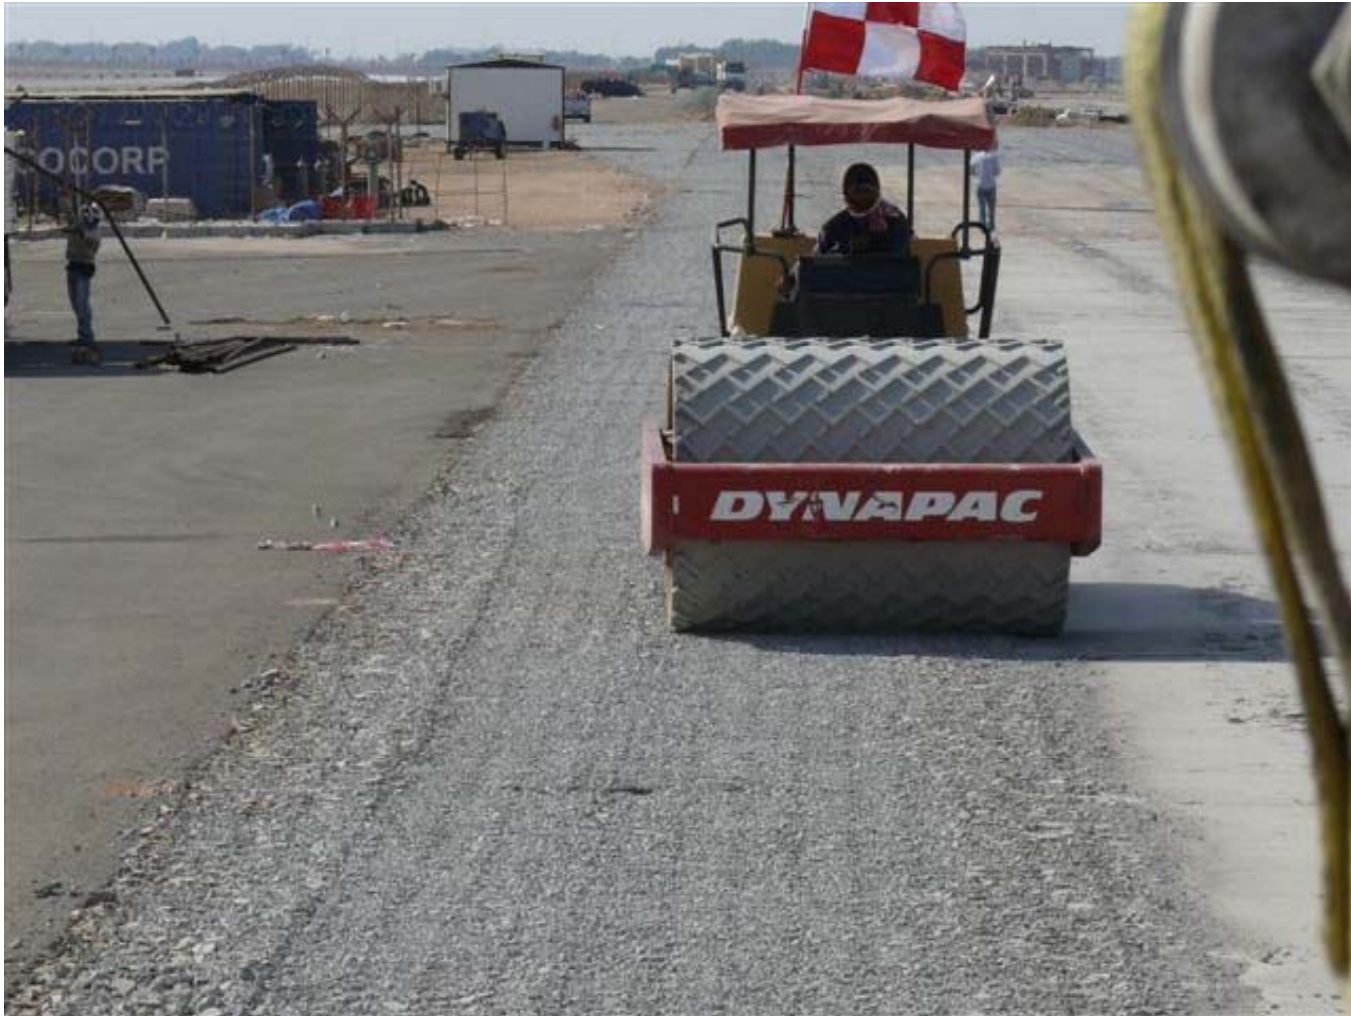
After the Multi-Head breaker finished the rubblization process, a 10 ton vibratory steel drum roller with ‘Z’ Grid attachment was used to break the bigger particles at the surface.

# Z-Grid Roller
