**RUBBLIZATION OF EXISTING AIRFILED PAVEMENTS AT  
KING ABDULAZIZ INTERNATIONAL AIRPORT, JEDDAH  
SAUDI ARABIA**

**2014 FAA WORLDWIDE AIRPORT TECHNOLOGY  
TRANSFER CONFERENCE**

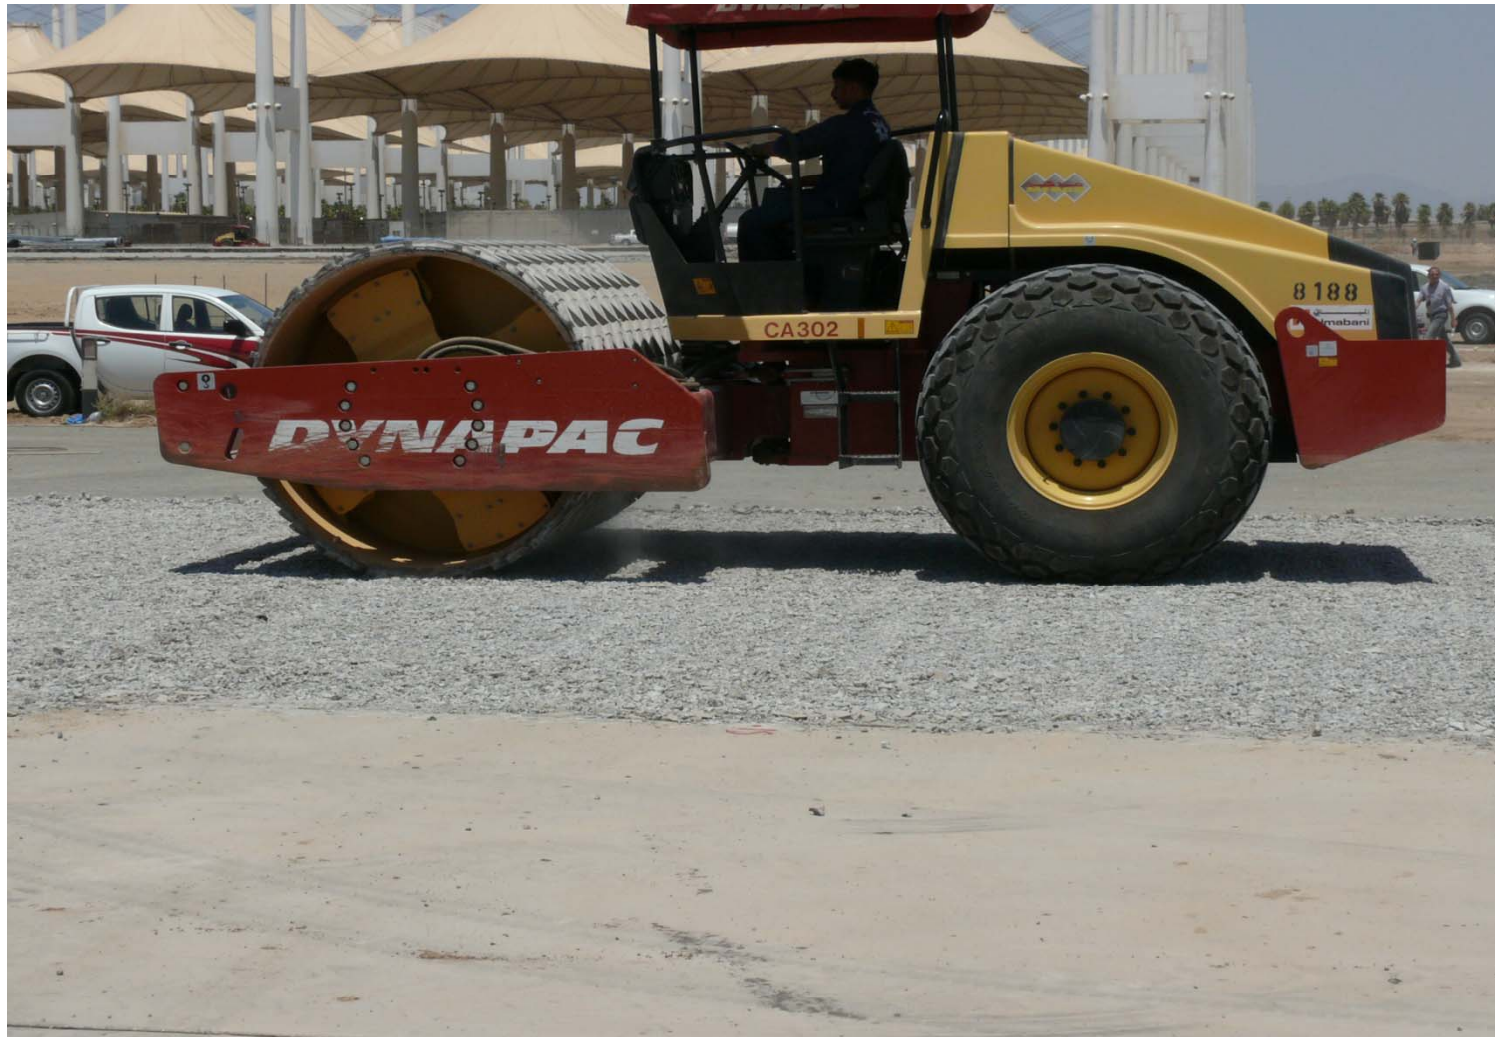
After the Multi-Head breaker finished the rubblization process, a 10 ton vibratory steel drum roller with ‘Z’ Grid attachment was used to break the bigger particles at the surface.

# Z - Grid Roller

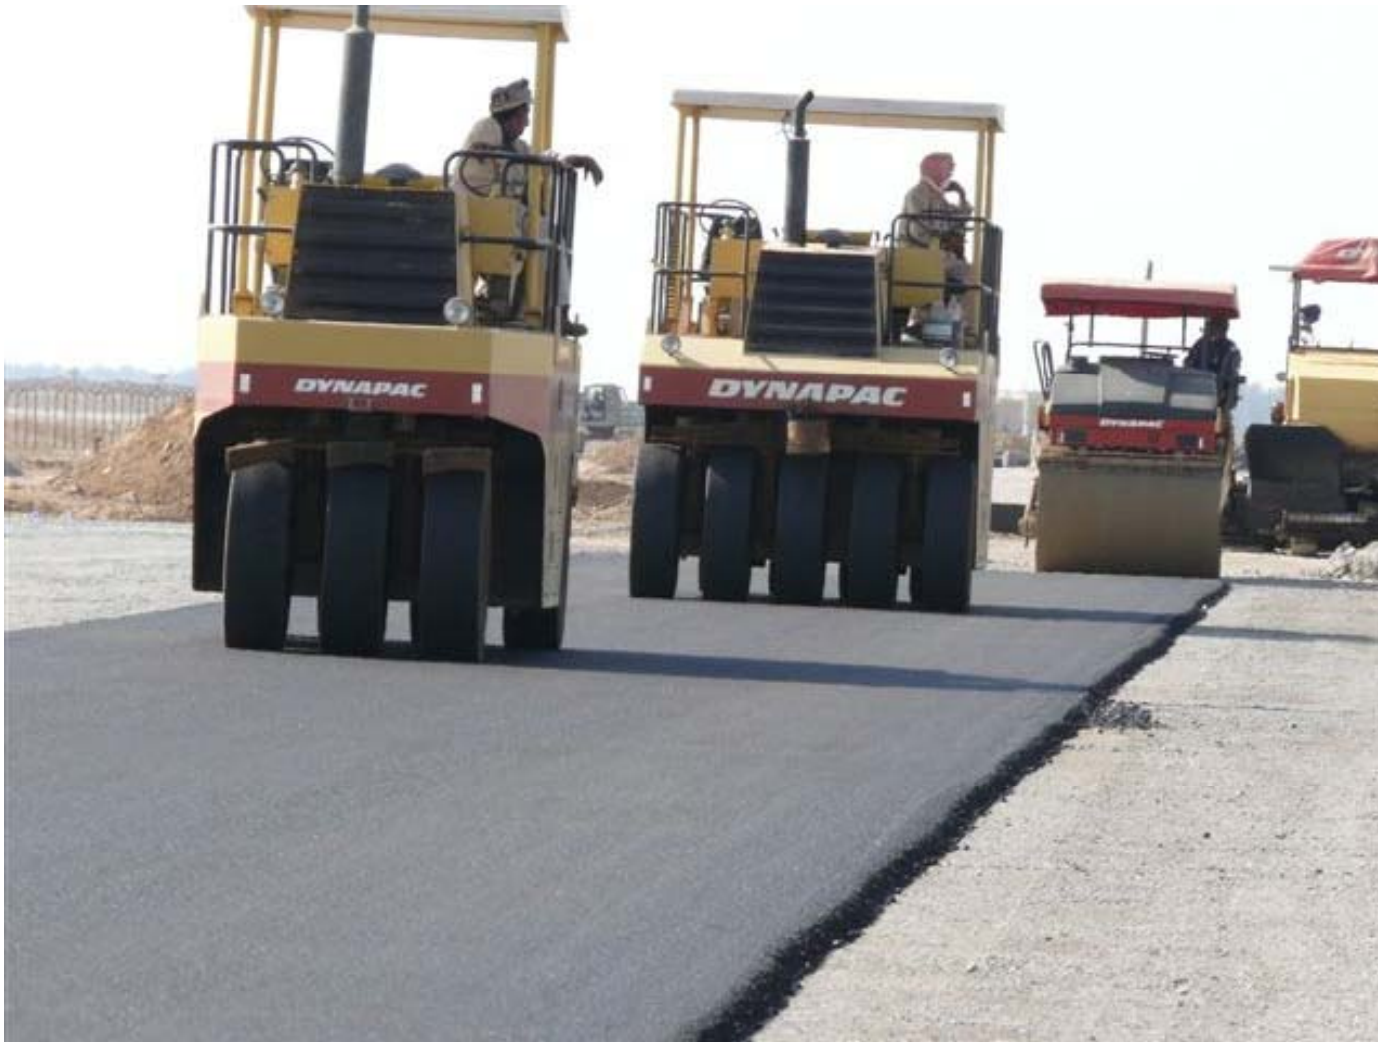
A 20 tons pneumatic-tired roller was used to seat the rubblized surface.

# Pneumatic Tire Roller

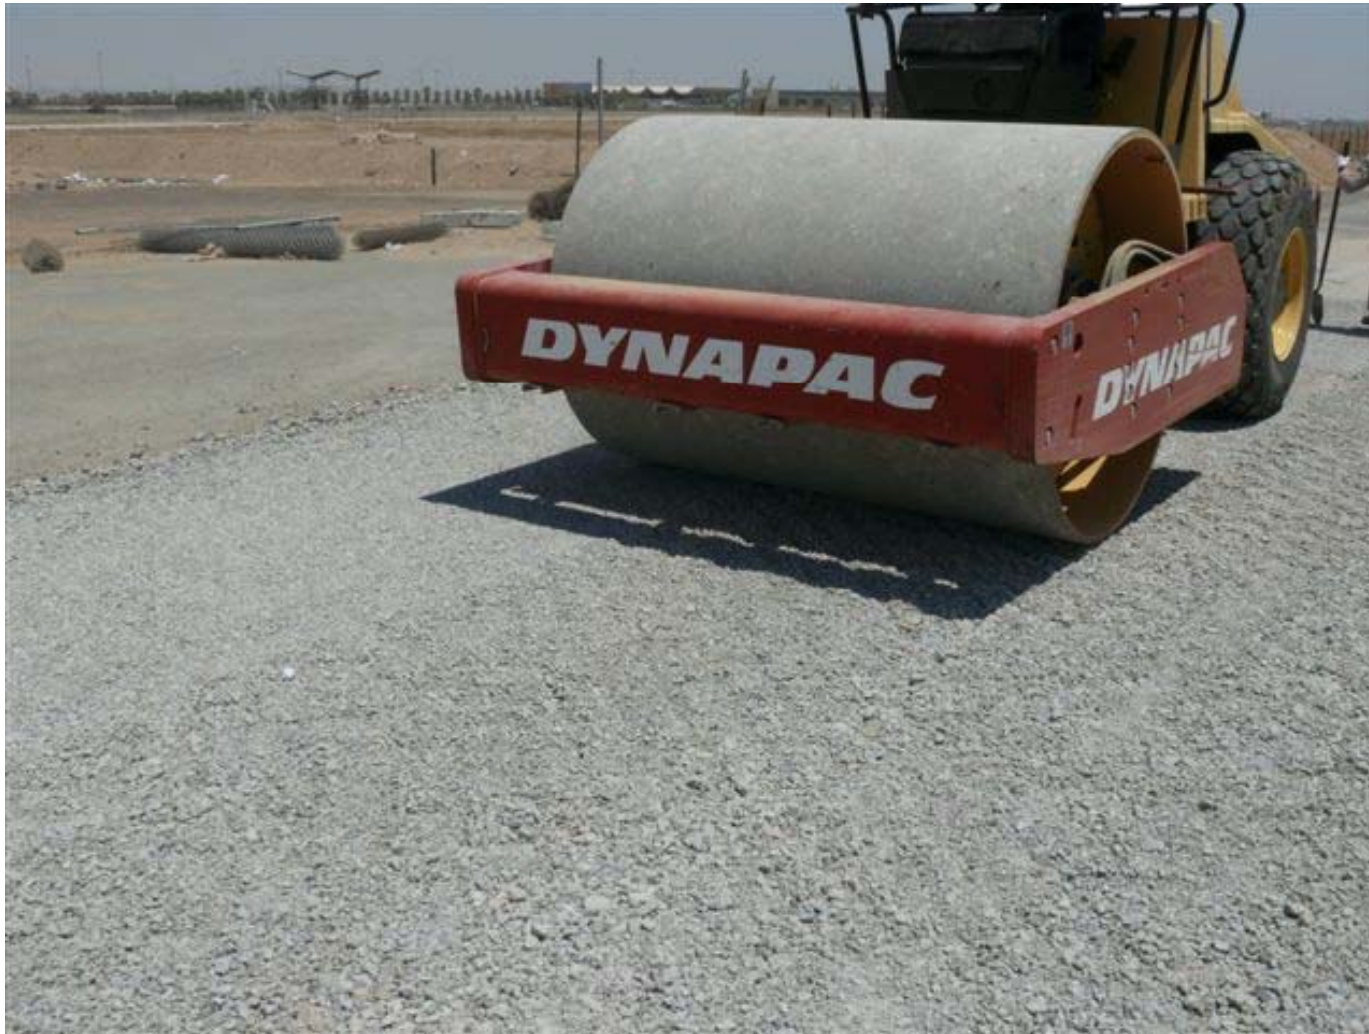
A 10 ton smooth steel drum vibratory roller was used to seat the rubblized surface and to provide smooth surface for AC overlay.

# Smooth Steel Drum Vibratory Roller

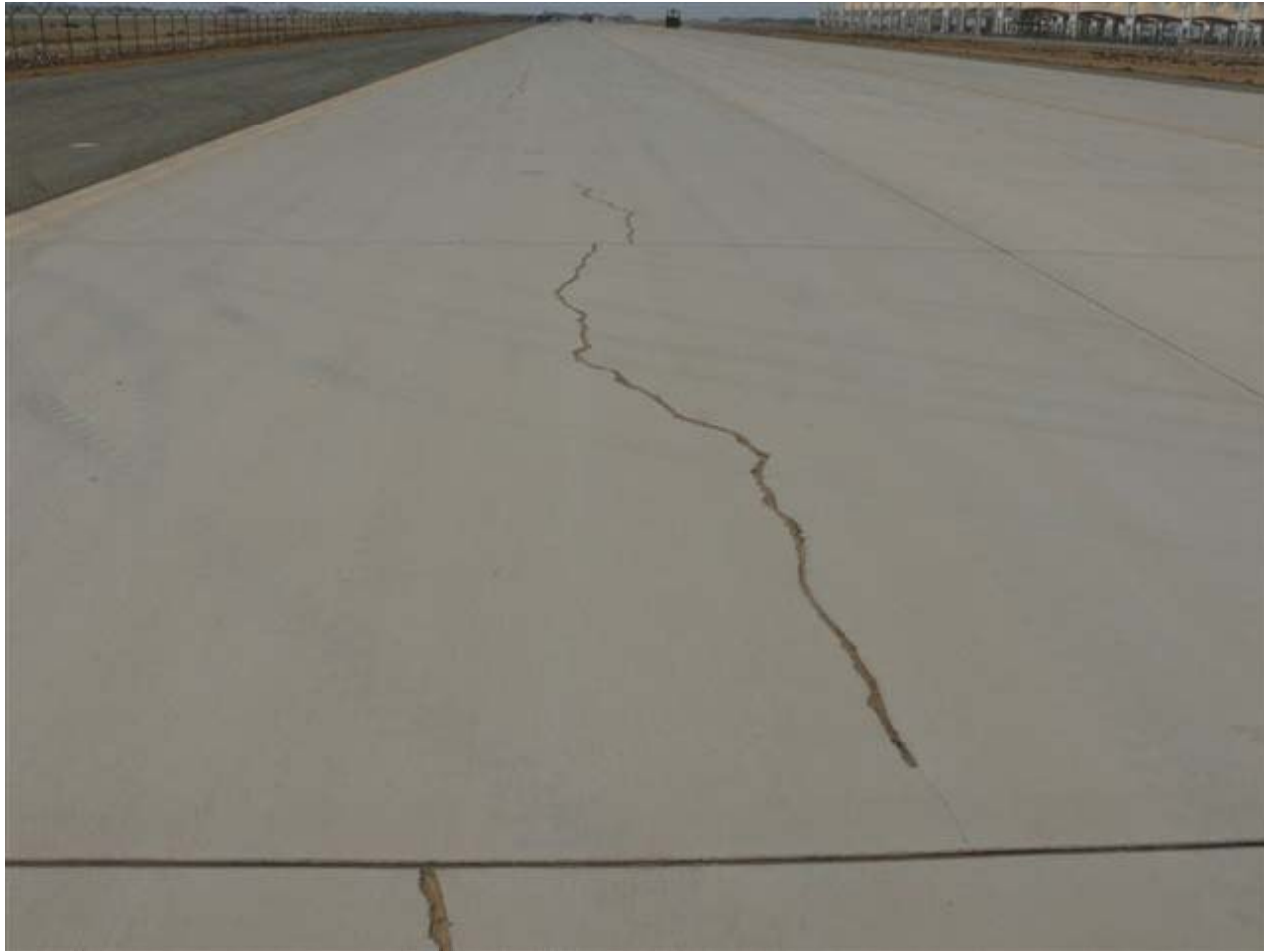
# Test Strip – Taxiway C

- **Visual inspection of the pavement to be rubblized to identify any shallow underground structures.**
- **Test Strip For Rubblization. Before starting the process of rubblizing, the contractor prepared a test strip 50mx3.5m wide. To ensure the test strip is rubblized as per the specification. The test strips was repeated at each change of PCC thickness areas.**

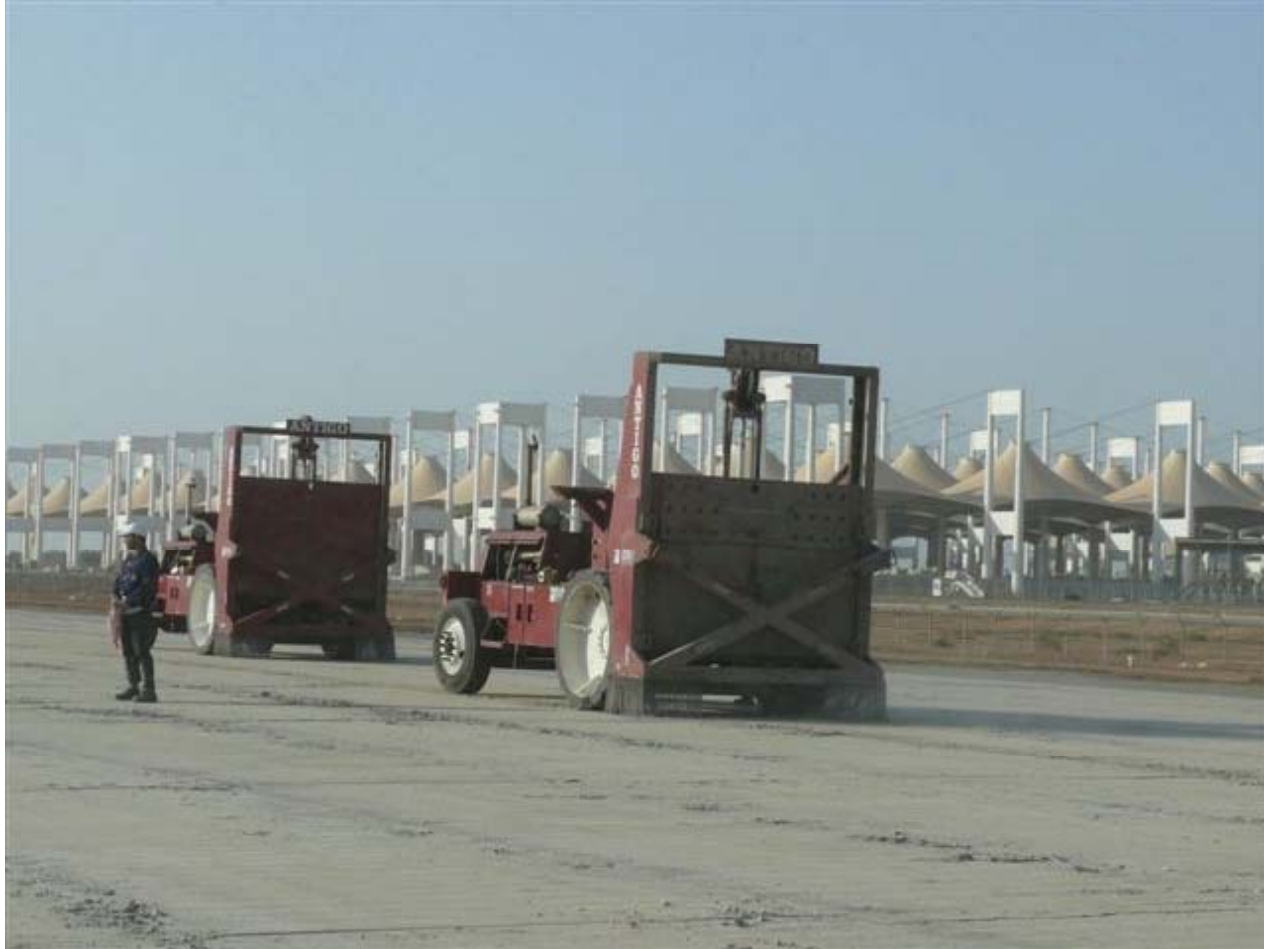
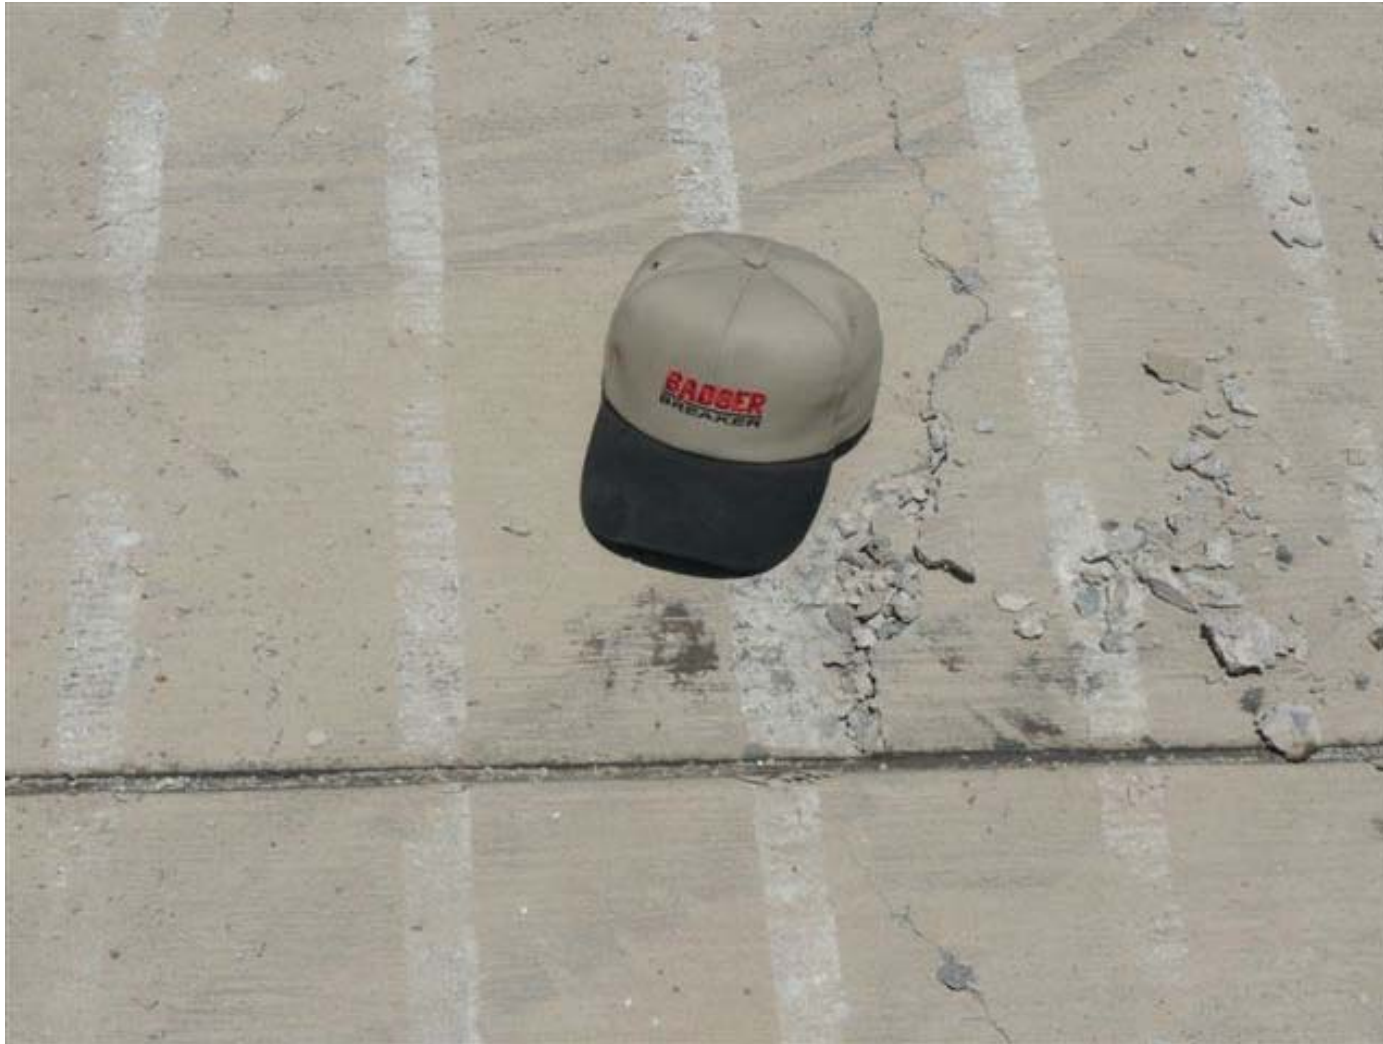
- **The initial breaking of the pavement was performed with the guillotine hammer**

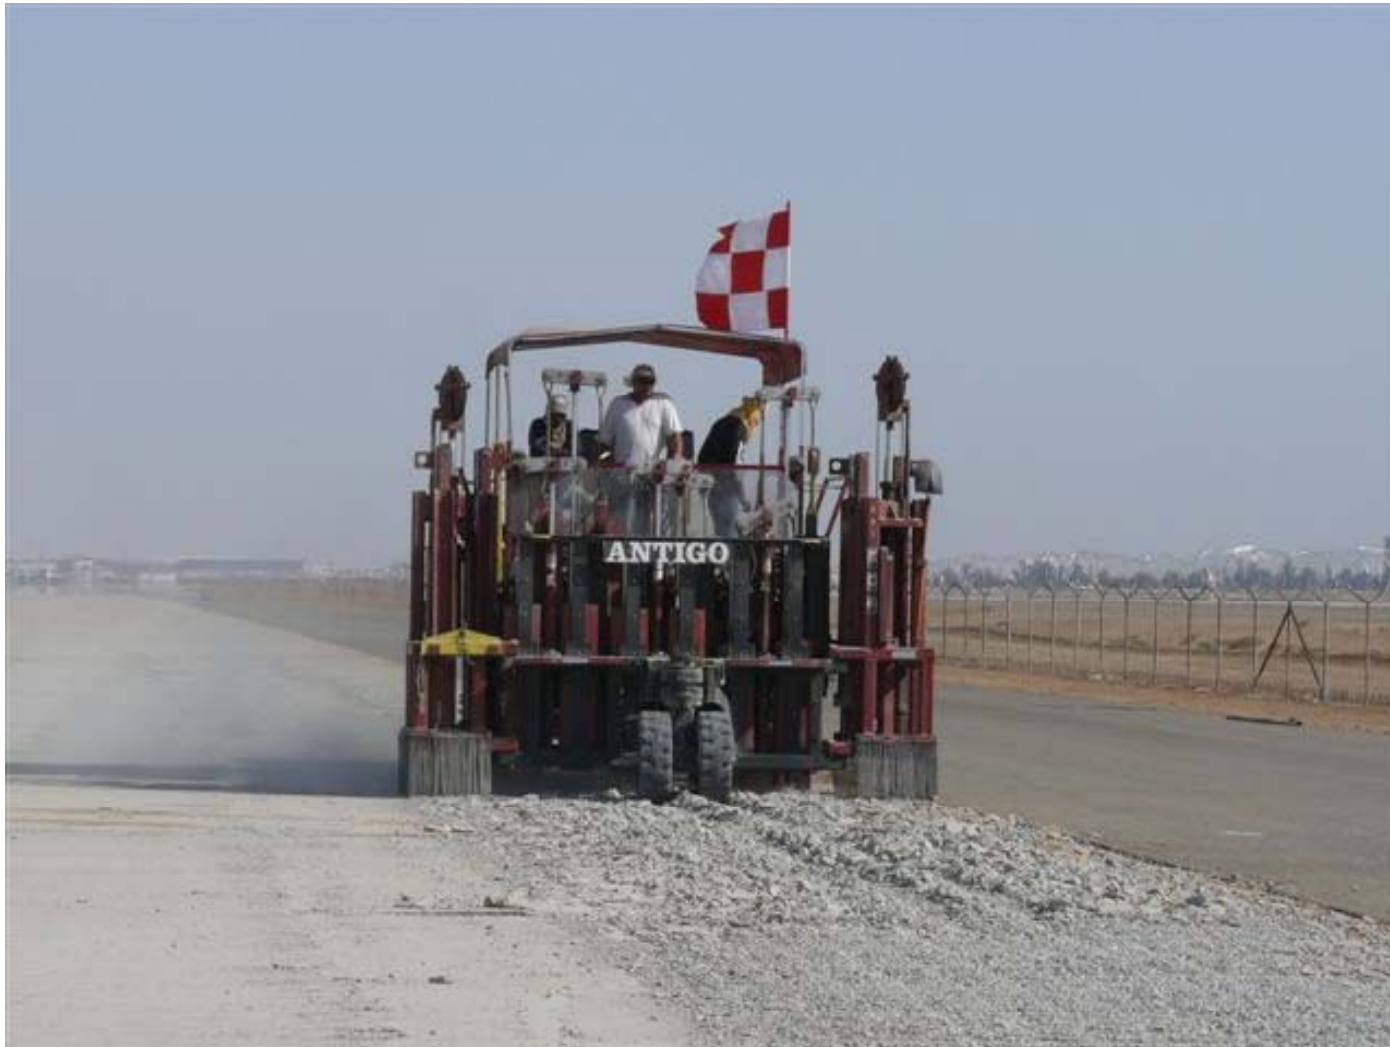
# Test Strip – Taxiway C

- **The rubblizing was accomplished using a MHB.**

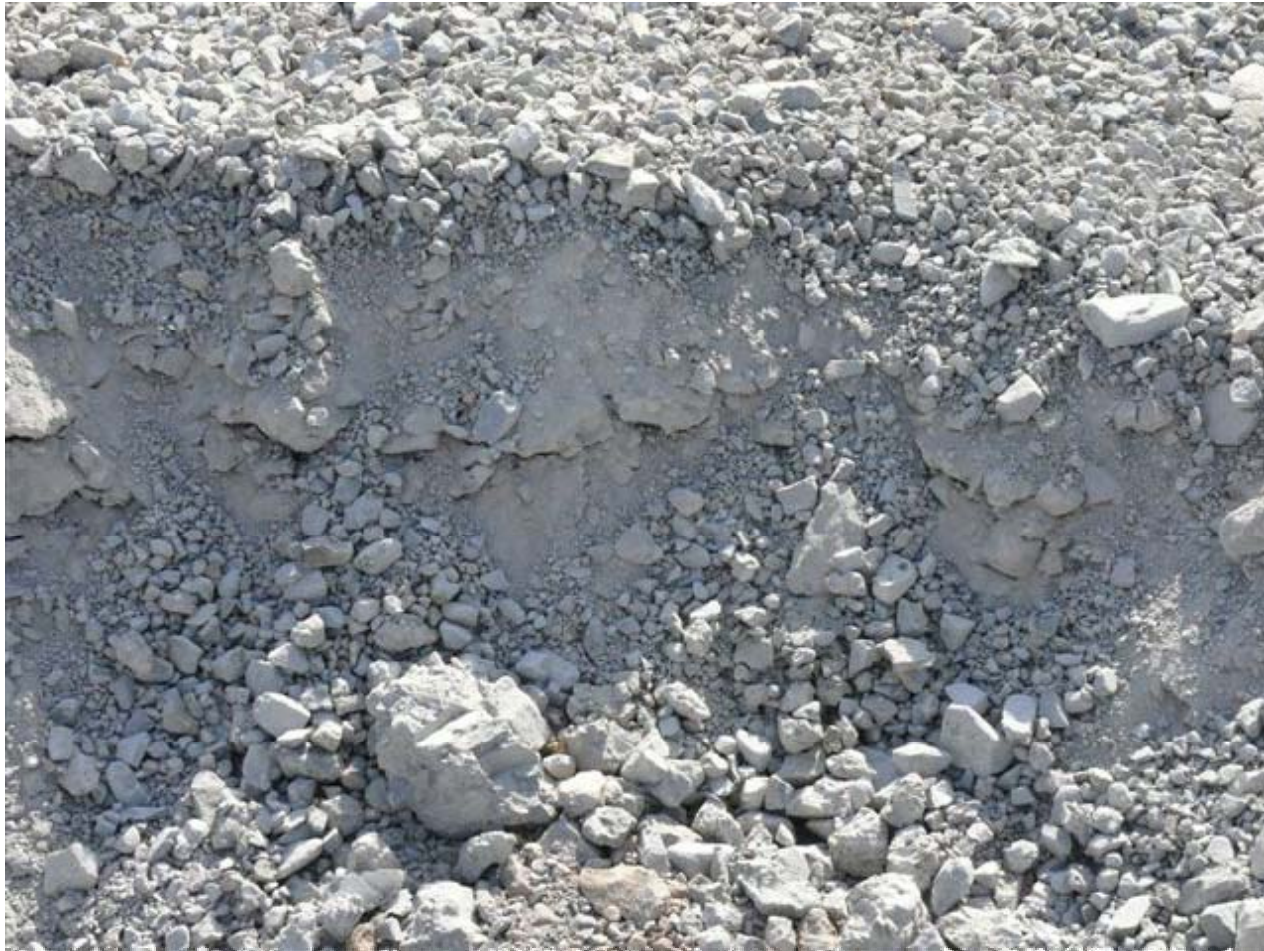
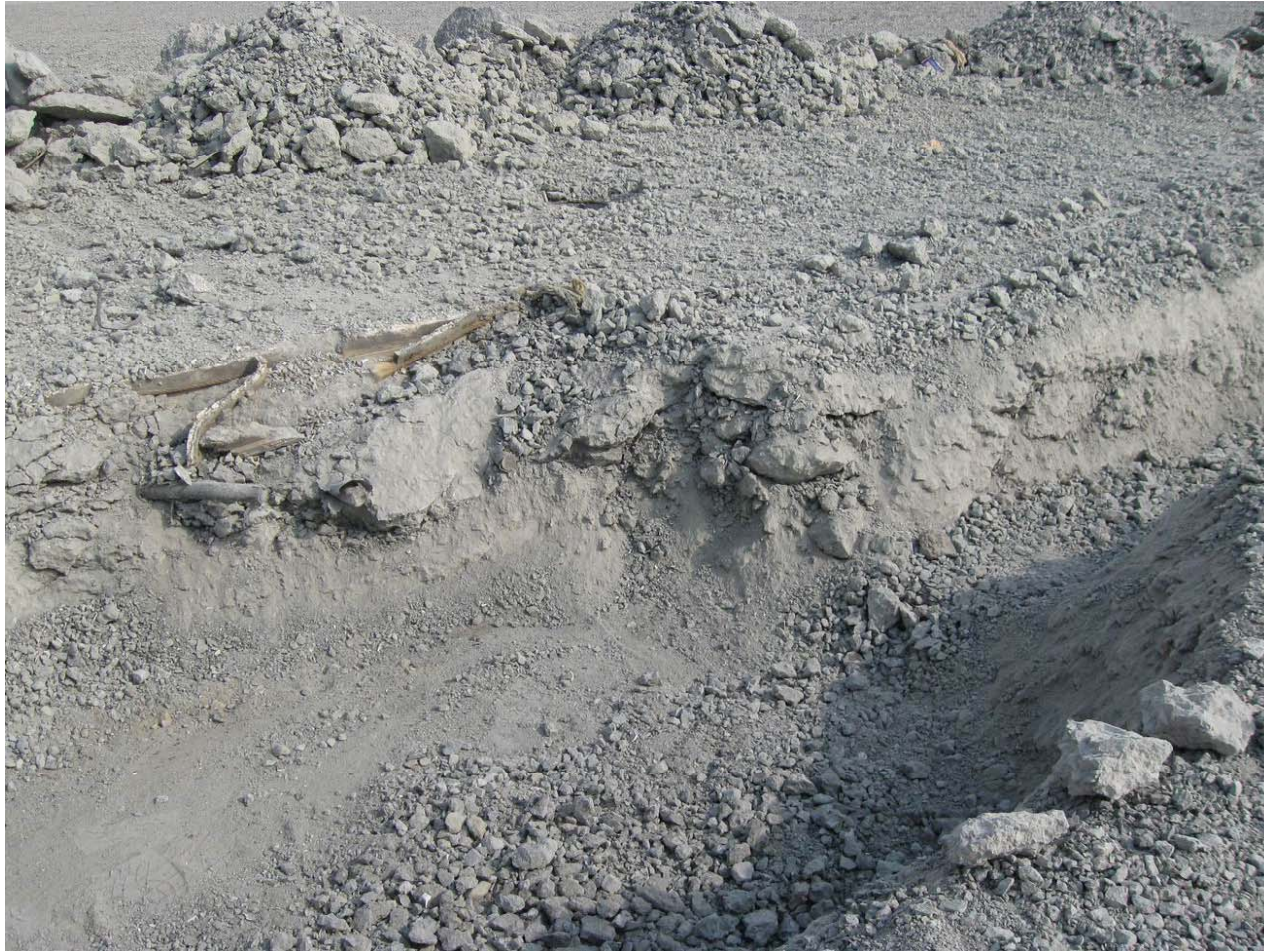
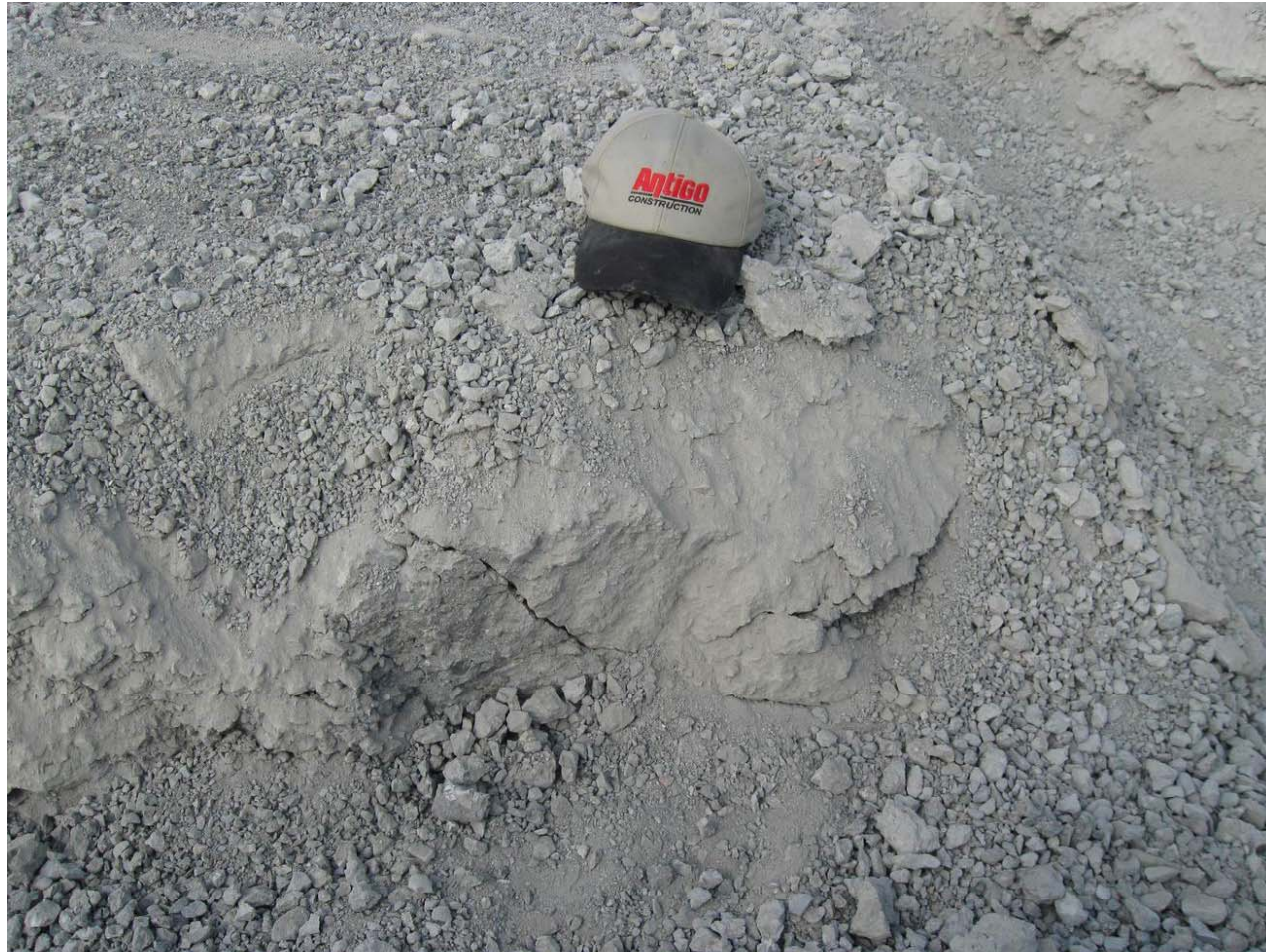
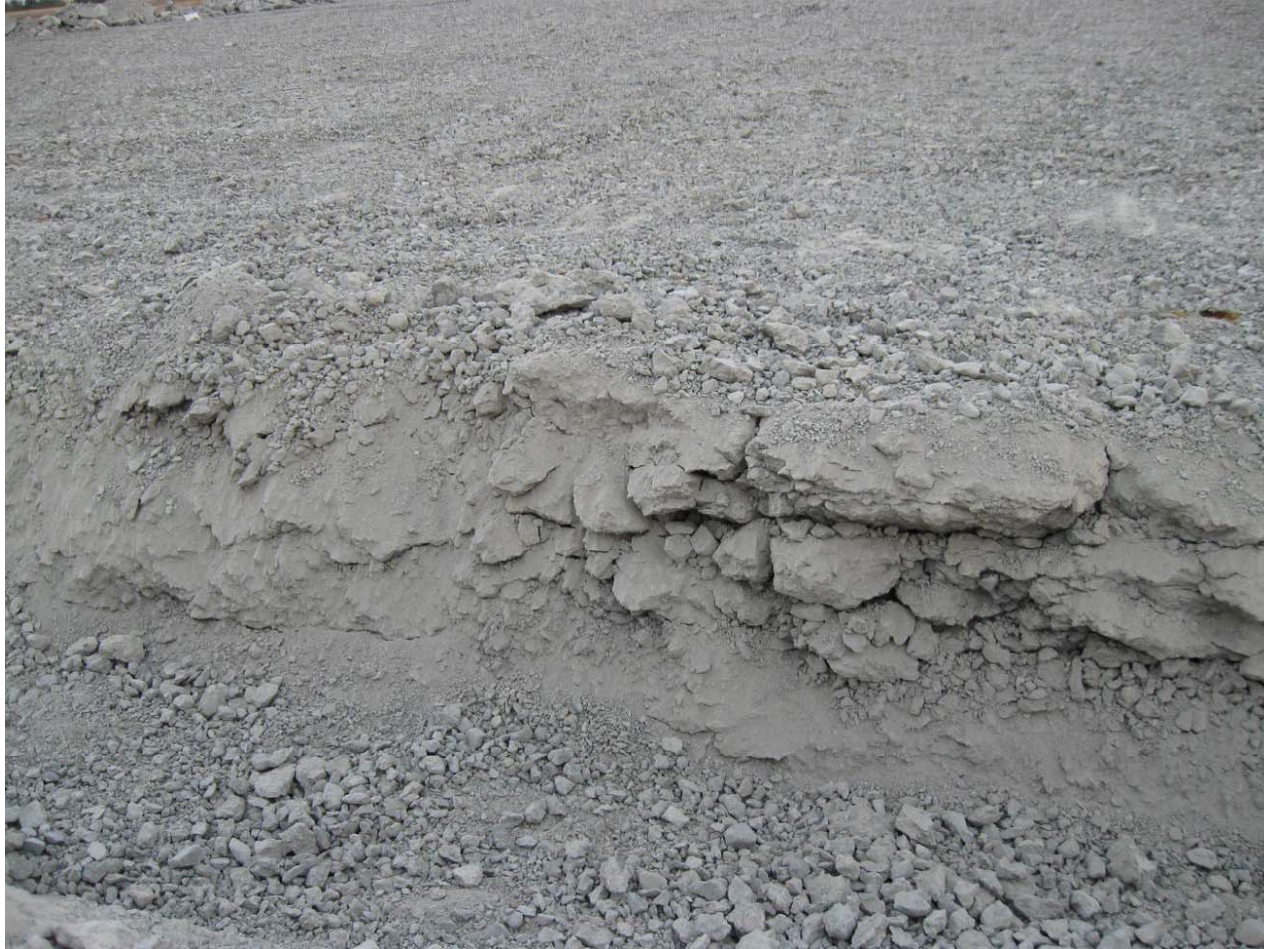
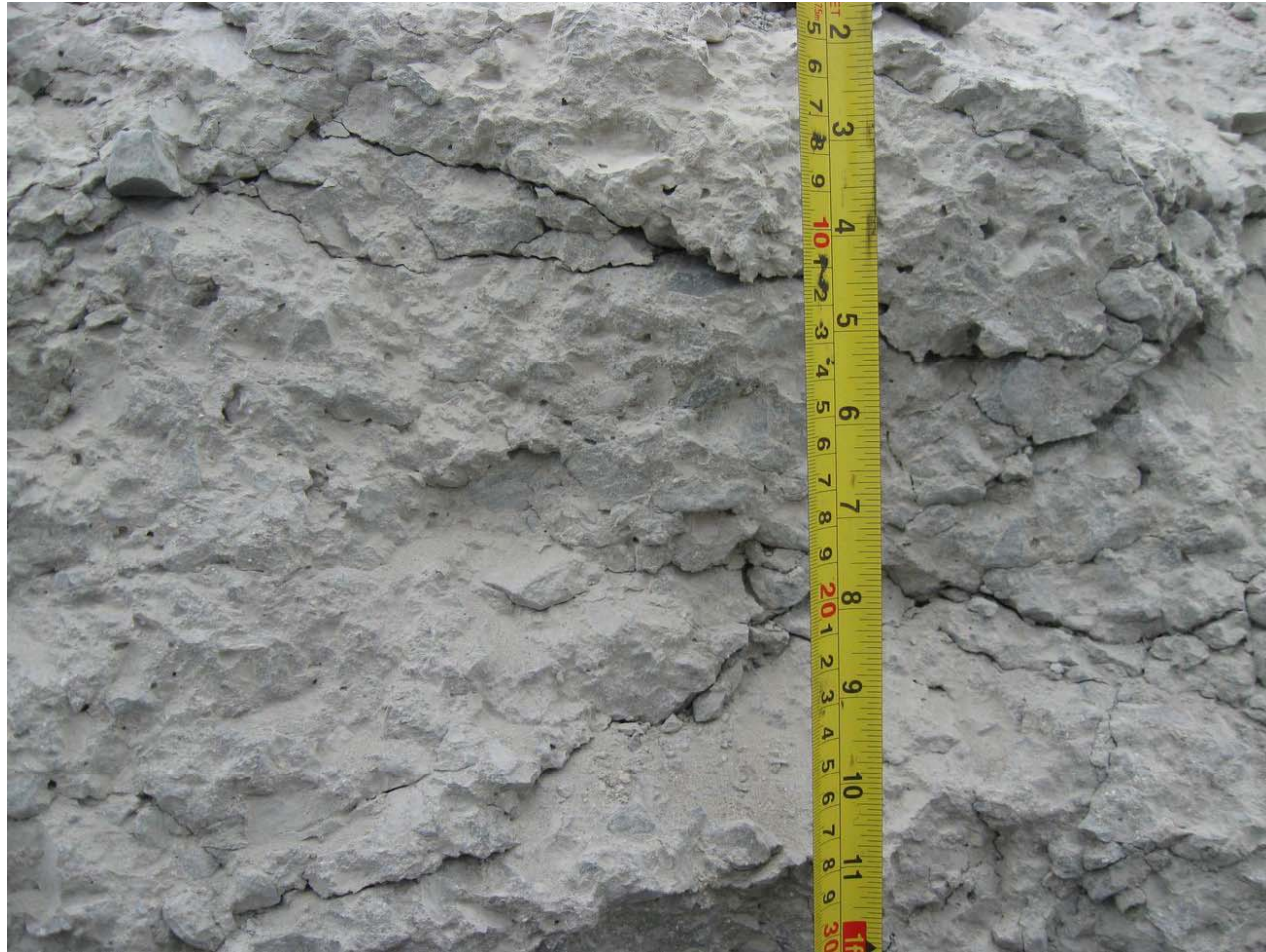
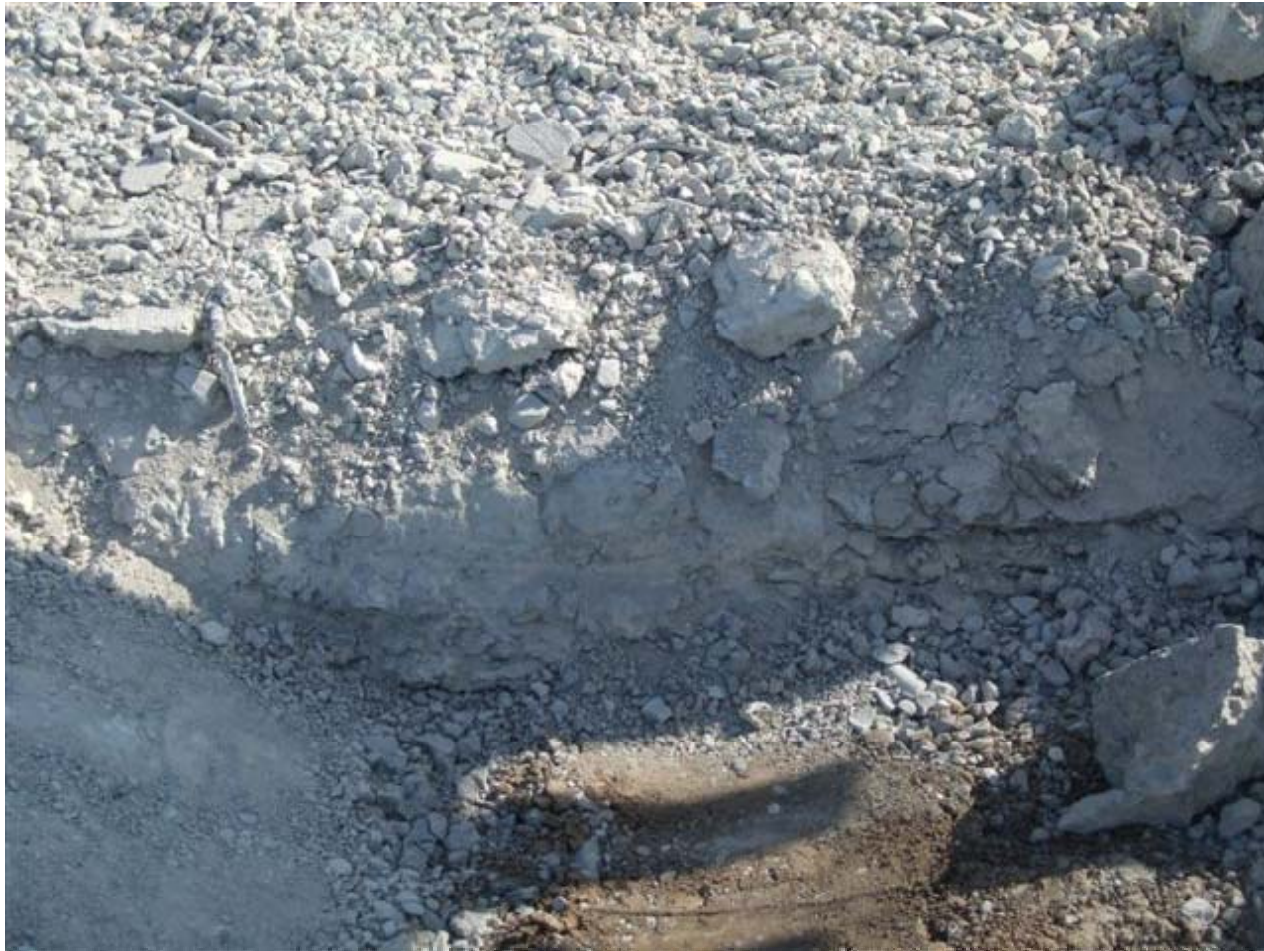
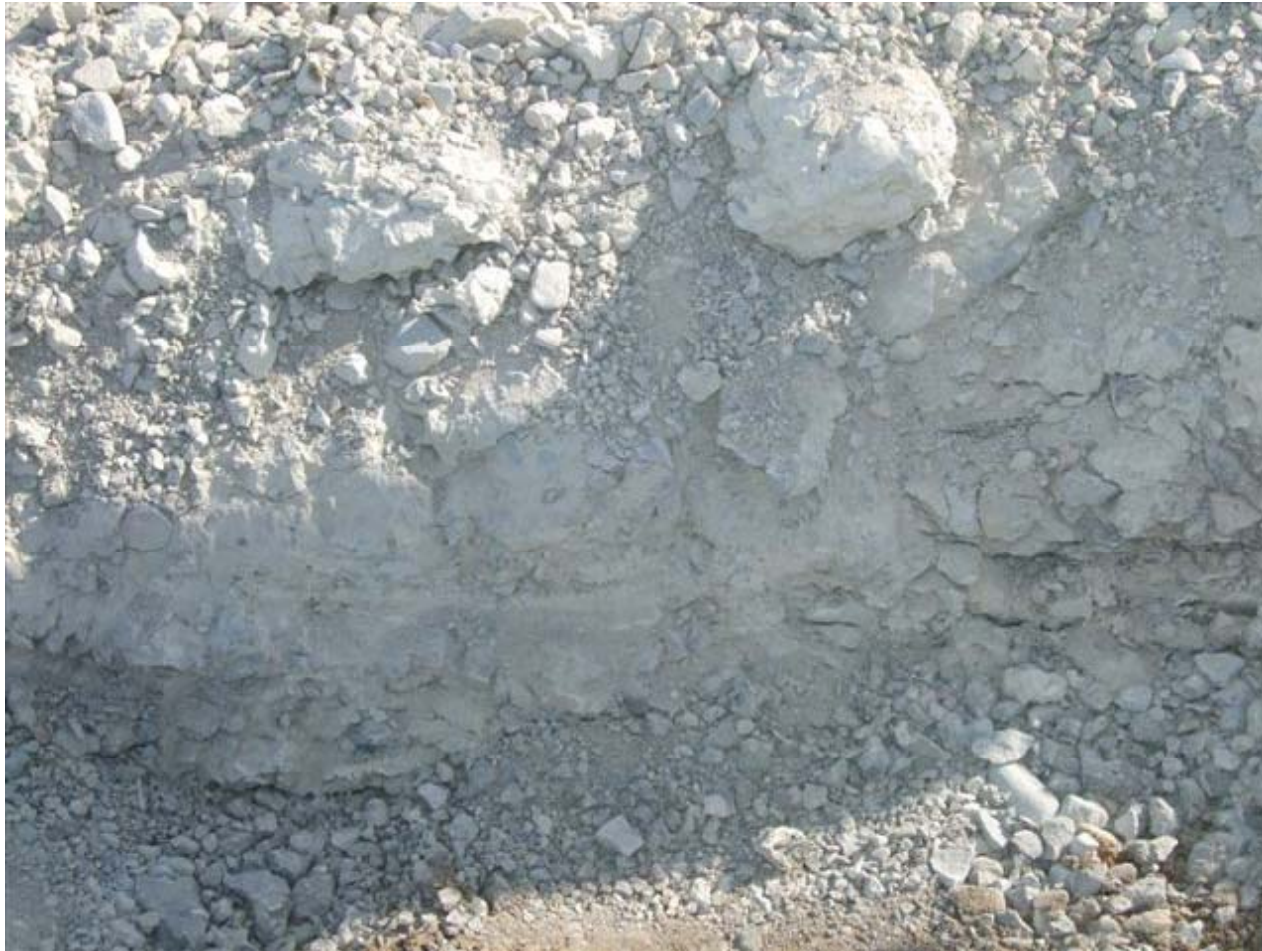
- Routine test pits were excavated for each 5000M2(lot) of rubblized area for inspection, quality control and acceptance as per specification.
- The rubblized material in the test pits was examined to check largest size within the guidelines of the specification.
- The operator adjusted the drop heights and/or impact spacing if necessary to achieve the required sizing.

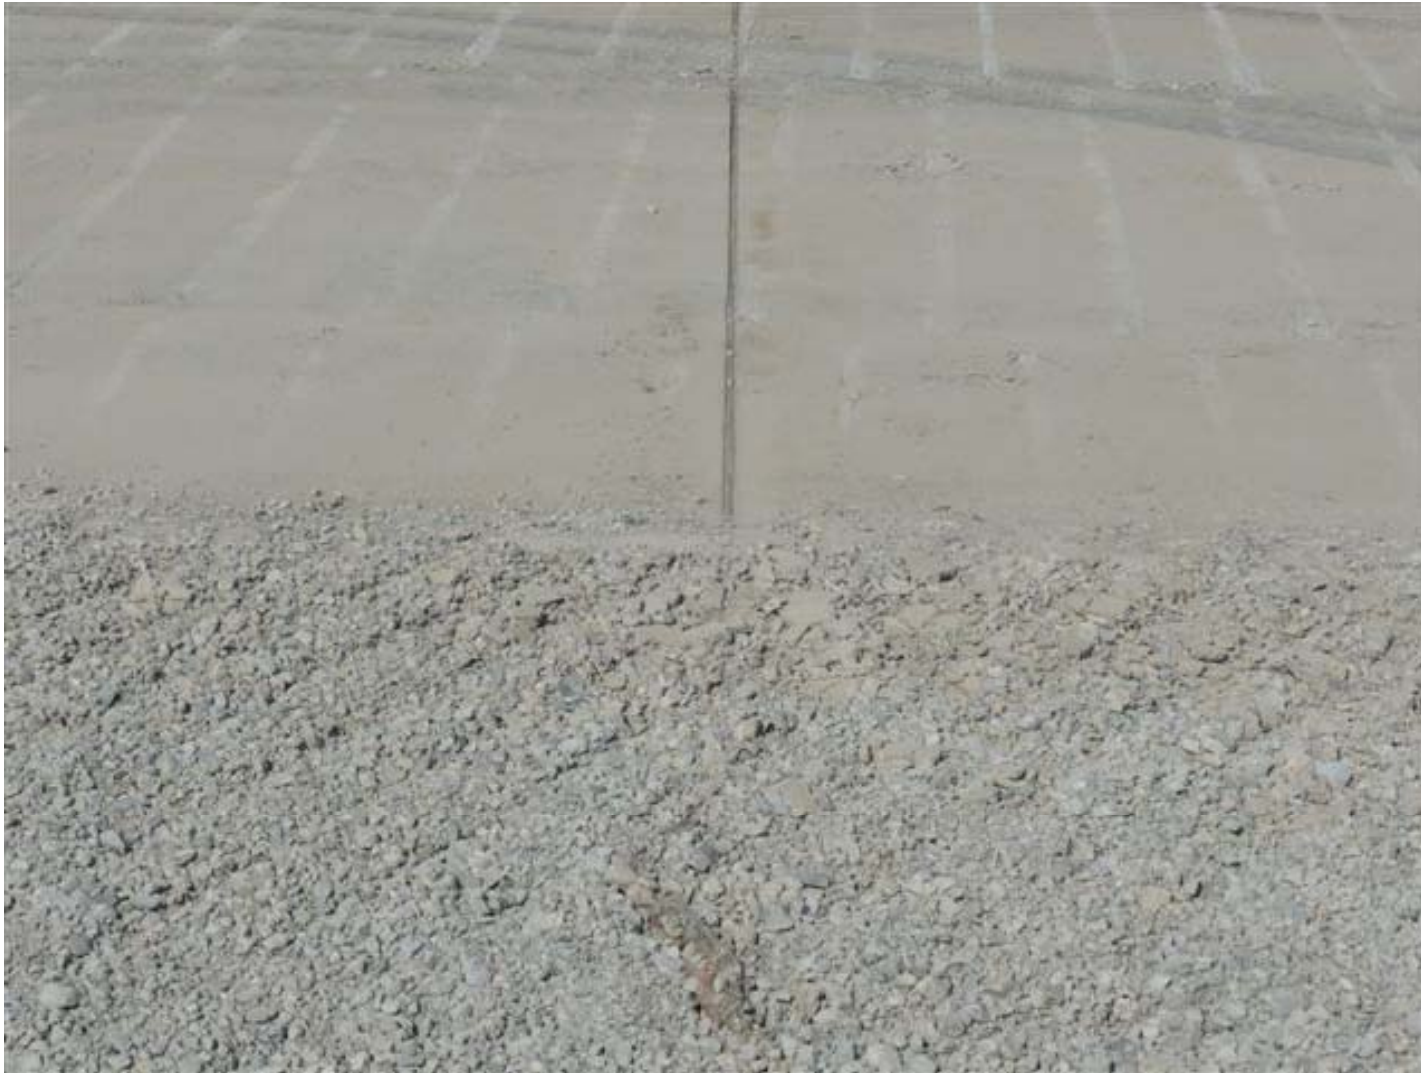
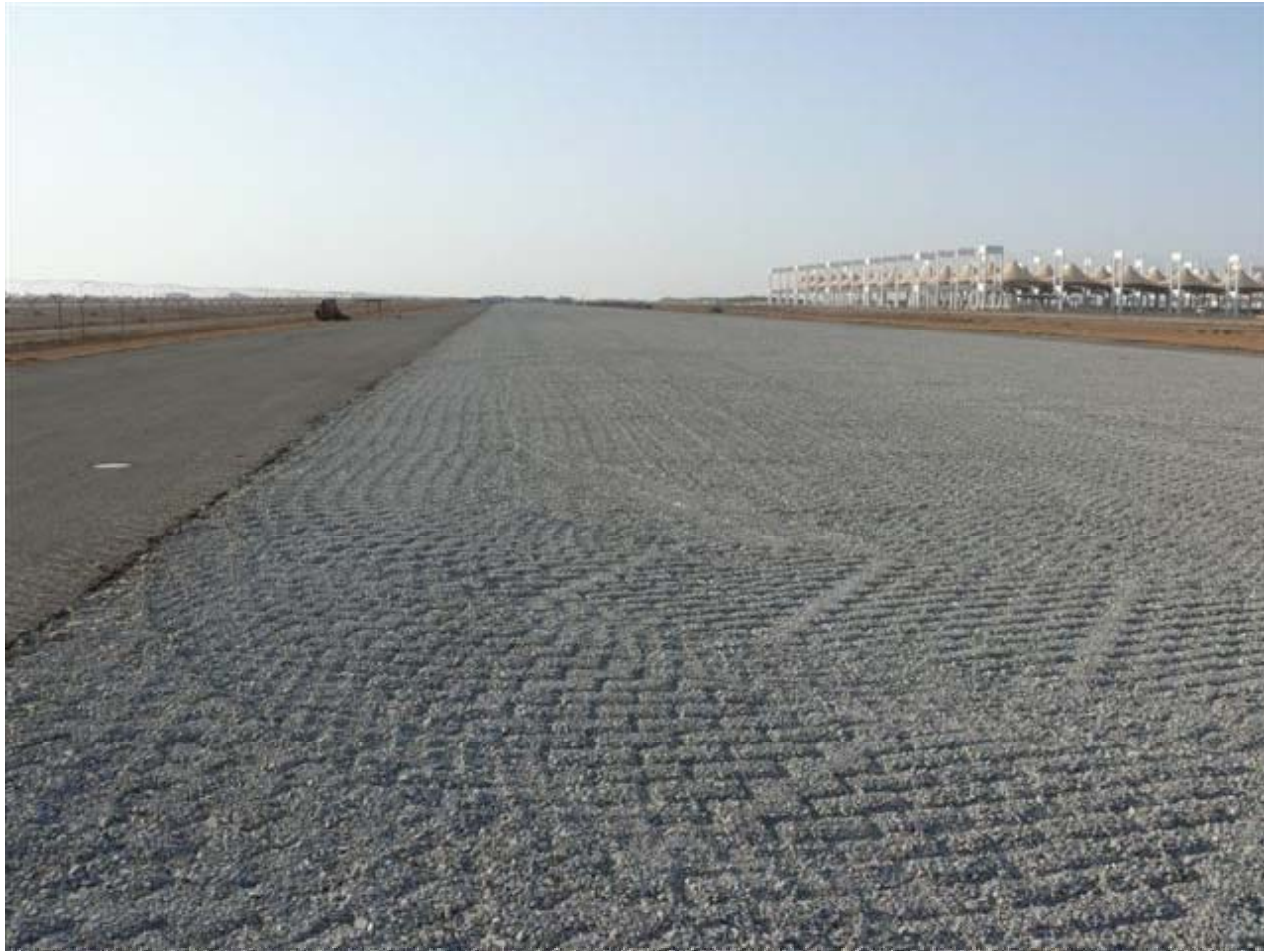
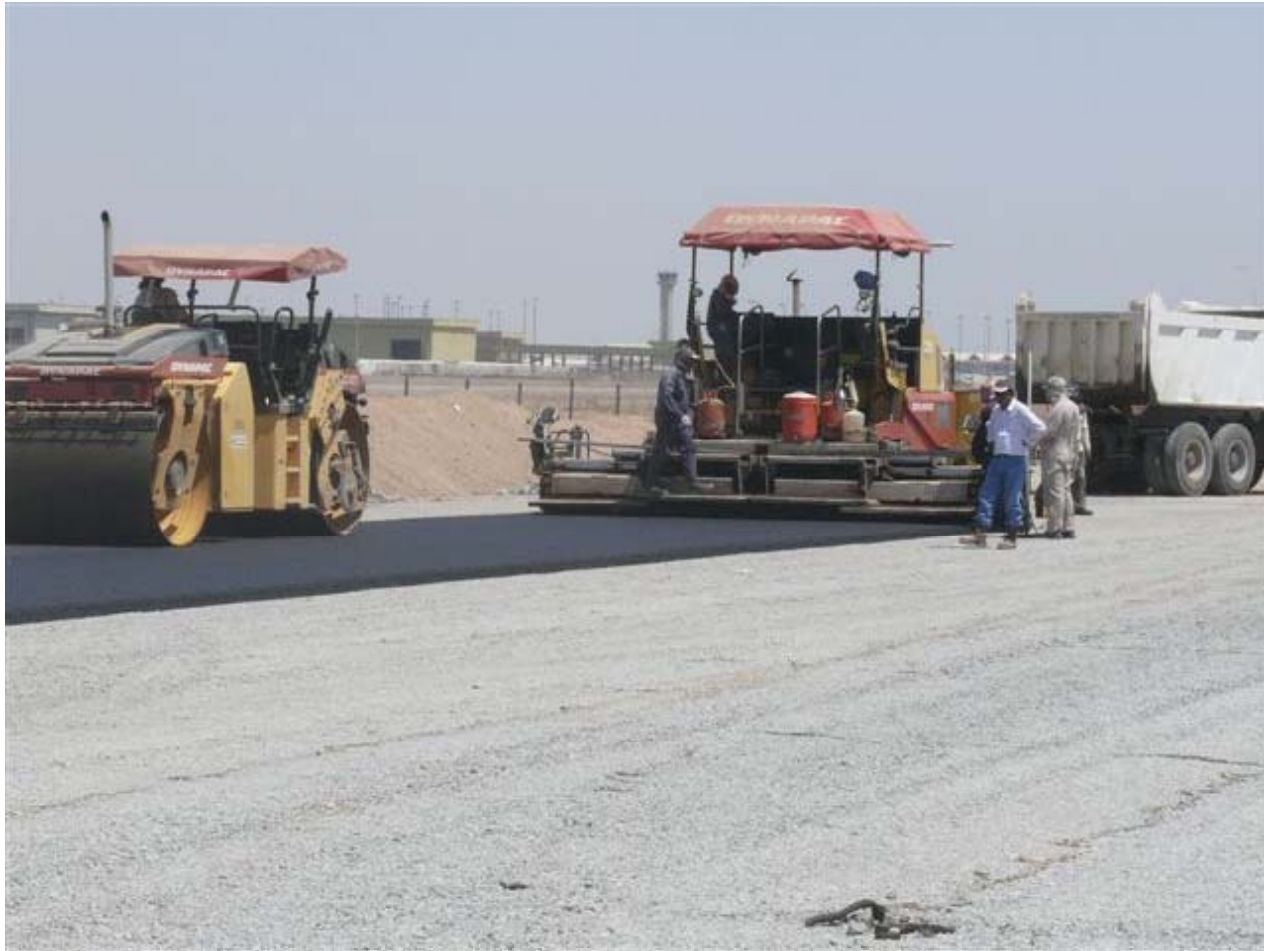
- **Before the asphalt overlay was placed, the rubblized pavement was compacted by a variety of compaction equipment in the following sequence:**
  - Vibratory steel drum roller with Z-grid attachment
  - 20 ton pneumatic-tired roller
  - 10 ton vibratory steel drum roller.
