Antigo Construction Family of Companies

Rubblization or Crack/Break & Seat – Things to Consider

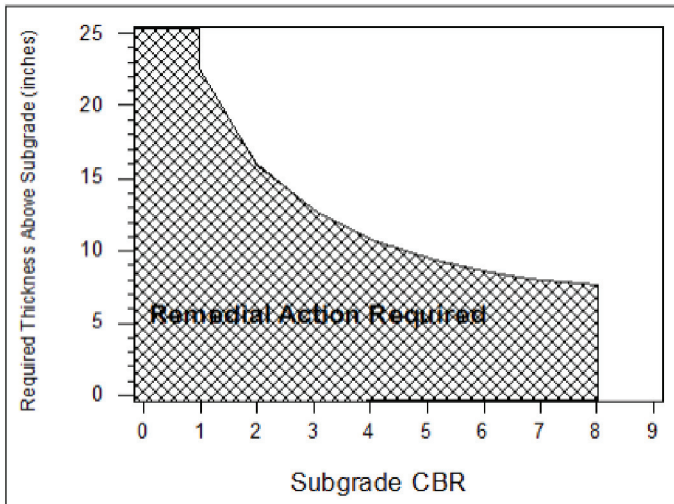
Figure 15.2. Subgrade/Base Layer Adequacy

The Wisconsin Department of Transportation's Facilities Development Manual section "FDM 14-25-15 Concrete Pavement Rubblization" (<https://wisconsindot.gov/rdwy/fdm/fd-14-25.pdf#fd14-25-15>) includes guidance on how to "determine whether the subgrade, rubblized concrete, and base aggregate layer provide enough support to accommodate the construction process". The figure on the next page represents the relationship between subgrade CBR and the combined thickness of the materials above the subgrade (subbase, base, rubblized concrete) with points in the area above and to the right of the curve representing conditions that will allow for effective rubblization. For example, a

6-inch thick base layer with a 9-inch thick rubblized concrete layer requires a CBR of approximately 3. That same concrete layer directly on subgrade requires a CBR of approximately 6.

As points enter the “Remedial Action Required” area, best practice is to utilize a “modified rubblization” process (see description at end of document) or crack/break & seat to retain more of the structural support of the existing concrete slab to compensate for low subgrade/base support. In extreme situations, Antigo recommends that fractured slab techniques not be utilized.
