Field Performance of Crack and Seat Projects

SAMUEL H. CARPENTER AND MICHAEL I. DARTER

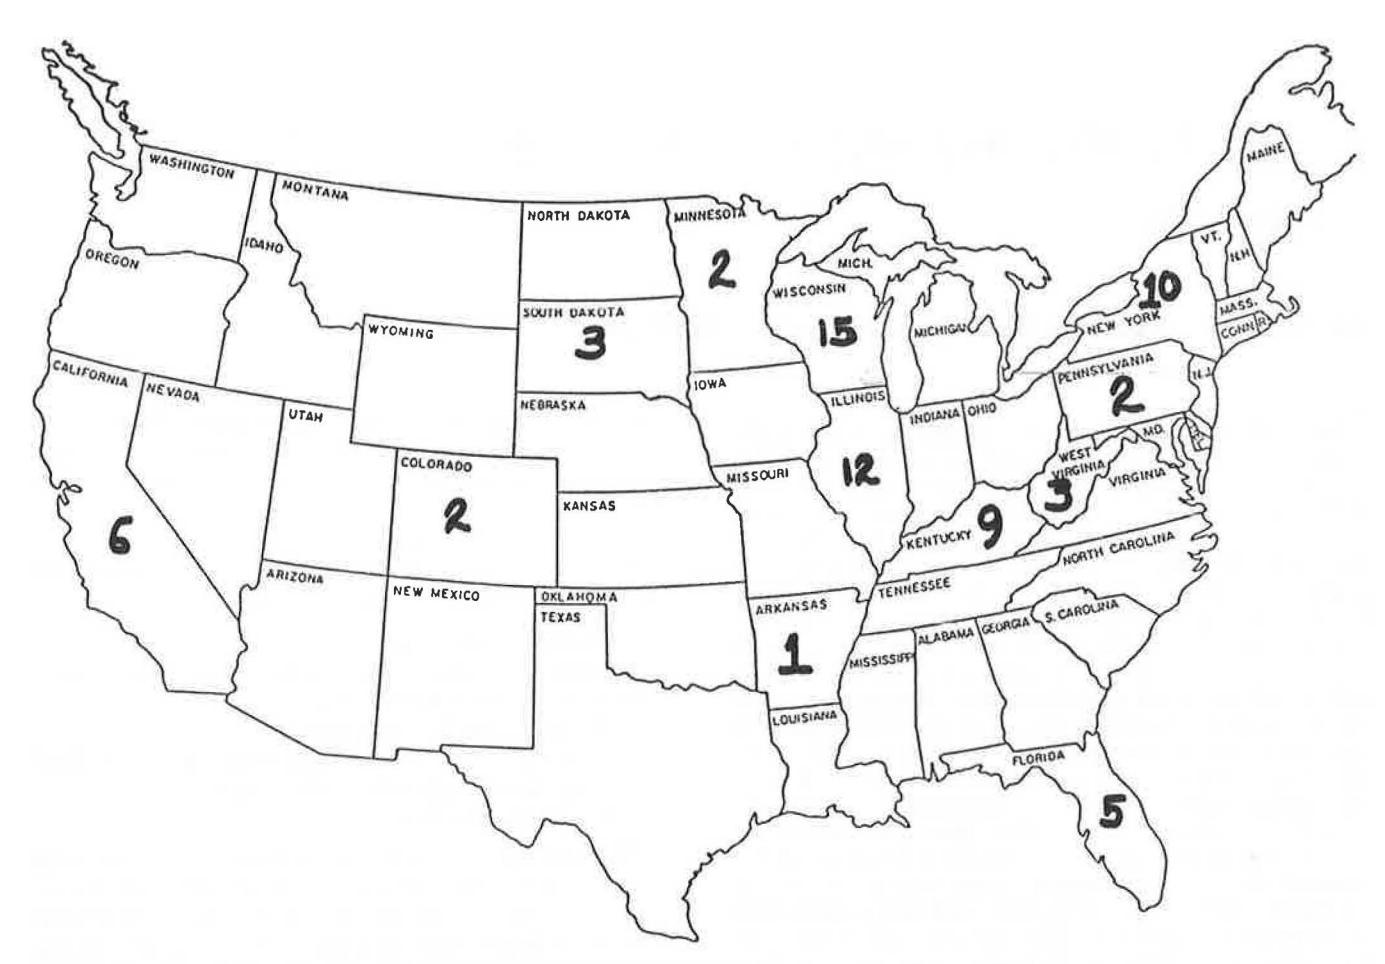
FIGURE 1 Distribution of crack and seat projects in the United States.

The database contains as many projects as were available or that could be included, given available resources, to provide a valid range of design parameters. Figure 1 shows the general location of the crack and seat and asphalt concrete overlay projects.

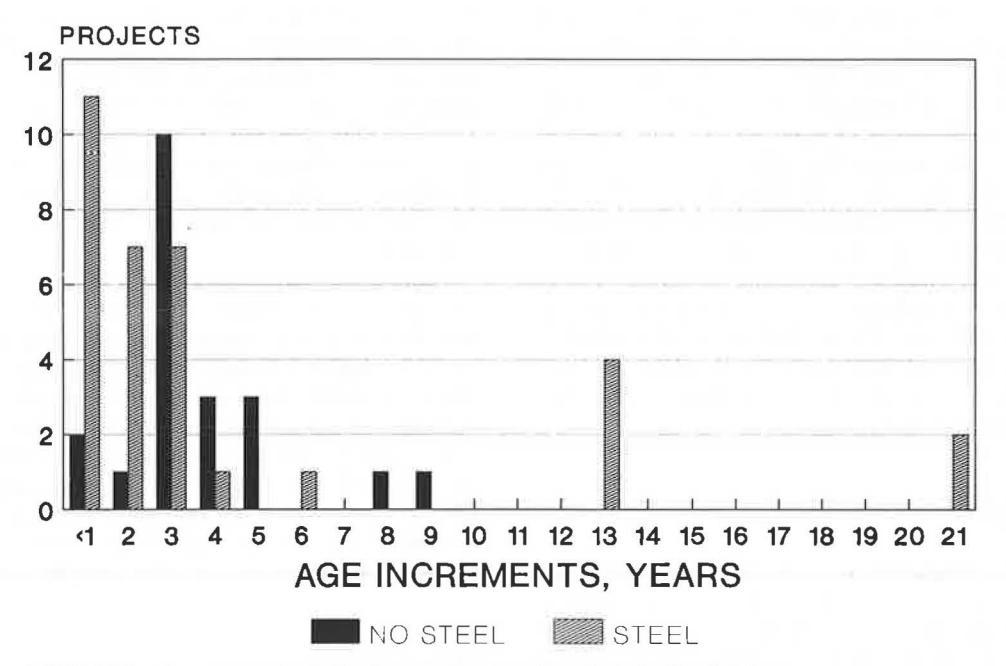
FIGURE 2 Age comparisons for the crack and seat projects in the database.

Figures 2 and 3 show the distribution of age and thickness for the crack and seat projects in the database. These parameters are broken out based on whether the original concrete pavement was plain or reinforced. The presence of reinforcing steel has long been felt to be a major factor influencing the performance of crack and seat rehabilitation. It is seen from the figures that the reinforced pavements have received thicker overlays and are generally not much older than the plain pavements.

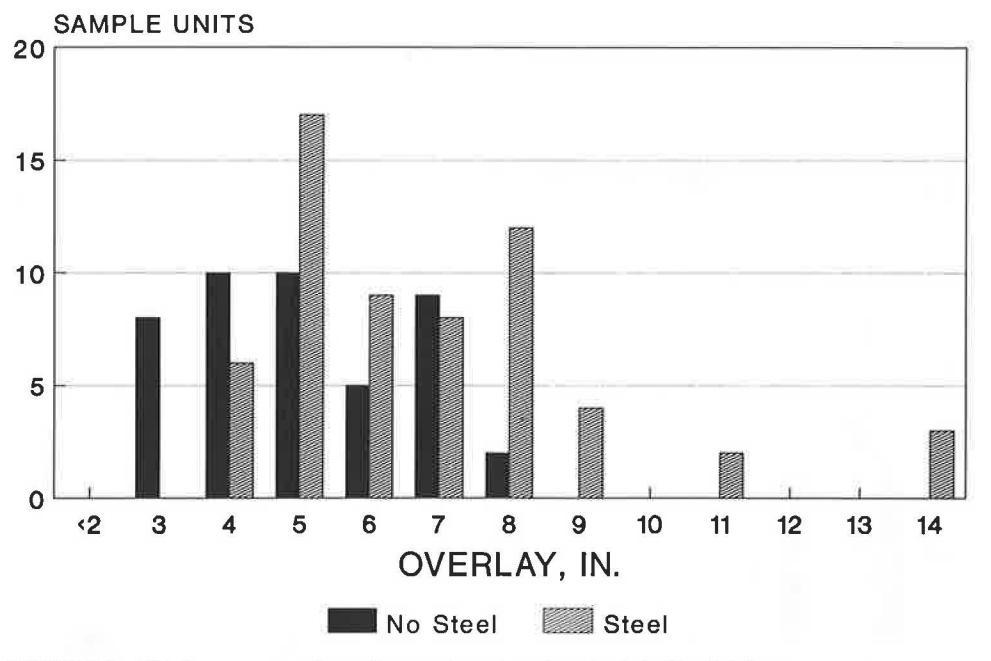
FIGURE 3 Thickness comparisons for crack and seat projects in the database.

The thickness of the overlay has a critical role in the development of reflection cracking, particularly when the overlay is below approximately 6 in. thick. Figure 3 shows the distribution of overlay thicknesses broken out by pavement type. The average overlay thickness for the plain pavements was 4.25 in., while the average overlay thickness for the reinforced pavements was 6.25 in. Thicker overlays retard the appearance of reflection cracking and should produce a lower-severity crack, significantly reducing the development of high-severity cracking. The thicker overlays are indicating a higher potential for medium-severity reflection cracking, which may indicate that the presence of reinforcing steel, joint spacing, and other factors may be significant in the performance of the overlay on a crack and seat project.

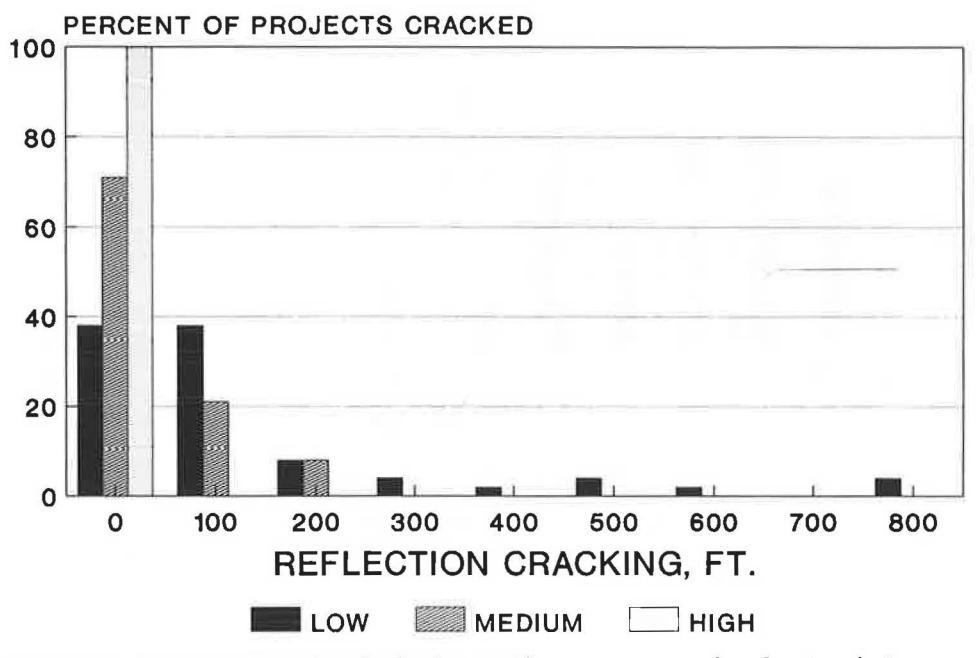
FIGURE 4 Amount and severity of reflection cracking present on crack and seat projects with no reinforcing steel.

The percentage of projects containing lengths of cracking (ft/1,000 ft) of low, medium, and high severity are shown in Figures 4 and 5. These figures indicate, for example, that 100 percent of the projects exhibited no high-severity cracking for the plain pavements, and 96 percent of the reinforced pavements had no high-severity cracking. These figures are separated to demonstrate any differences caused by the presence of reinforcing steel in the concrete slab, as this is felt to be a significant variable in the performance of crack and seat rehabilitation.

Figures 4 and 5 show that the reinforced pavements develop more high- and medium-severity cracking than the plain pavements. The plain pavements exhibit much more low-severity cracking, as demonstrated by the greater length of cracking found on the plain sections, which may be a function of shorter joint spacings not allowing the reflection crack to deteriorate.

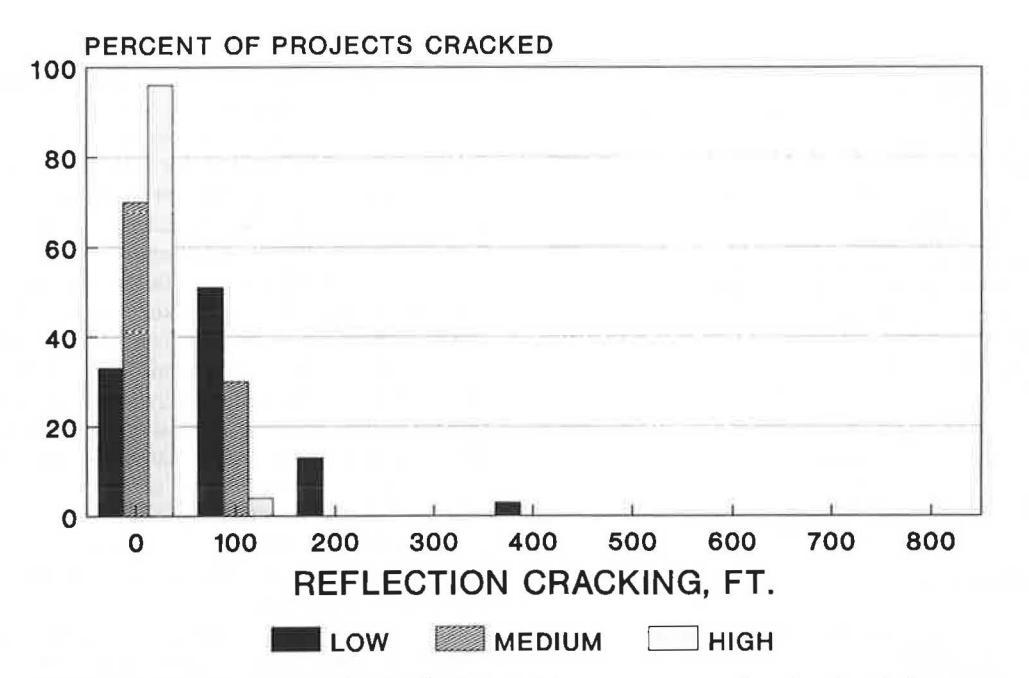
FIGURE 5 Amount and severity of reflection cracking present on crack and seat projects with reinforcing steel.

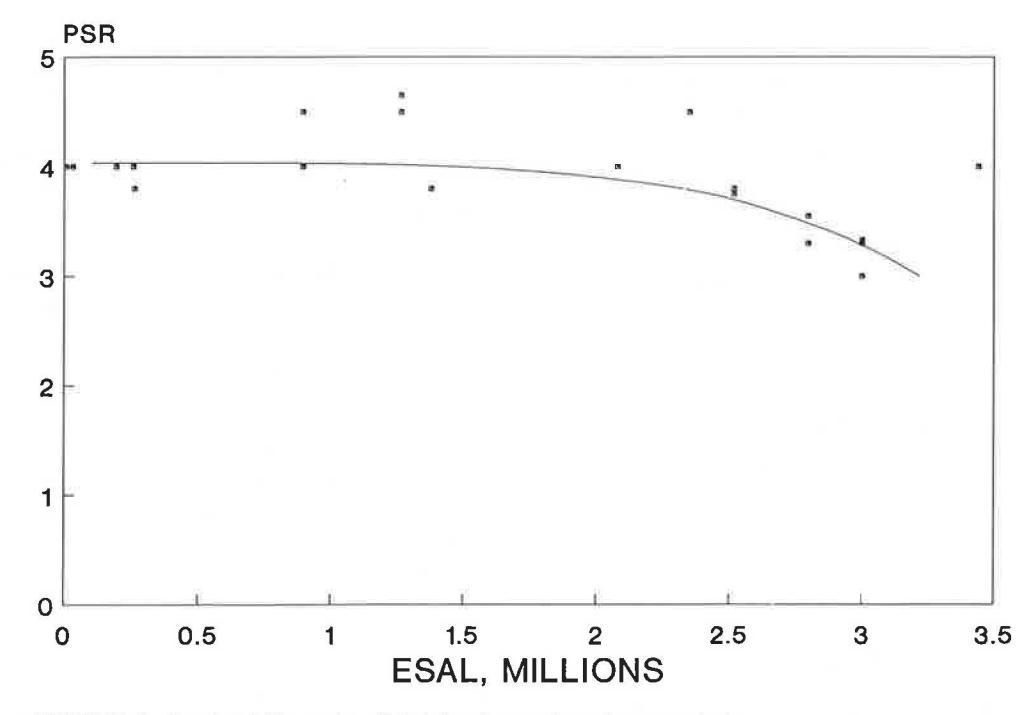
FIGURE 6 Serviceability rating (PSR) for the crack and seat projects.

Present Serviceability Rating (PSR) information was available from a small cross section of the crack and seat projects (twentyseven projects). The PSR curve for the crack and seat sections is shown in Figure 6. There is no tendency for the better performing pavements to have thicker overlays. The best performing projects were in the milder climates (California and Florida, with relatively thin overlays and mixed traffic levels).

This serviceability loss, which begins around 3 million ESALs, can be attributed to cracking, rutting, and possibly roughness induced by slab motion under traffic. The average rut depth for these projects was 0.15 in., with the maximum rut depth measured at 0.42 in., which may contribute to roughness on a few of the sections. In general, the higher rutting did not occur on the projects with lower PSR values, indicating that some design variable in the crack and seat procedure may be contributing to the development of the roughness. Similar correlations with the various forms of cracking also showed no direct relationship between the severity or amount of cracking and the roughness, further lending credence to the feeling that a design variable in the crack and seat process may be responsible.

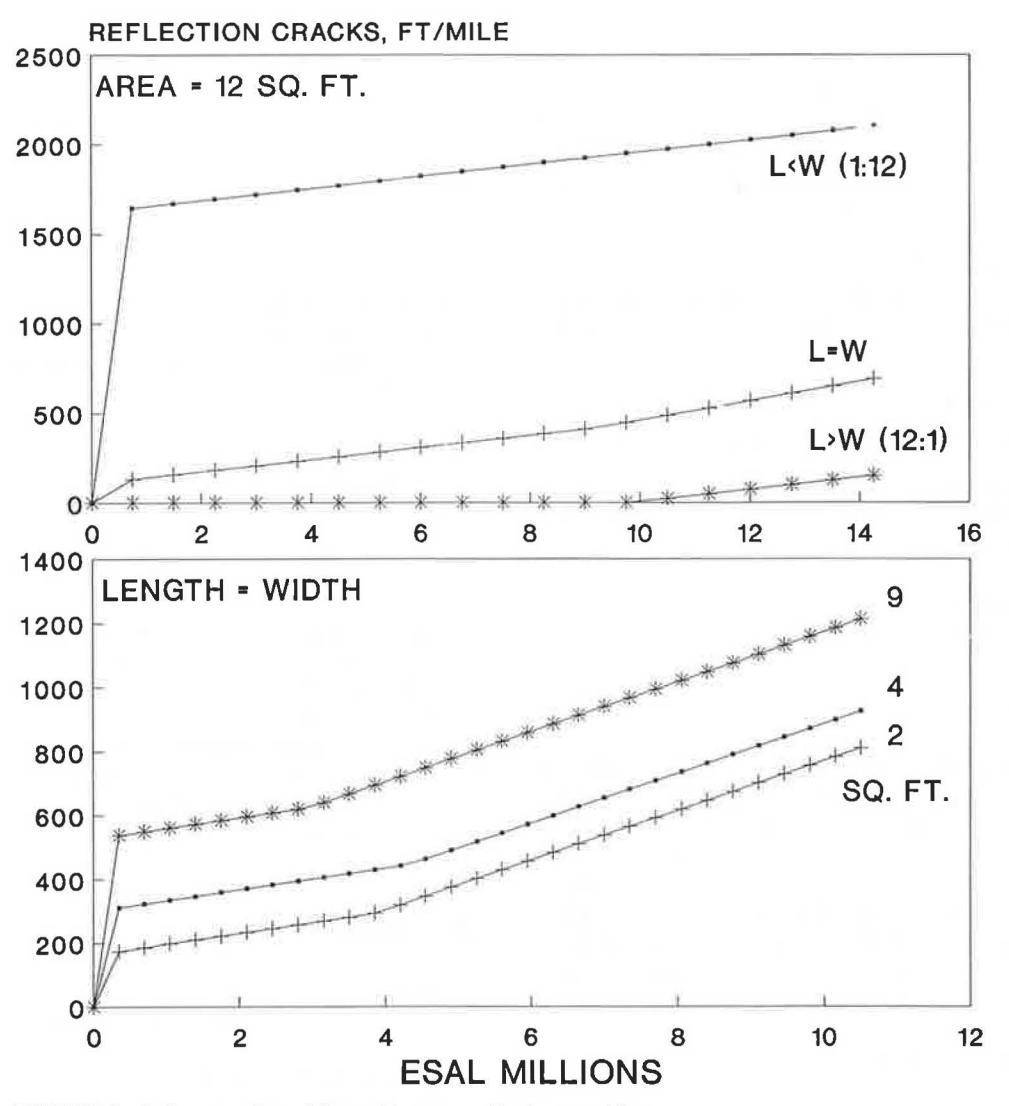
FIGURE 7 Influence of cracking pattern on reflection cracking.

Analysis of the area of the cracked sections shows that large areas should be avoided. The area shown on Figure 7 is calculated from length and width. The length-to-width ratio of the cracking pattern also influences the development of reflection cracking. The pattern should be kept nearly square as elongated pieces crack more readily.

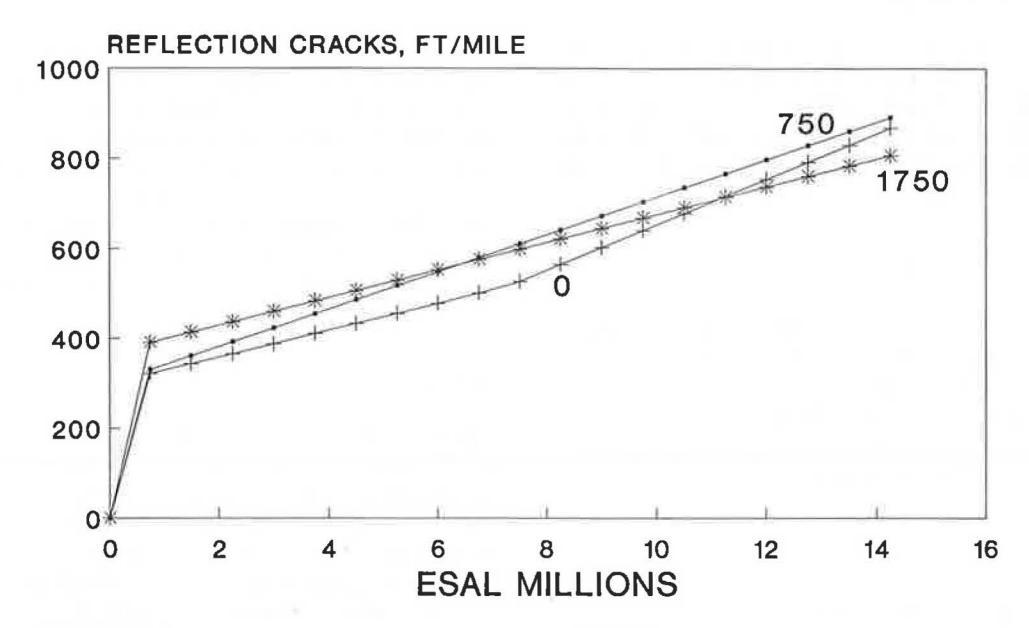
FIGURE 8 Influence of Freezing Index on reflection cracking.

More total reflection cracking can be expected in areas with higher Freezing Index (FI) values up to a certain age, as shown in Figure 8. The FI value relates directly to the amount of thermal activity that produces movement in the joint, propagating the reflection crack.

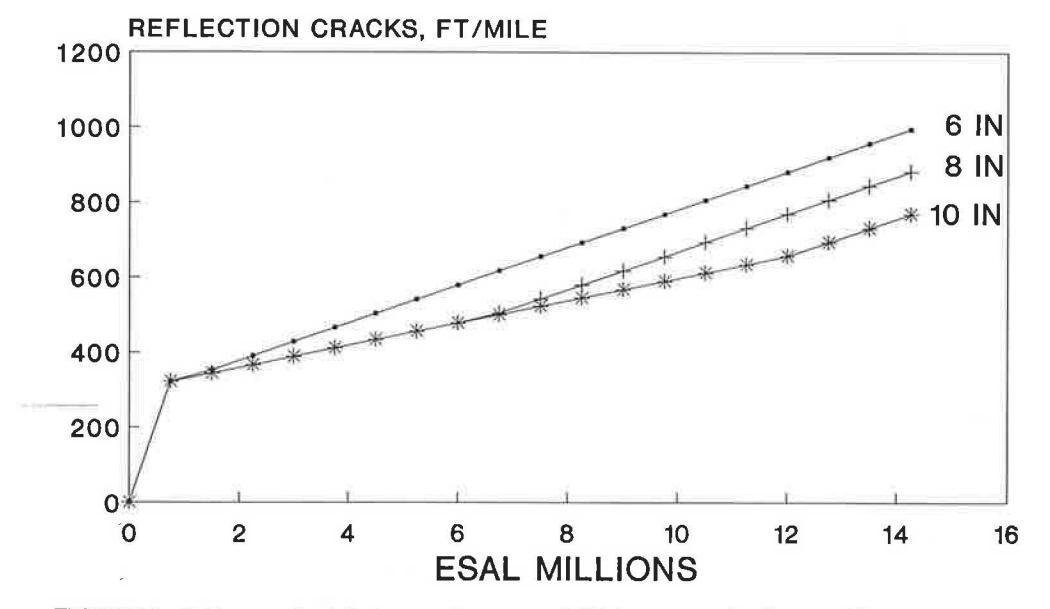
FIGURE 9 Influence of original concrete pavement thickness on reflection cracking.

The thickness of the original Portland cement concrete (PCC) slab affects medium- and high-severity cracking but does not alter the development of low-severity cracking, as shown in Figure 9.

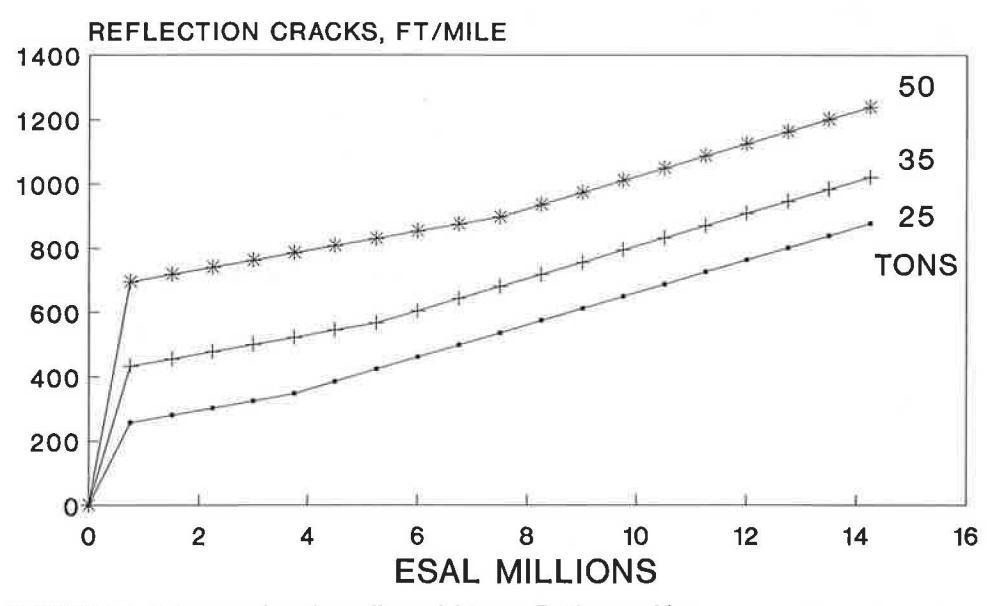
FIGURE 10 Influence of seating roller weight on reflection cracking.

Heavier rollers to seat the cracked sections will produce more low-severity reflection cracking while it reduces the development of medium- and high-severity cracking, as shown in Figure 10. The use of heavy rollers may alter the cracking effectiveness and change the development of low-severity cracking. The effectiveness of the cracking is a critical element in the performance of crack and seat; it cannot be evaluated from distress surveys and thus cannot be included in this analysis. The use of the heavier roller to seat the cracked sections delays the progression from low- to medium- or high-severity and may thus be beneficial.

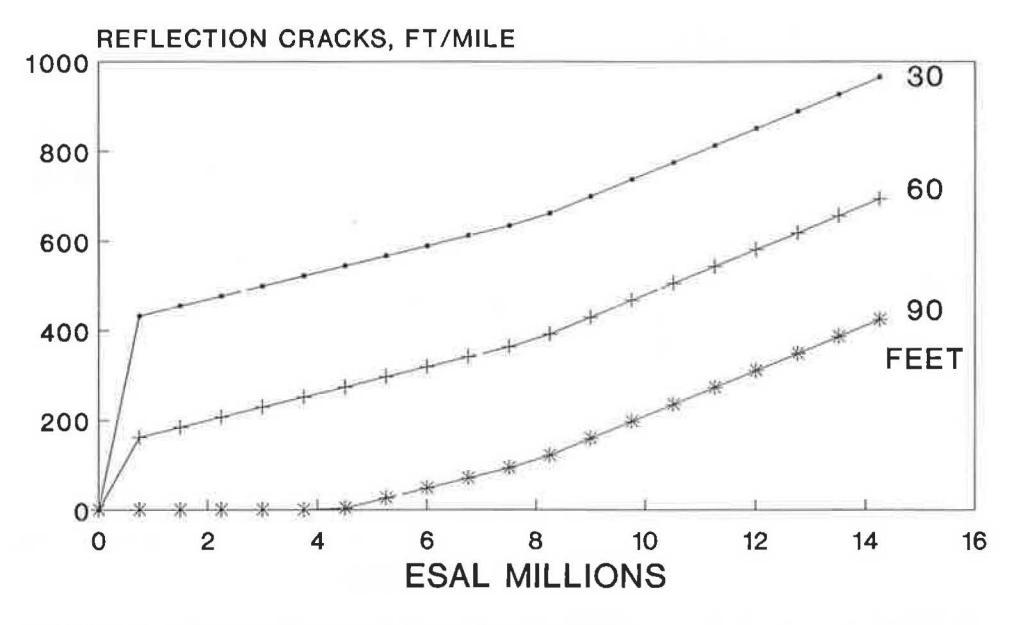
FIGURE 11 Influence of joint spacing on reflection cracking.

Longer joint spacings produce less total length of cracking in the overlay than do short joint spacings, as shown in Figure 11. This is due partly to the fact that there are fewer joints in a long jointed pavement. An examination of cracking as a percent of joints may be warranted as a better indicator of the performance of the procedure.

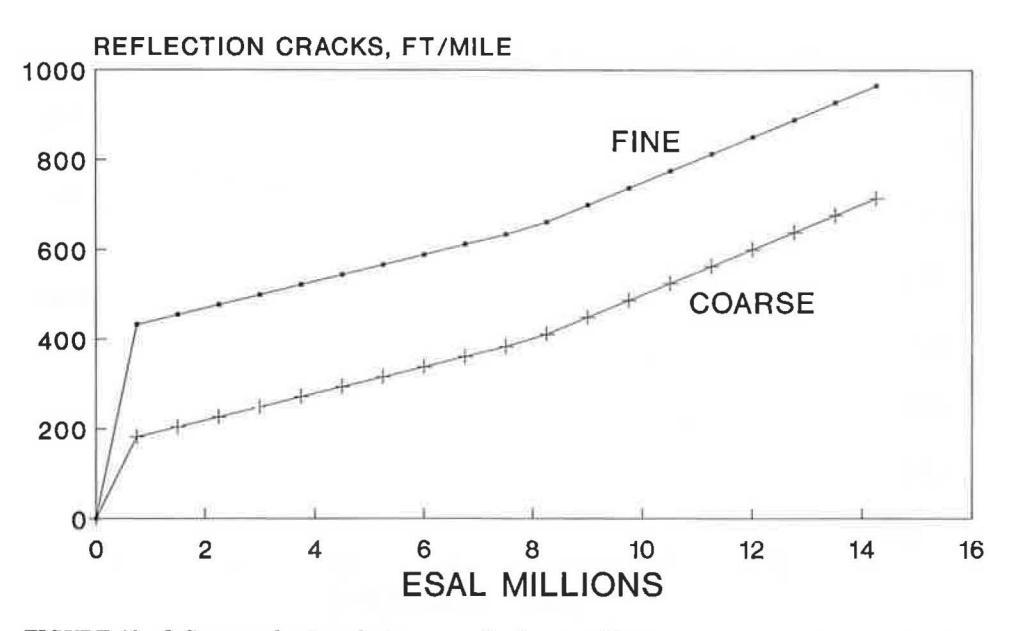
FIGURE 12 Influence of subgrade type on reflection cracking.

The presence of a coarse-grained subgrade soil greatly reduces the amount of low-severity cracking but has no effect on the development of medium- or high-severity cracking, as shown in Figure 12. Better subgrade support allows slightly larger cracked pieces to be produced in the cracking operation, although no correlation is available to relate an optimum size to a subgrade support factor. Poor subgrades generally indicate the need for drainage prior to the crack and seat operation. A thorough evaluation should be performed.

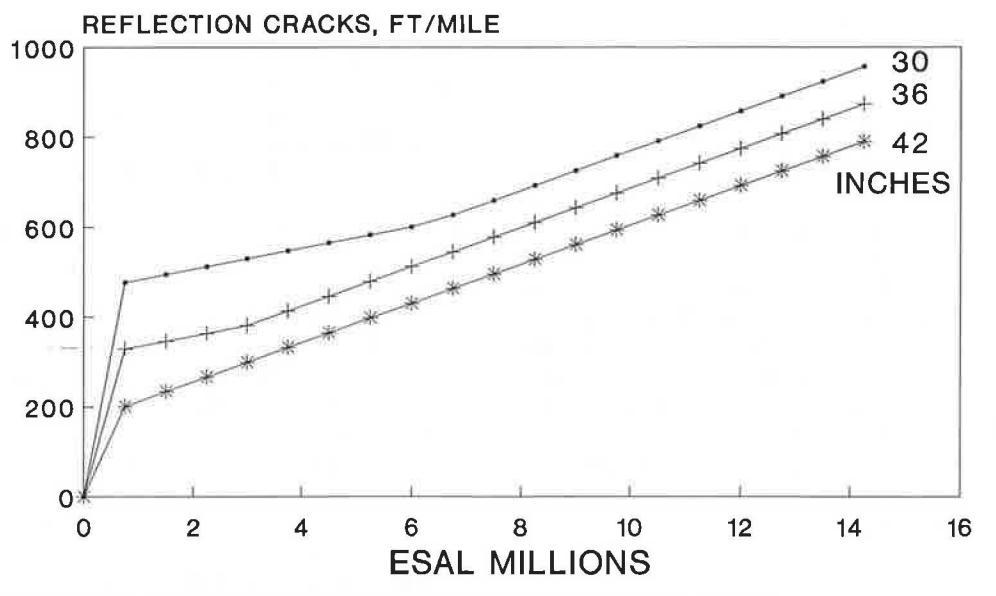
FIGURE 13 Influence of annual precipitation in inches on reflection cracking.

The climatic variables illustrate the impact of environment on reflection cracking performance. Areas with larger annual rainfall showed lower amounts of low-severity cracking, while the development of medium- and high-severity cracking is greater in these same areas, as shown in Figure 13. Mediumand high-severity cracking develops over time, and higher annual rainfall may produce a lower support in the subgrade that accelerates breakdown of existing cracks. The higher amount of low-severity cracking in areas having low rainfall may be due to greater temperature variations. The combined effects of the climatic factors cannot be totally separated and investigated independently. The annual average temperature and monthly average temperature range combine with the annual precipitation to describe the general climate in the area. Generally, the areas with warmer annual temperatures and a smaller temperature range performed better.
