Antigo Construction Family of Companies

Nighttime Rubblization and Asphalt Overlay Project Examples

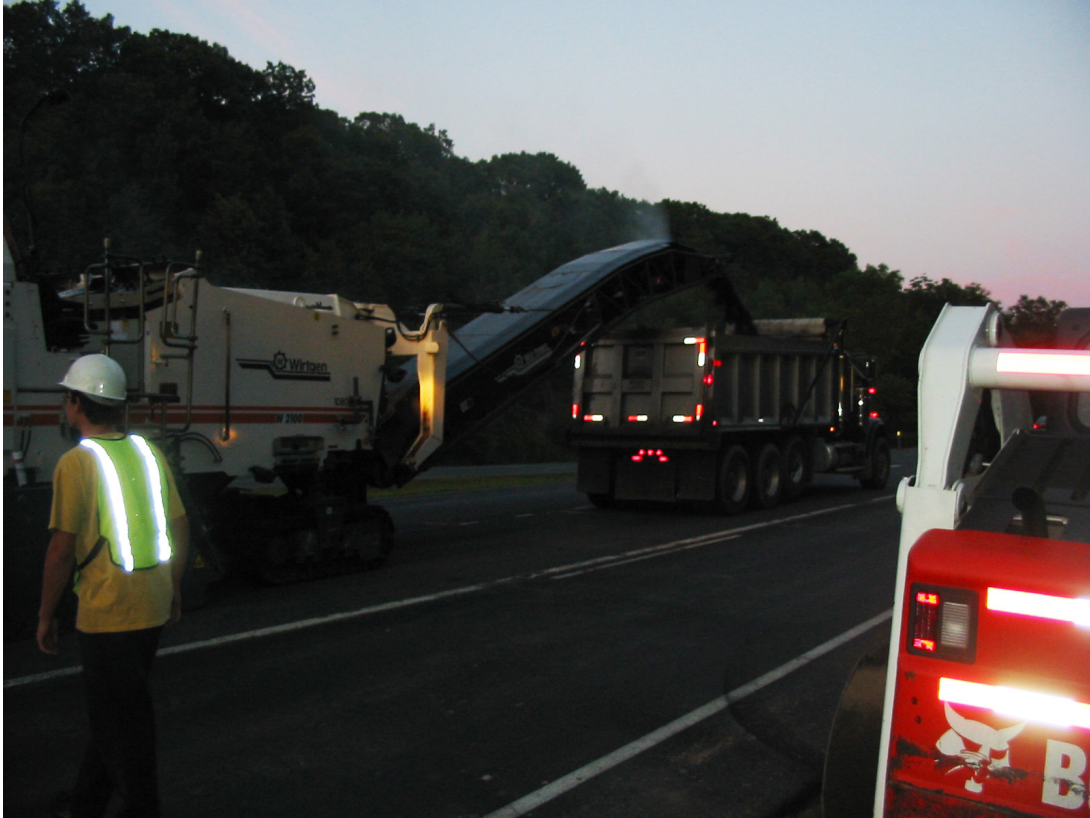
Milling off existing asphalt overlay in one lane.

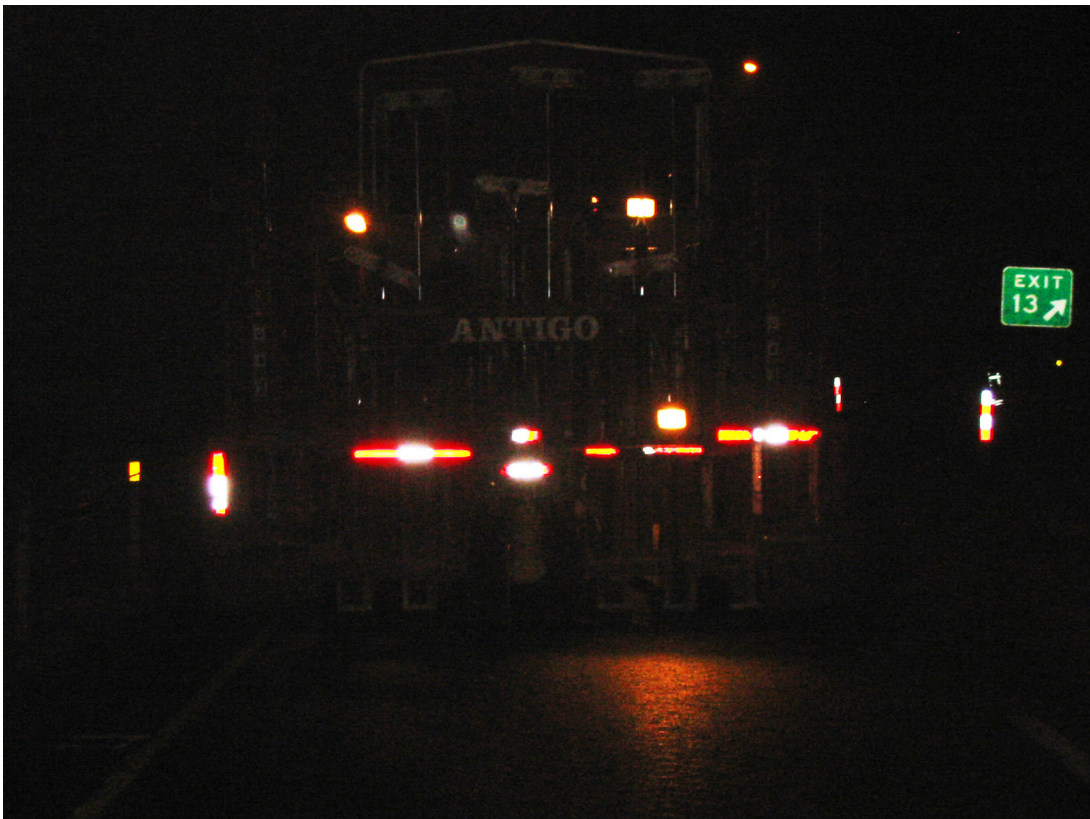
MHB Badger Breaker® rubblizing at night.

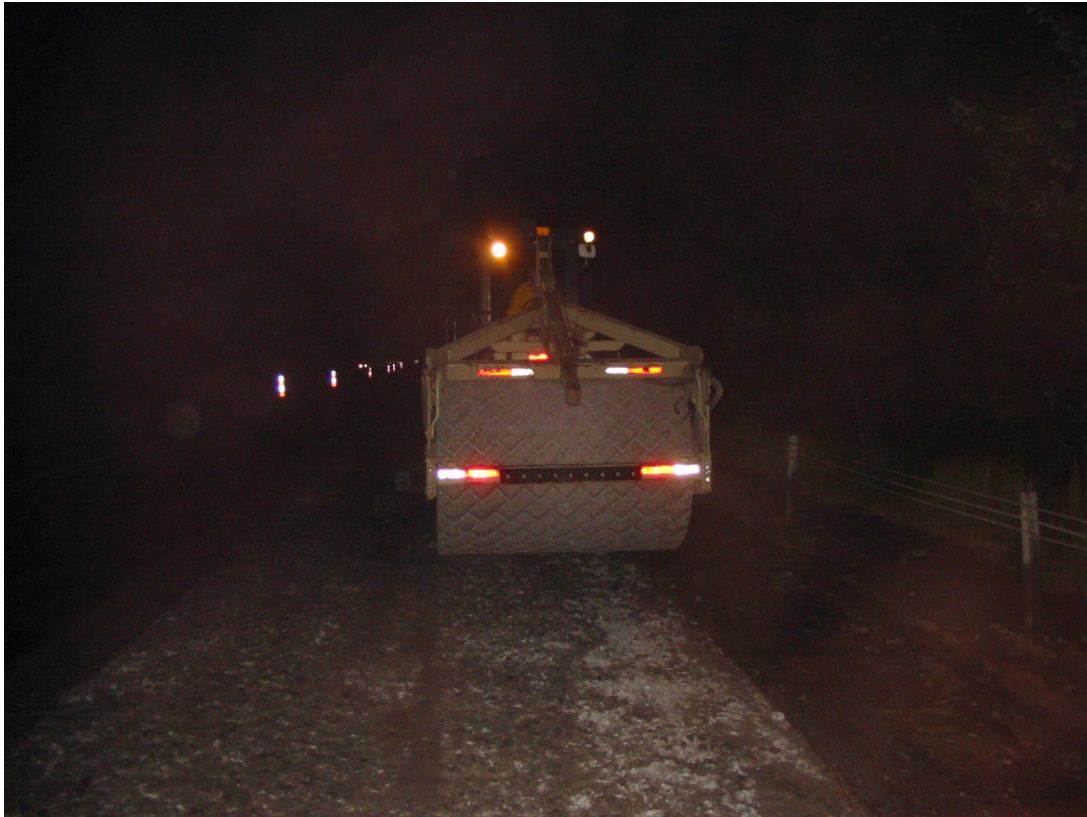
Grid roller pulverizes surface particles and begins compaction of rubblized concrete.

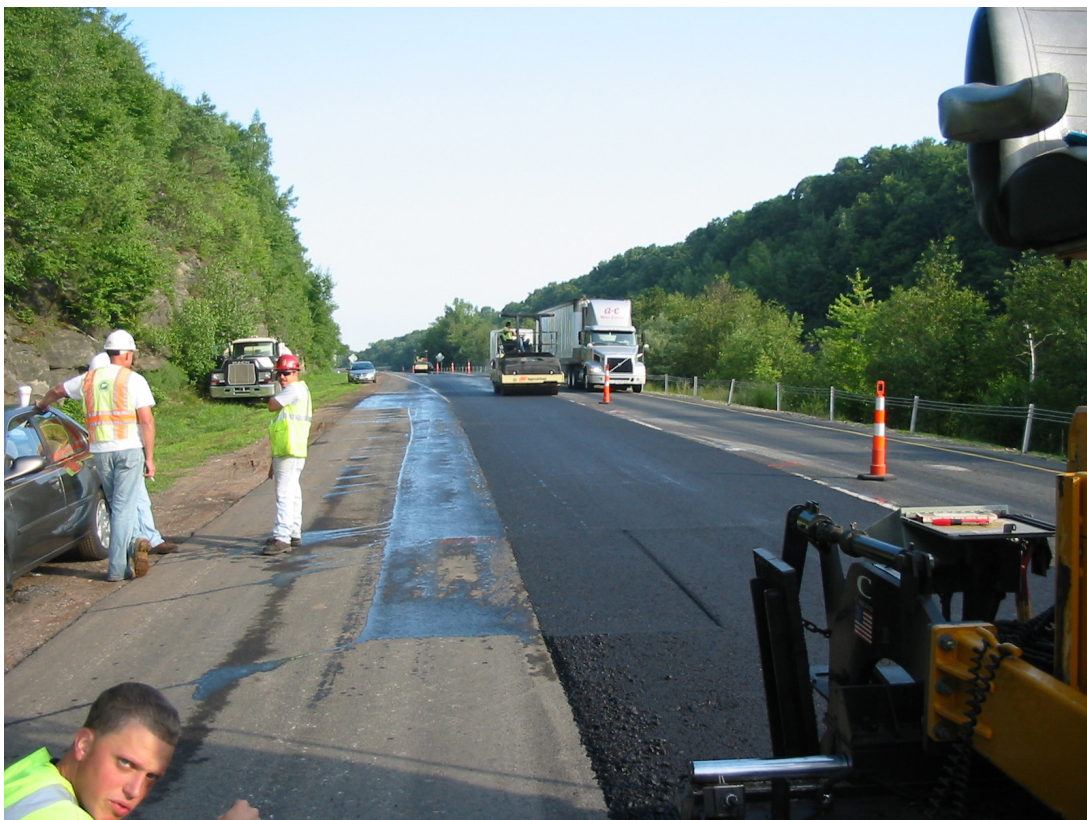
Finishing paving early next morning. Note that first lift of new asphalt overlay matches up with existing overlay on adjacent lane.

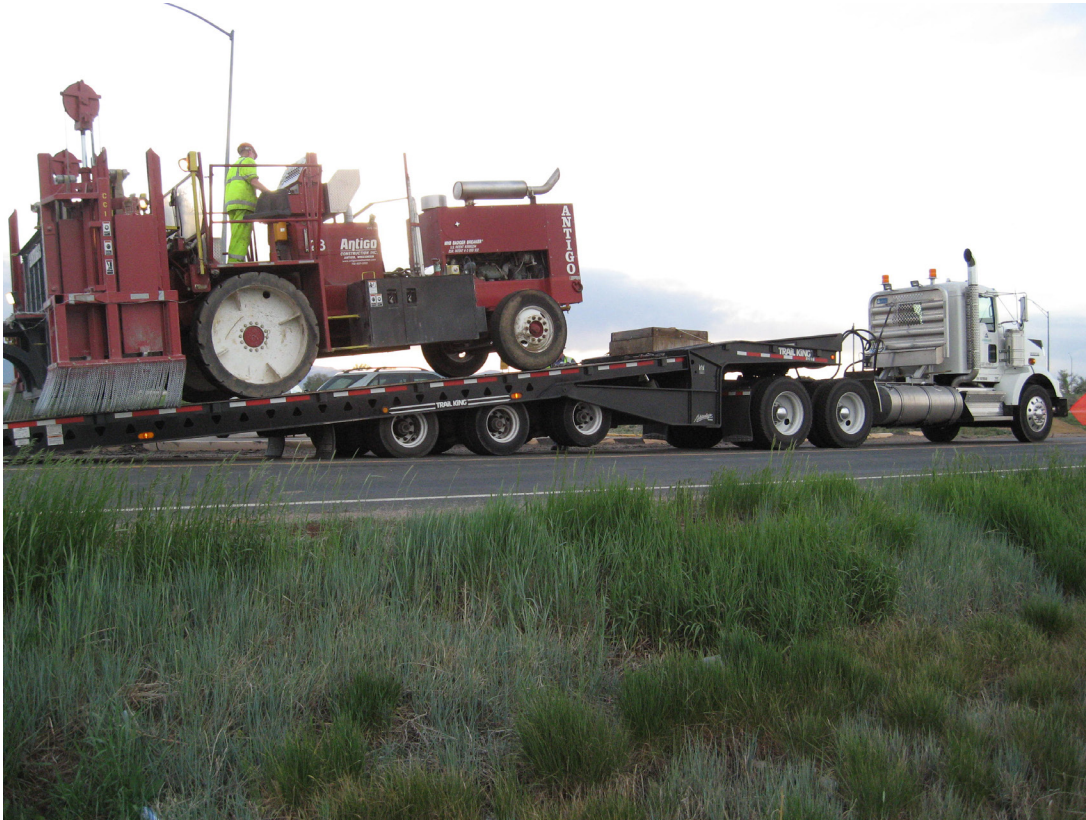
Delivering MHB Badger Breaker® to site each evening.

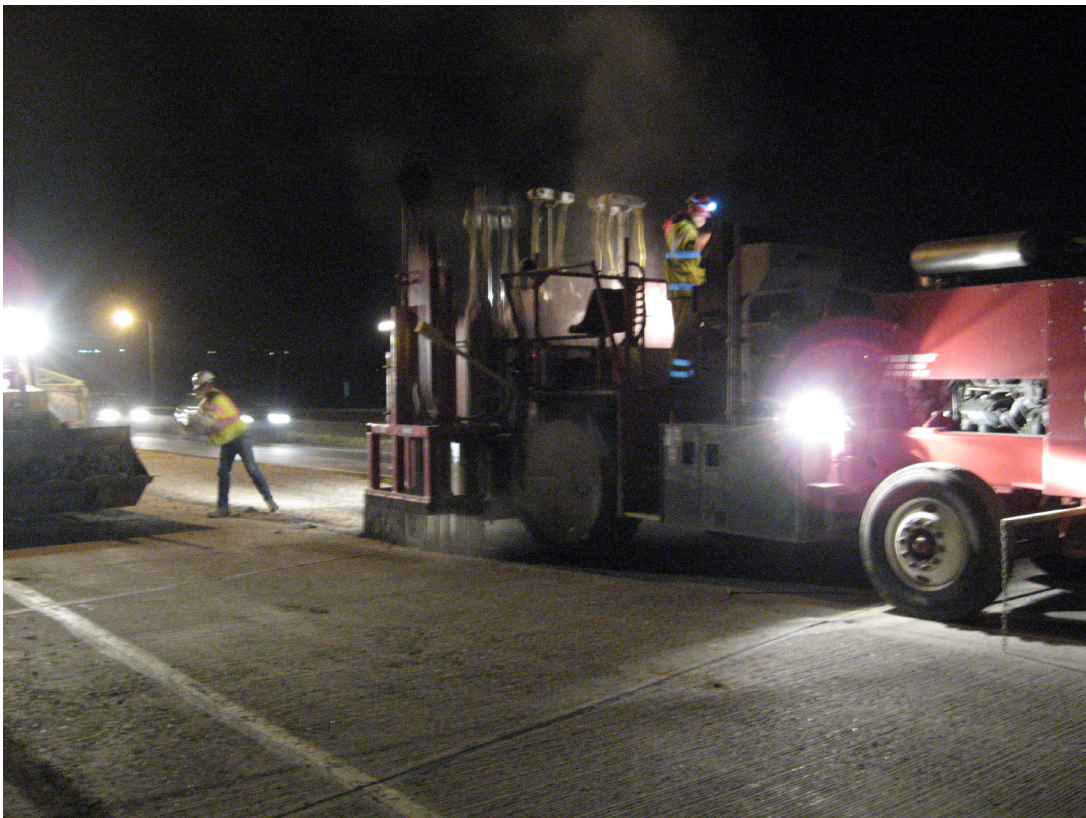
MHB rubblizing followed by crew removing miscellaneous joint sealant and patching.

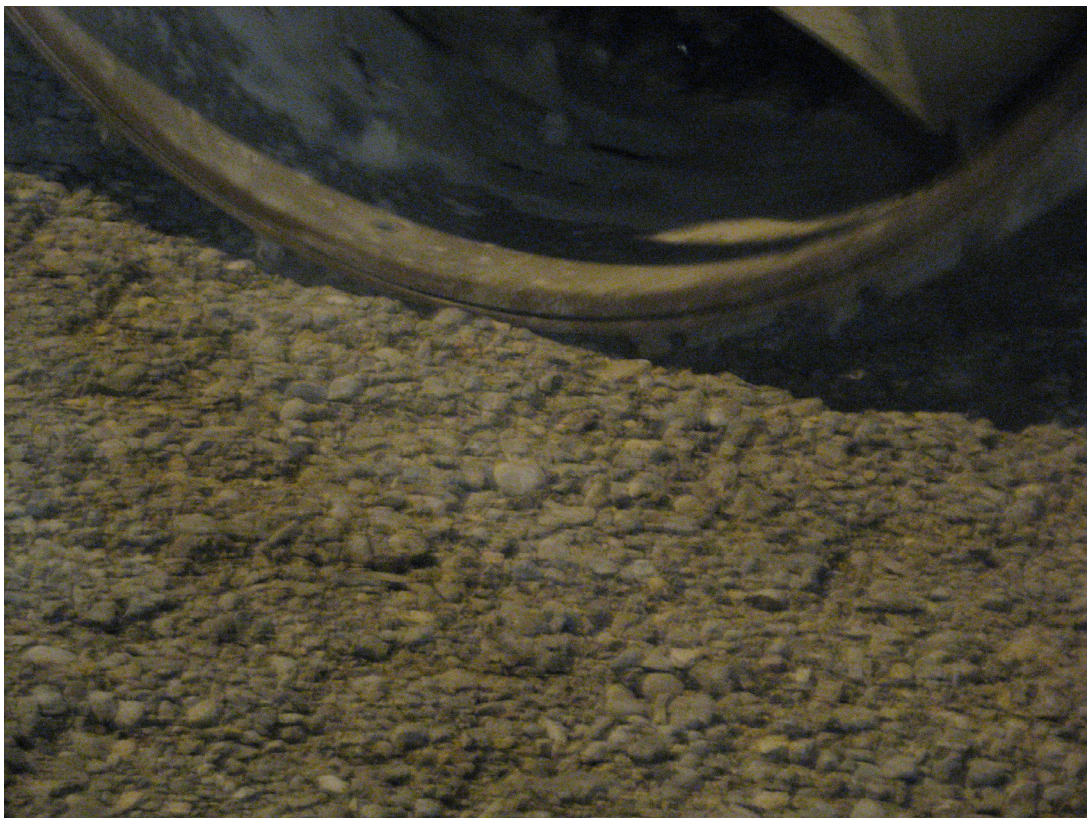
Close up of grid roller pulverizing surface particles.

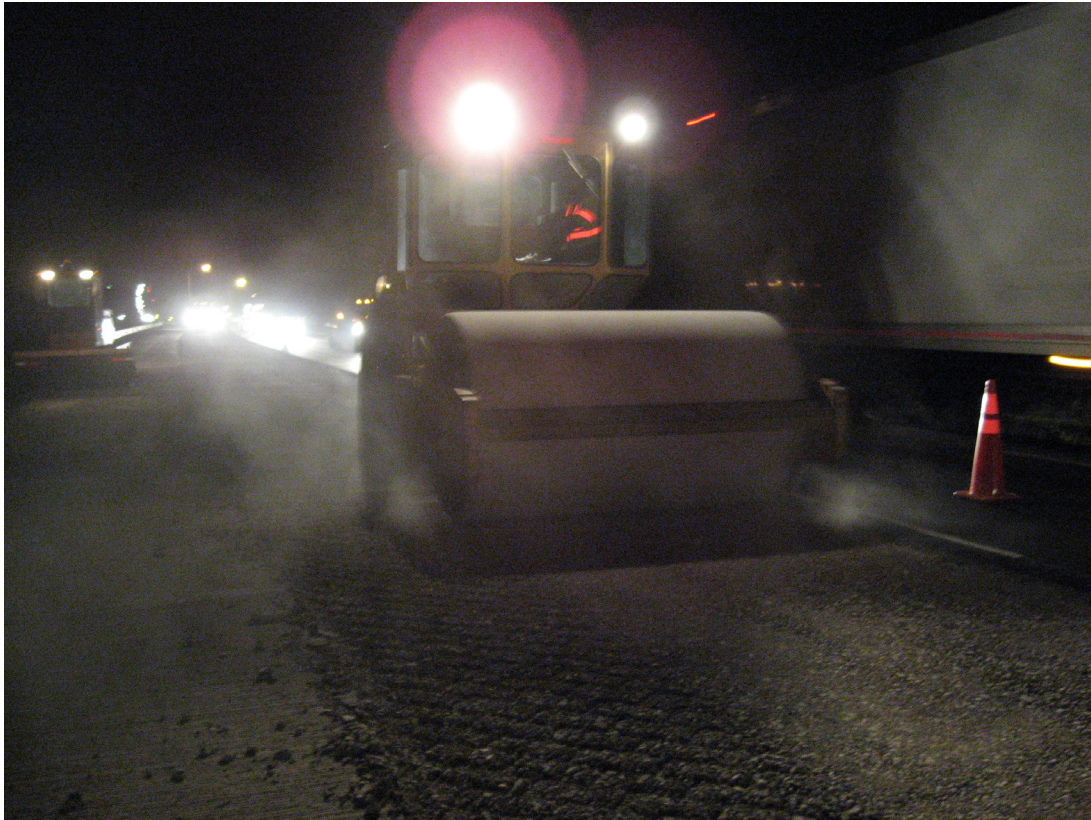
Smooth drum roller completing the rolling.

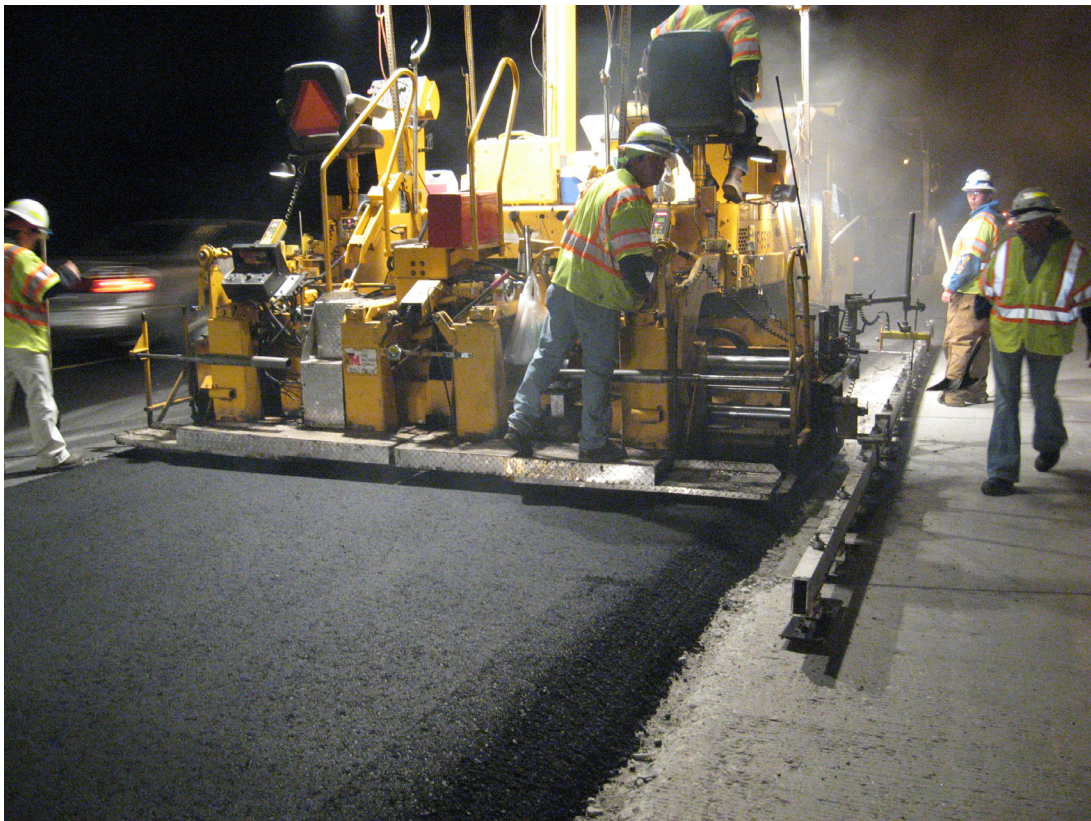
Paving first lift of asphalt overlay.

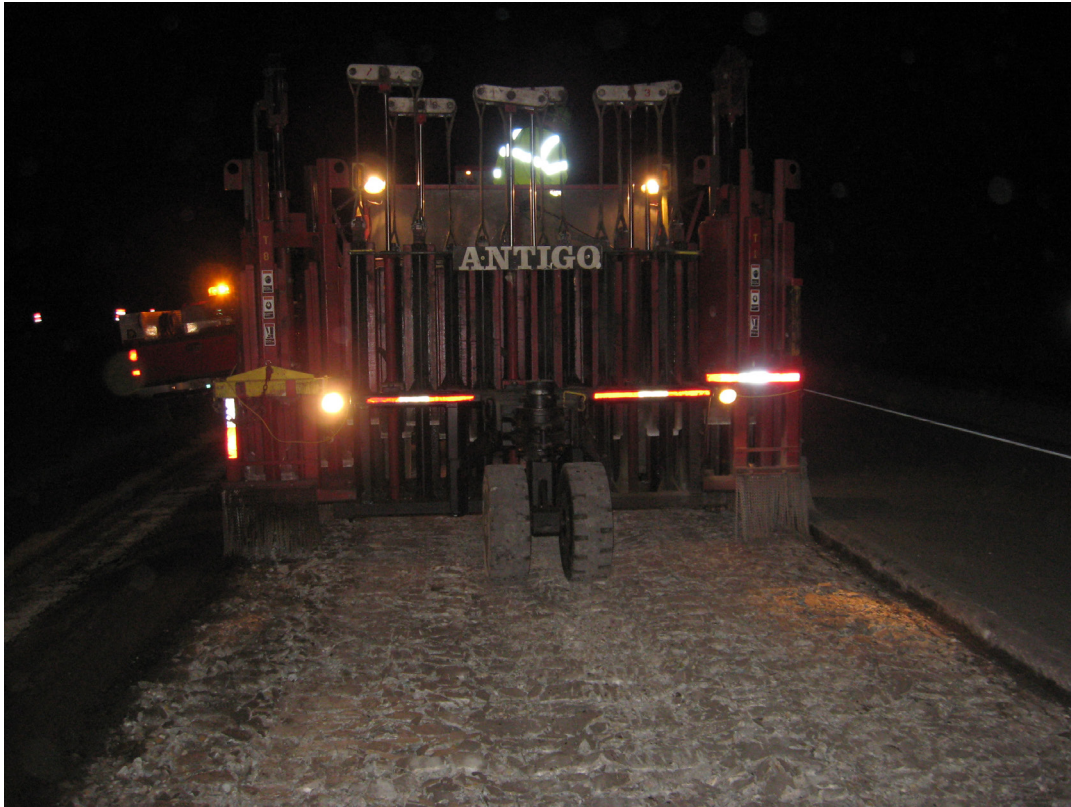
MHB Badger Breaker® rubblizing at night after existing asphalt overlay milled off.
Note existing asphalt overlay in place on right lane.

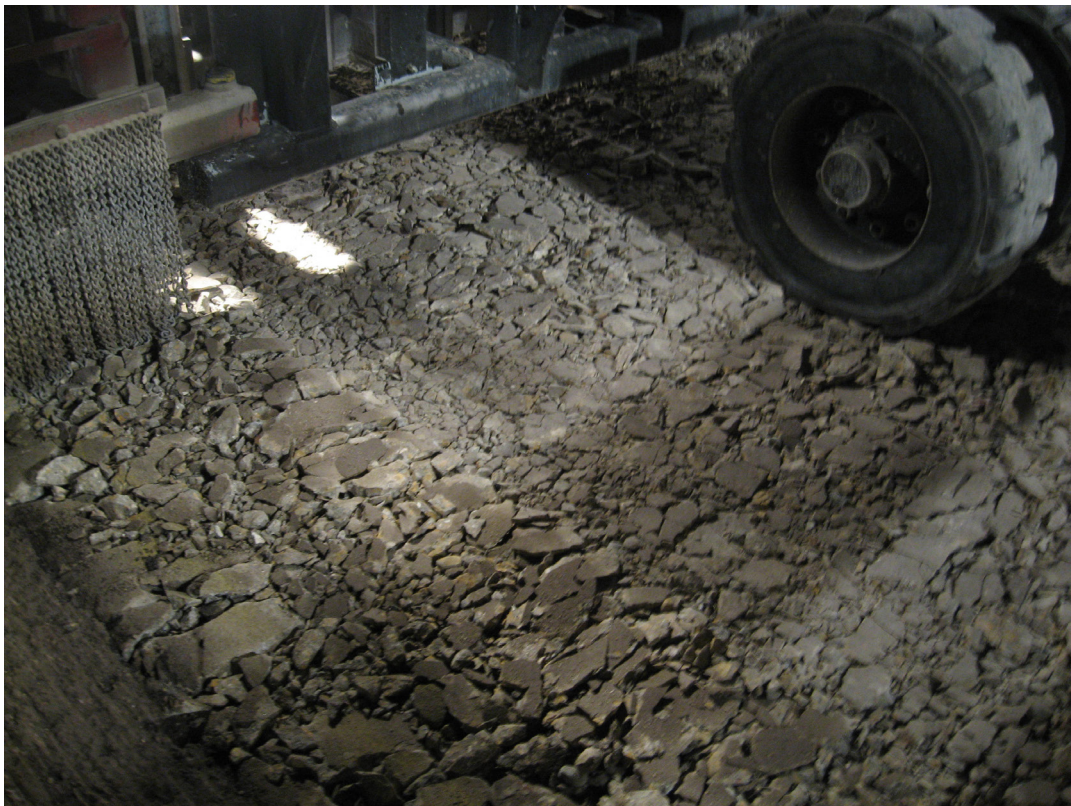
Close up of rubblized surface prior to rolling.

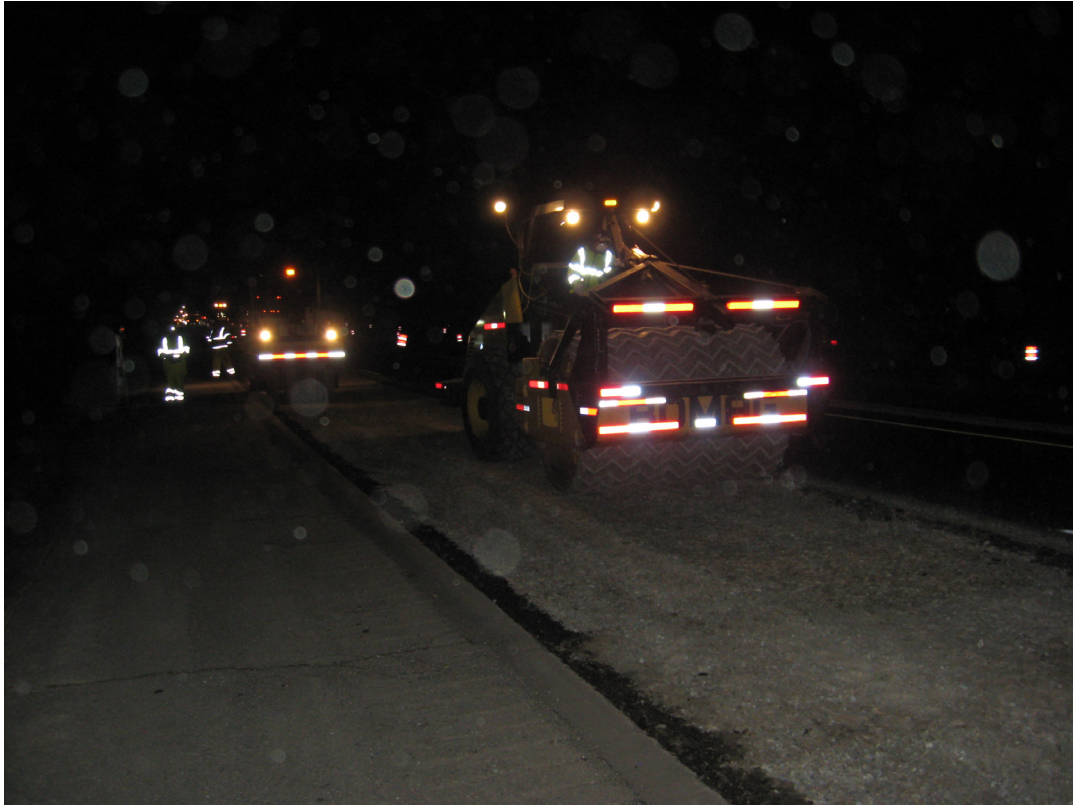
Grid roller pulverizes surface particles and begins compaction of rubblized concrete.

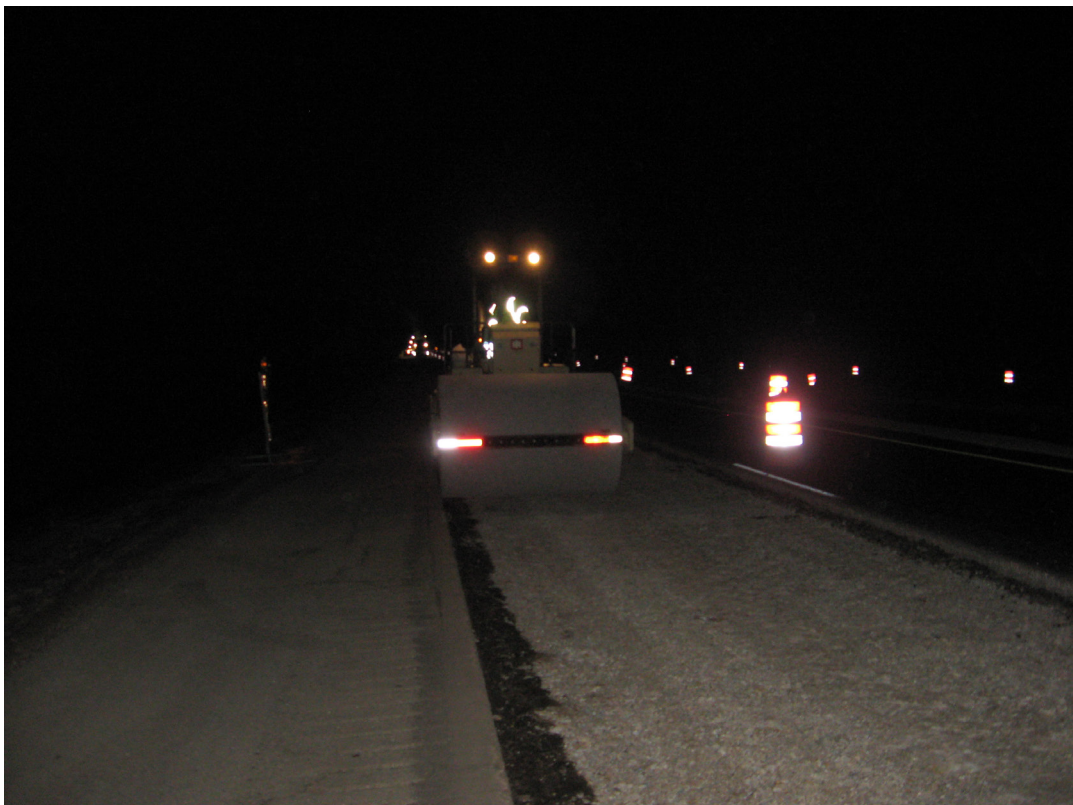
Smooth drum roller completing the rolling.

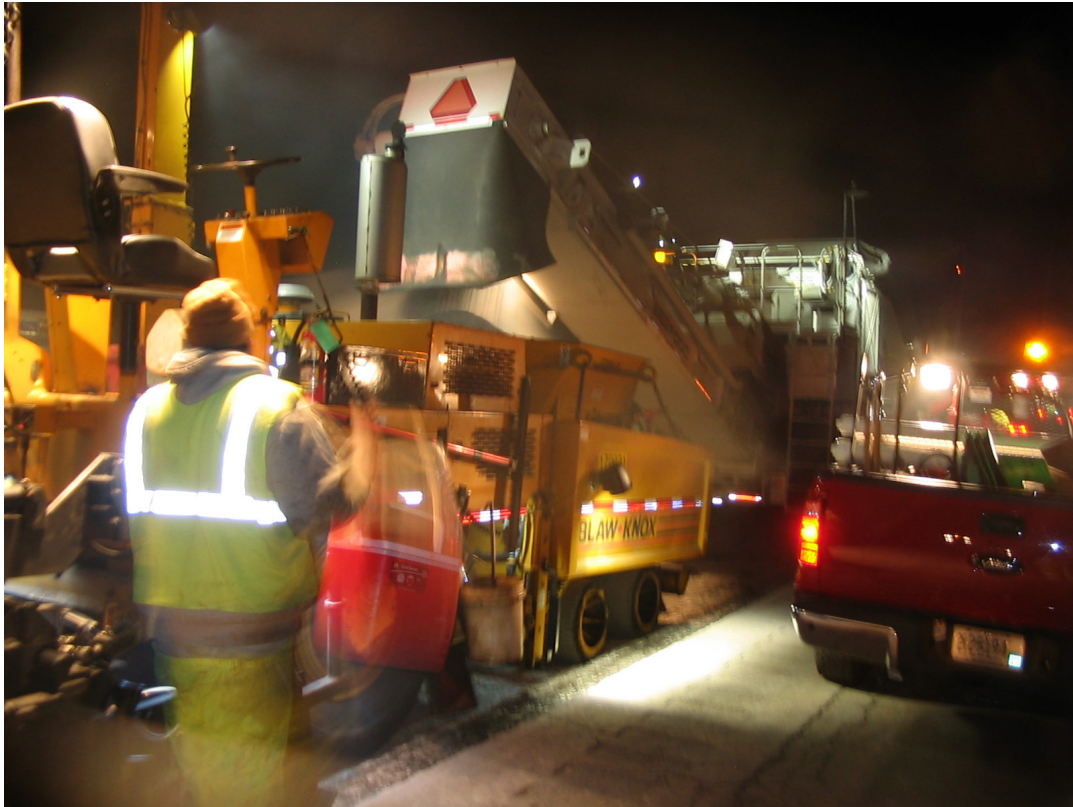
Paving asphalt overlay using Material Transfer Vehicle (shuttle buggy).
