## The right CSOL-ution

# Washington State DOT's last-ditch play against aging pavements is a unique success

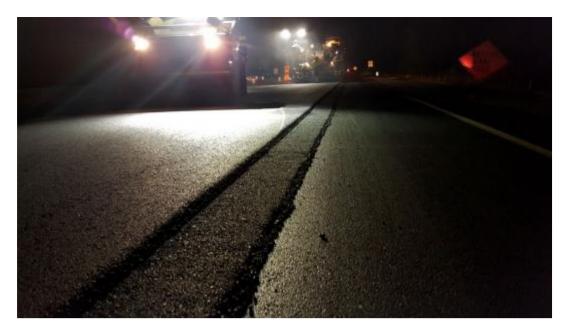
*Paving crews worked the inside lanes at night utilizing the notched wedge joint on the shoulder lane.*

ICON's paving train for each crew typically consisted of a Roadtec SB-2500 Shuttle Buggy material transfer vehicle, a Caterpillar AB1055E paver, a Dynapac CC624HF roller in breakdown mode, a Hypac pneumatic roller in the middle, and a Cat CB54 finish roller. Pavement edges left open to traffic between closures were paved to meet WSDOT's notched-wedge joint specification, providing non-abrupt transition edges for traffic and resulting in high-quality, high-density longitudinal joints when echelon paving was not practical.

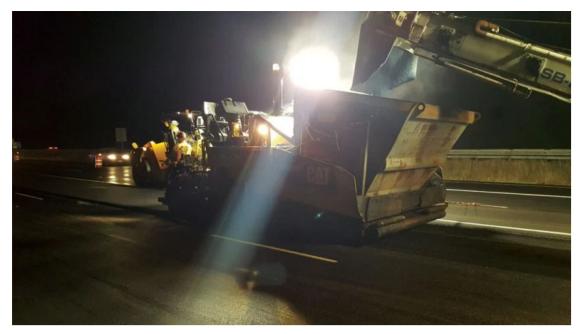
*Crews perform WSDOT's "most ambitious" CSOL project on a busy section of I-5 in King County, just south of Seattle's urban core.*

WSDOT performed its first modern CSOL project in 2011 on I-5 near the city of Burlington, about 50 miles south of the Canadian border. With the favorable results of that project and with additional lessons learned from two CSOL projects on I-90 in the intervening years, WSDOT was ready in 2015 to put this strategy to work on its most ambitious "conversion" project to date—the crack, seat and overlay on a busy section of I-5 in King County, just south of Seattle's urban core.

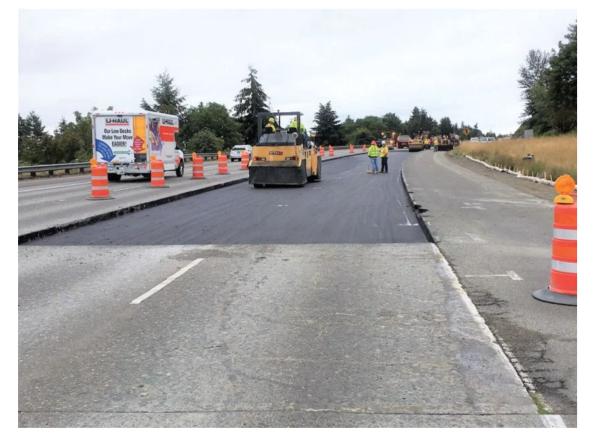
A 35-ton pneumatic roller reseats concrete panels on I-5.

The effectiveness of the cracking process was initially evaluated within a 500-ft test section. After getting "dialed in," Antigo set to work with the T8600, cracking each of the 2.5-mile lanes in five to six hours. The operation was monitored continuously for compliance with WSDOT's specifications for both the cracking pattern and for full-depth vertical cracking effectiveness. MidMountain then permanently "seated" the cracked concrete slabs using a 35-ton pneumatic roller.

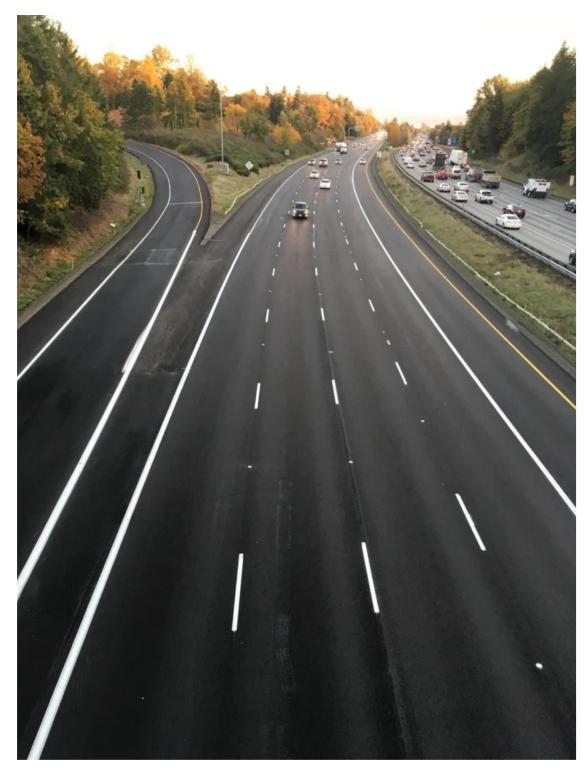
*The CSOL road segment of I-5 after paving completion.*

The quality of the finished pavement speaks for itself (albeit in a soft, smooth whisper). The resulting average IRI on the newly paved CSOL road segment is 46 in. per mile, with the outside passing lane the smoothest of all at 41 in. per mile. Compaction levels on all the paving lifts averaged greater that 93% of maximum theoretical density, with the wearing course lift exceeding 94% density across the board.
